North and South Delta Seepage Well Monitoring Network Update

Memorandum Report
April 2015

Subject: North and South Delta Seepage Monitoring Program Well Status Update

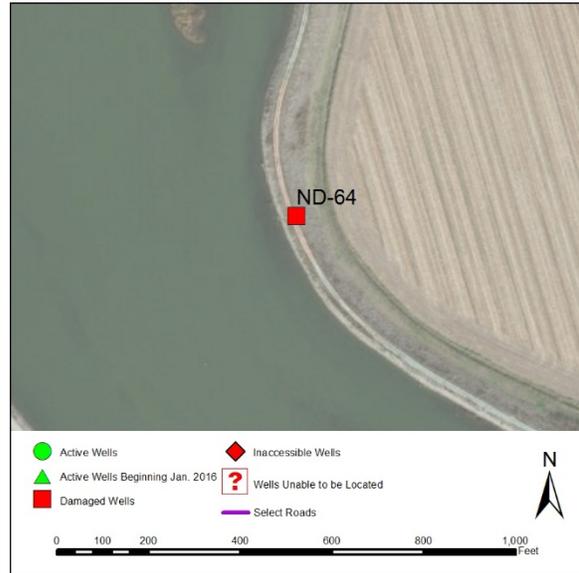
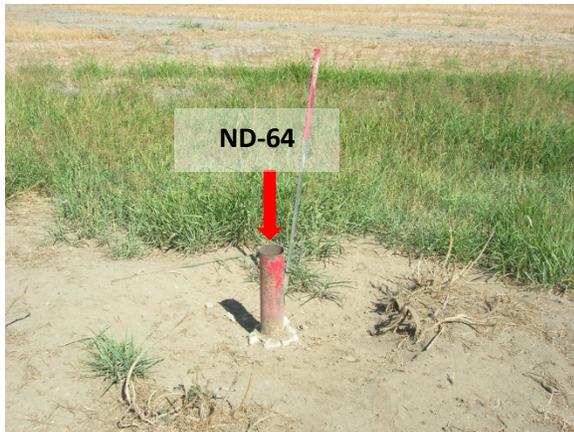
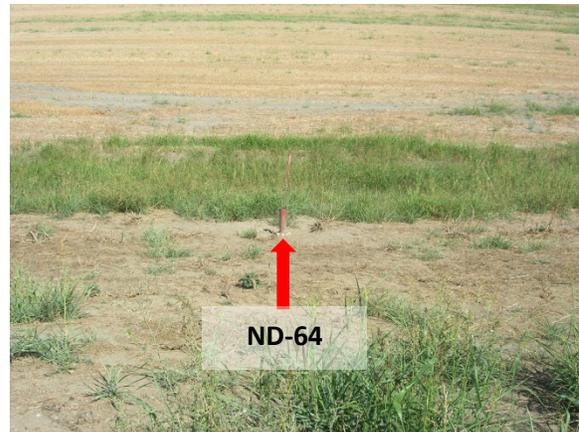
Comments: This well has an obstruction approximately 8ft down from the reference point and the last accurate reading occurred in May 2013. The cap is missing.

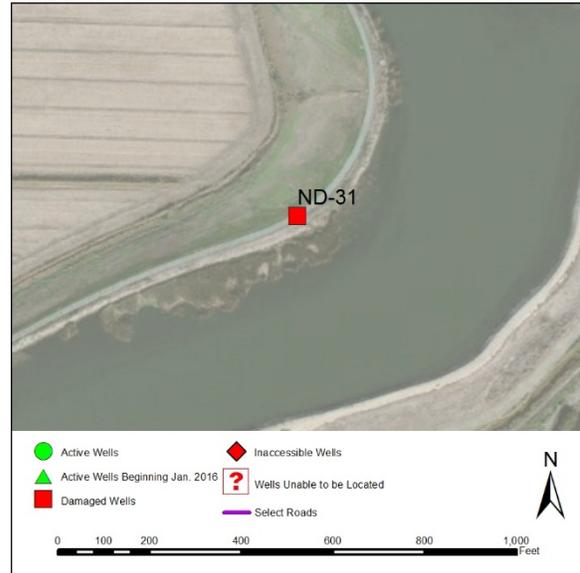
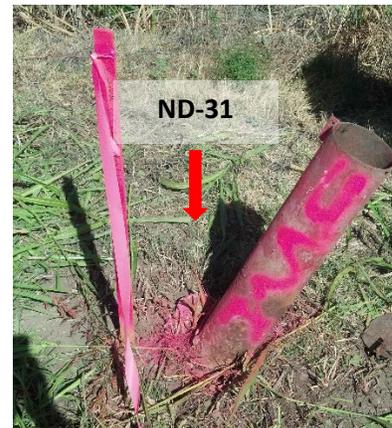
Comments: The well has been damaged. The well is located at the levee toe and marked with a wood stake. The well was damaged when hit by a tractor, with the last accurate measurement occurring in May 2013.

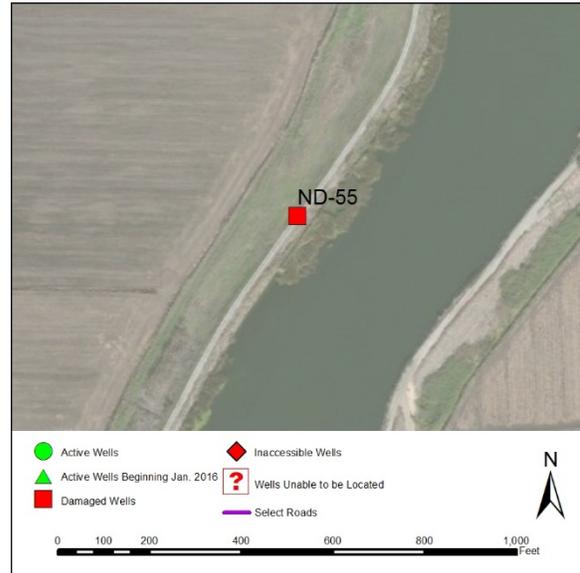
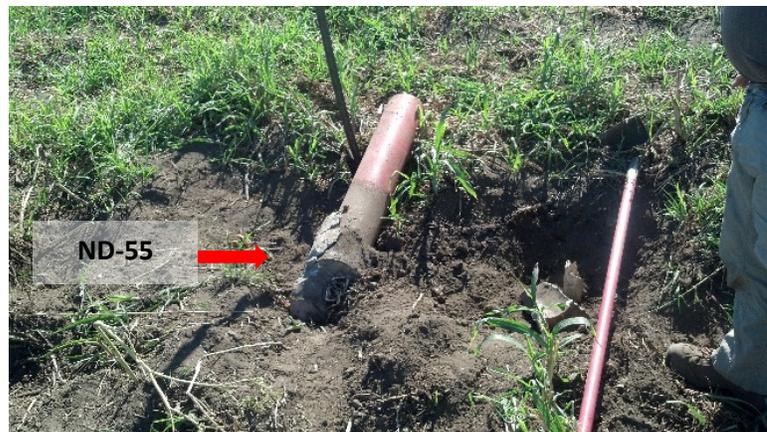
Comments: The well has been damaged. Well was hit by something in September 2011.

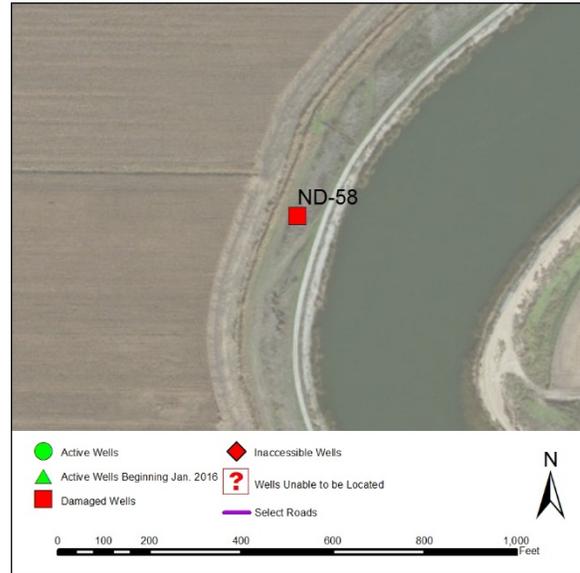
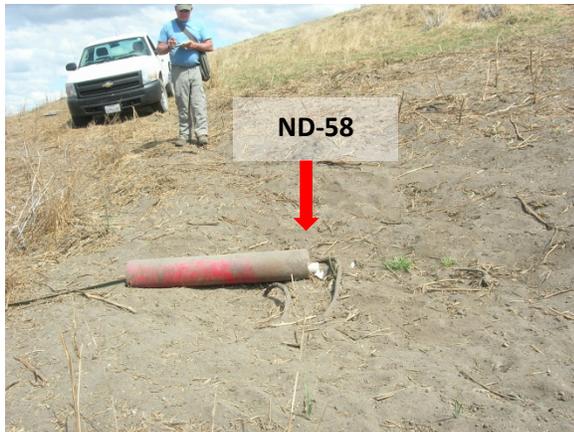
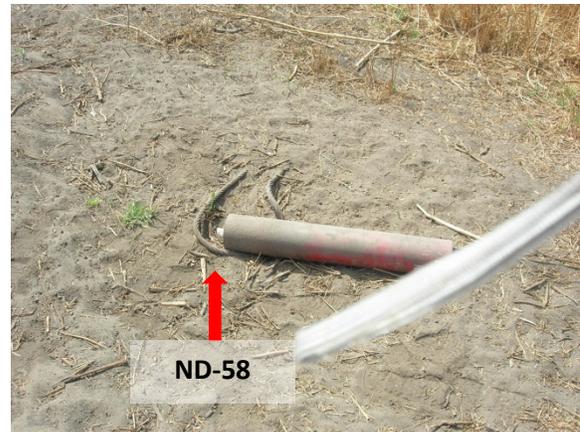
Comments: The well has been damaged. Last accurate measurement was July 2014. The well was damaged between July and September 2014. Located on the levee slope.

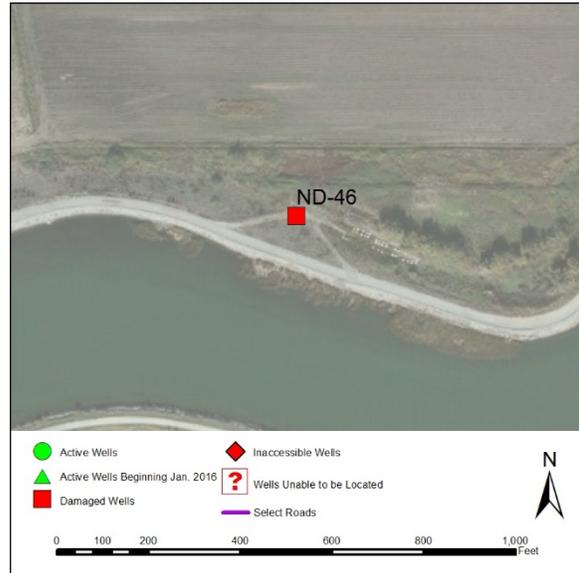
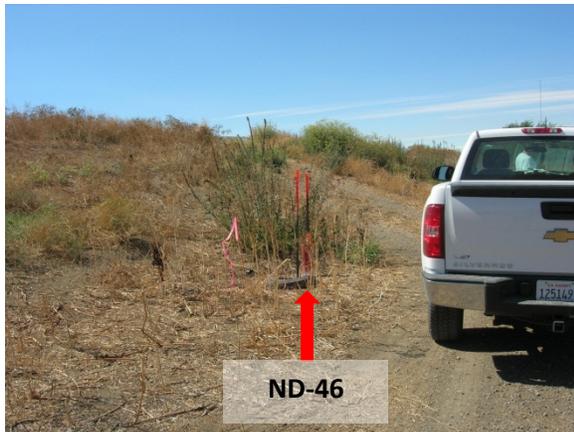
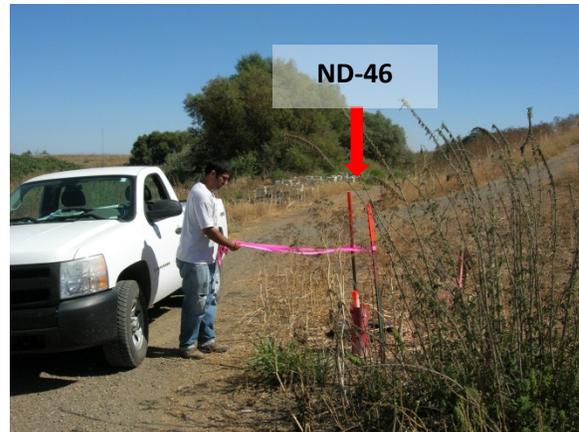
Comments: The well has been damaged. The well is located at the levee toe, next to the access ramp.

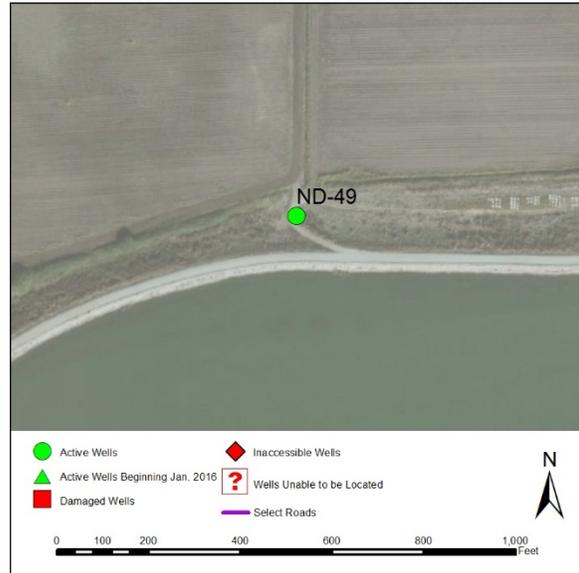
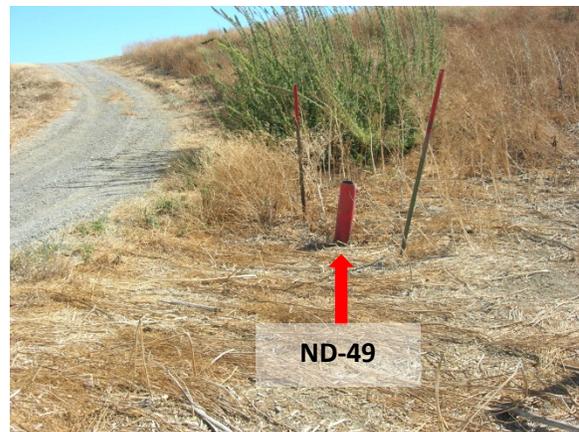
Comments: The well is located at the bottom of the access ramp, and marked by two red t-posts. The casing cap is missing.

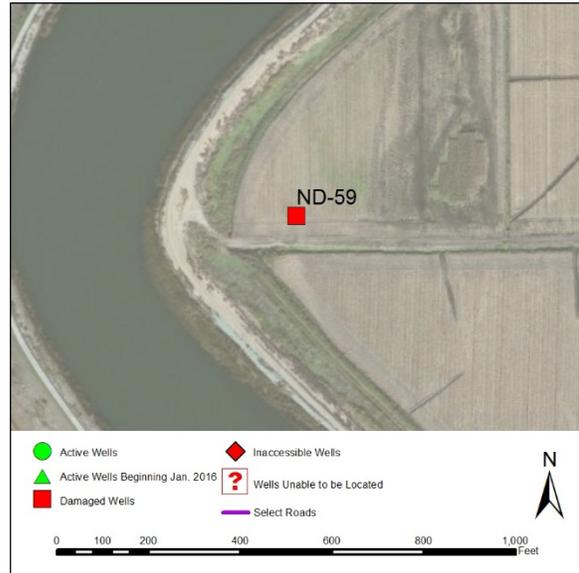
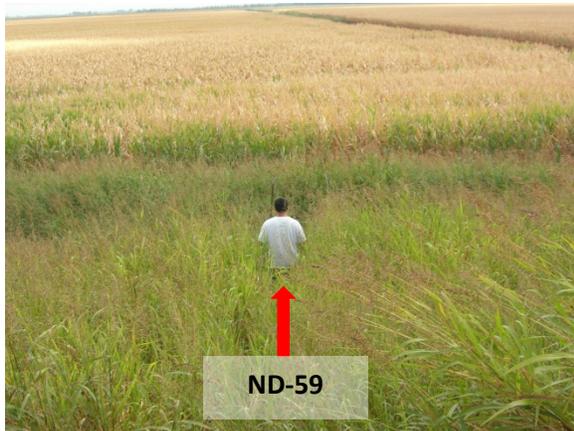
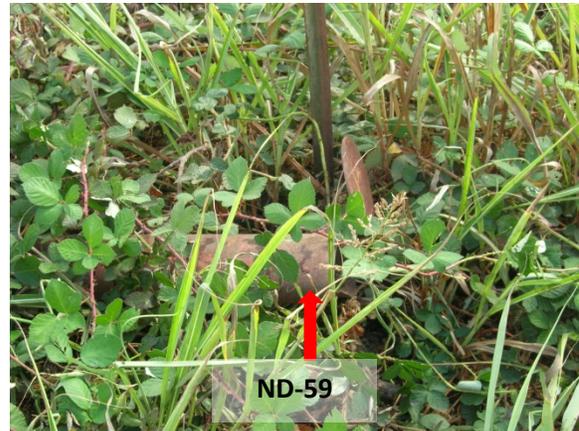
Comments: The well has been damaged. The well is marked by a single t-post.

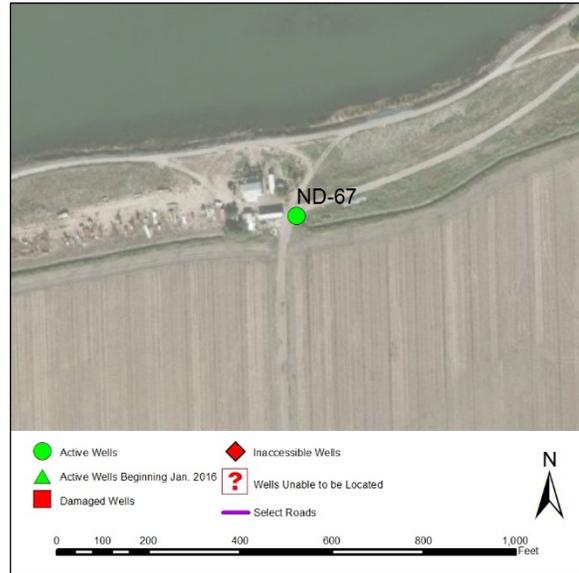
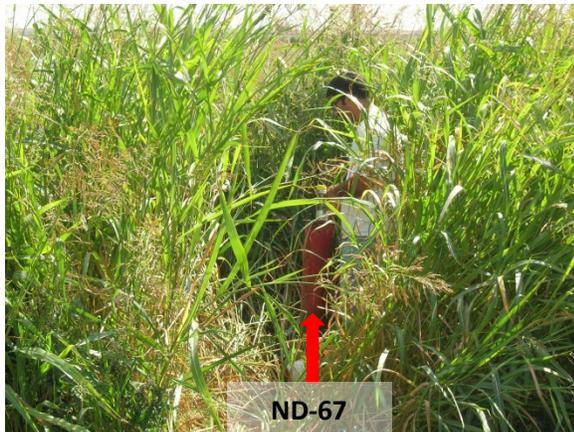
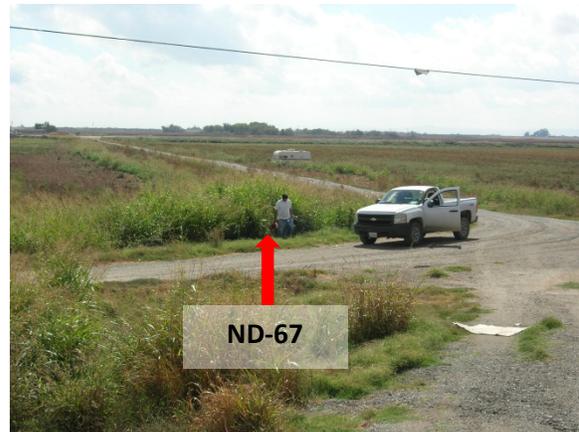
Comments: The PVC casing is damaged, but still intact and measurements are able to be obtained.

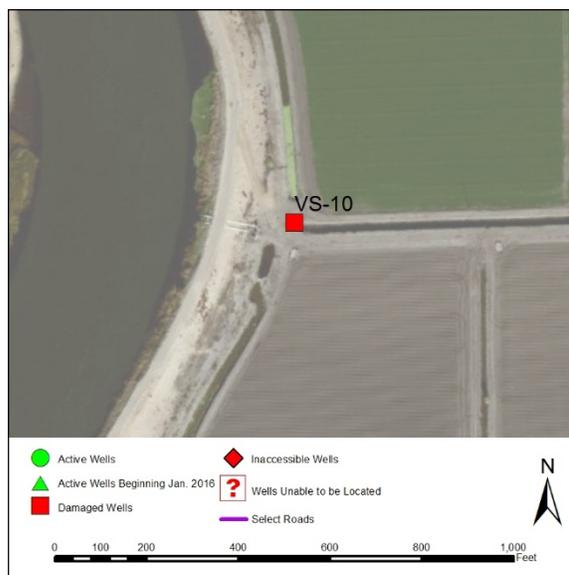
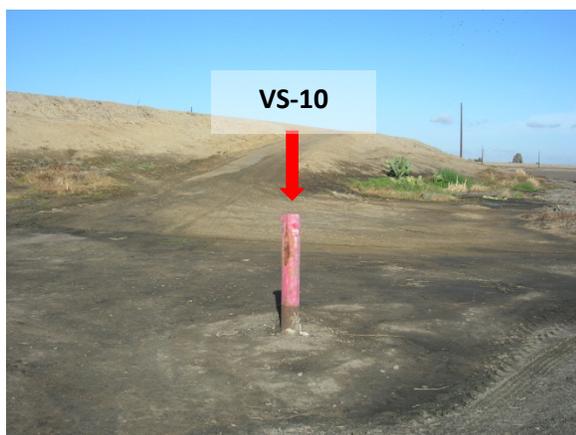
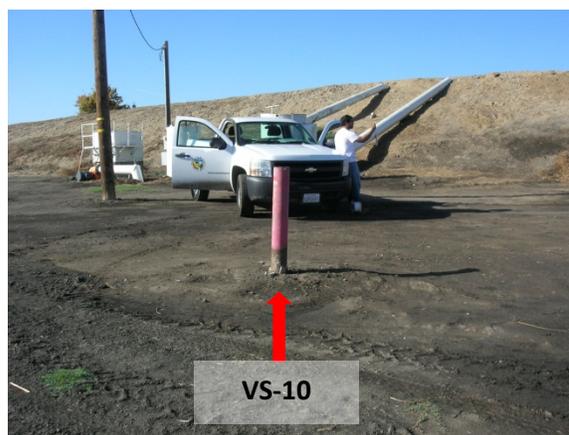
Comments: The well has been damaged, and has an obstruction in the casing. Well located at the base of the access ramp, near power/phone pole.

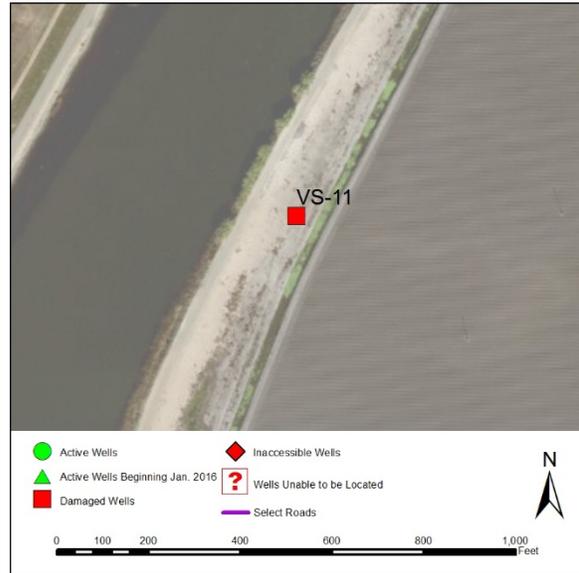
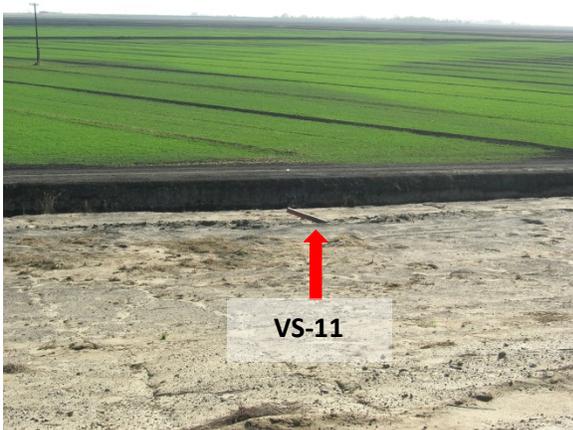
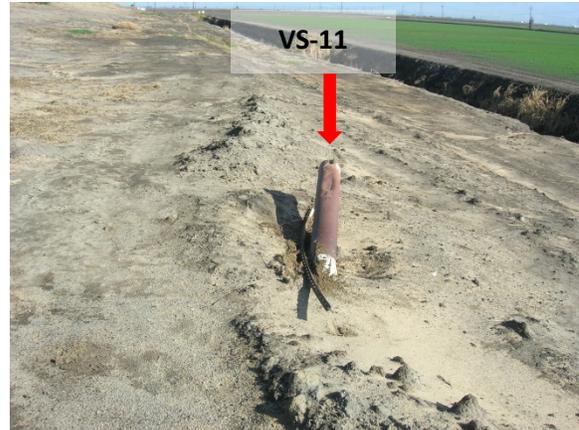
Comments: The well has been damaged.
