North and South Delta Seepage Well Monitoring Network Update

Memorandum Report
April 2015

Subject: North and South Delta Seepage Monitoring Program Well Status Update

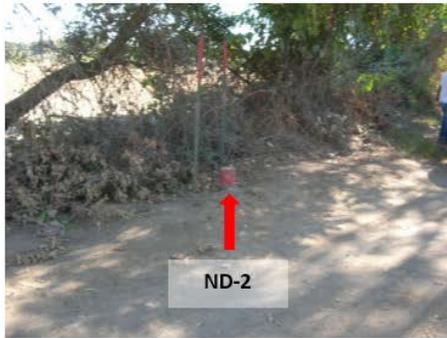
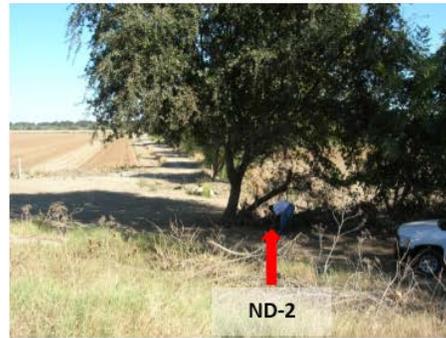
ND-2

Monitoring Status: Active
Reclamation District: 2110
McCormack-Williamson Tract
Coordinates: N 38°15'37.3" W 121°27'27.5"
State Well Number: 05N05E30A004M
Permit Status: Pending
Construction Depth: 20ft
Comments: Well on levee toe, near oak tree, marked with two red t-posts.

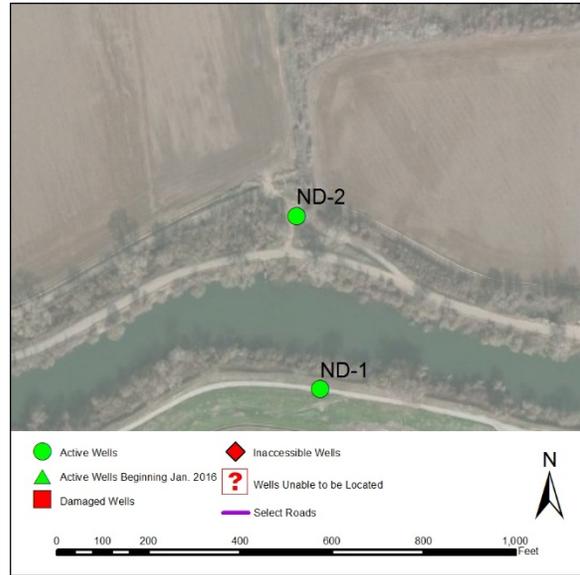
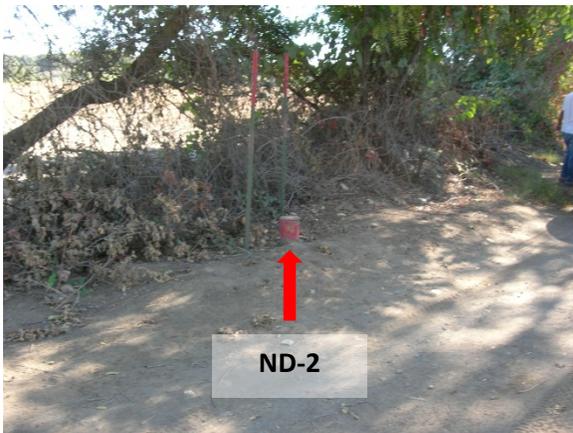
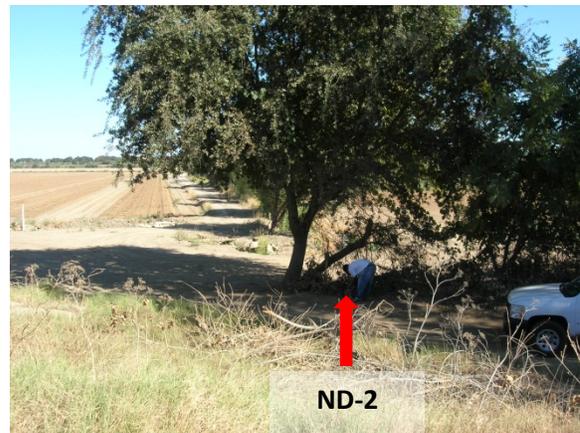
ND-2

Comments: Well on levee toe, near oak tree, marked with two red t-posts.

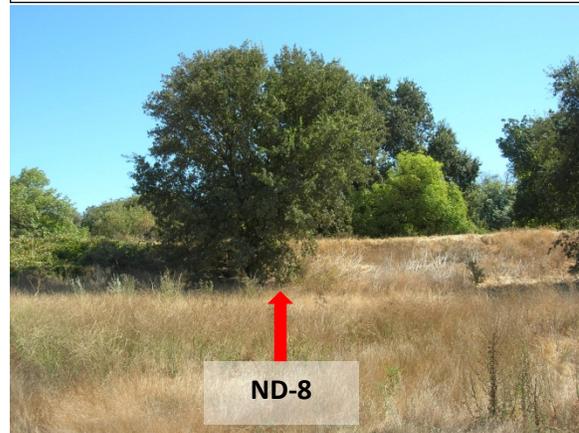
ND-8

Comments: The well was unable to be located. The field book said the well was buried. Using the GPS coordinates a buried object was found, most likely rebar.

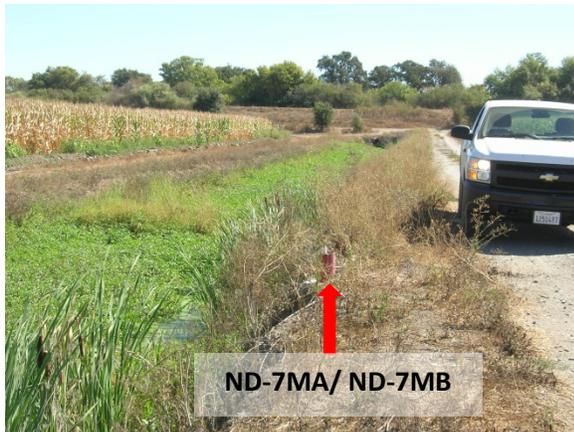
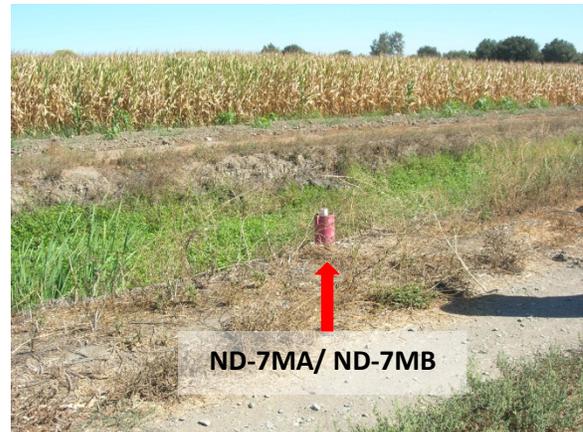
ND-7MA/ ND-7MB

Comments: Well located 500ft inland adjacent to drainage ditch, on southern side of ditch, marked with a red pipe sticking up approximately 1ft out of the ground. This is an uncapped well.

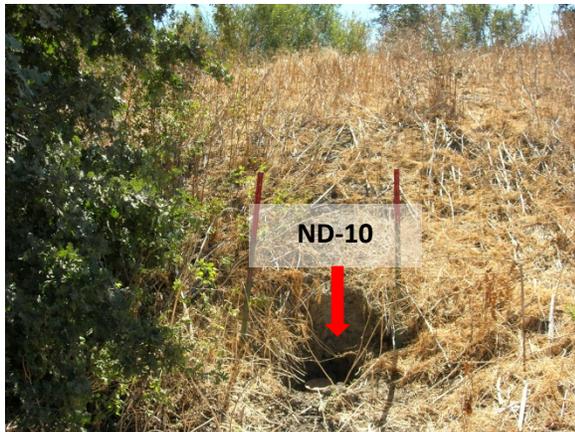
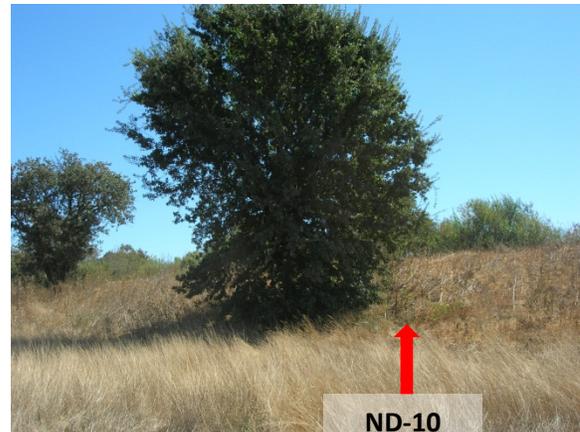
ND-10

Comments: Well located on levee, near oak tree, marked with two red t-posts. The casing is below the ground surface.

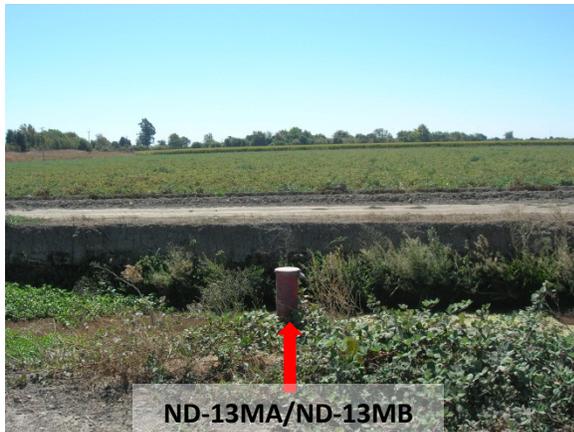
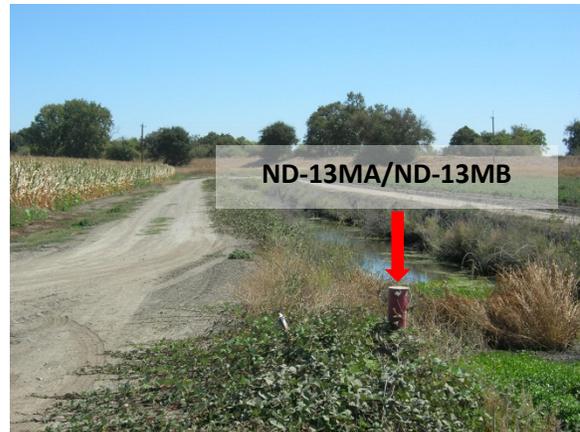
ND-13MA/ ND-13MB

Comments: Well located approximately 500ft inland on the north side of the ditch, where two farm roads intersect. Marked by red casing approximately 1.5ft out of the ground.

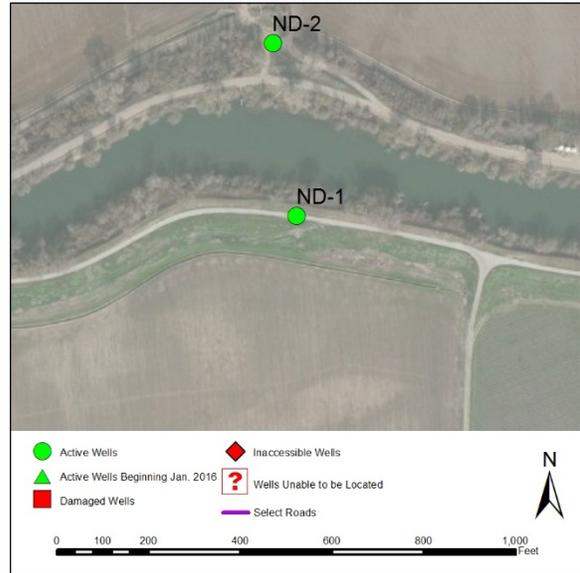
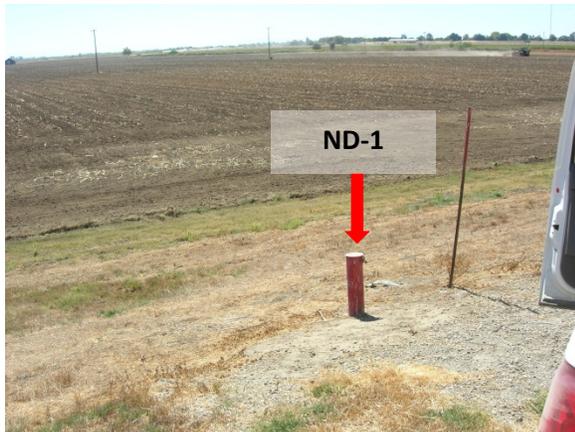
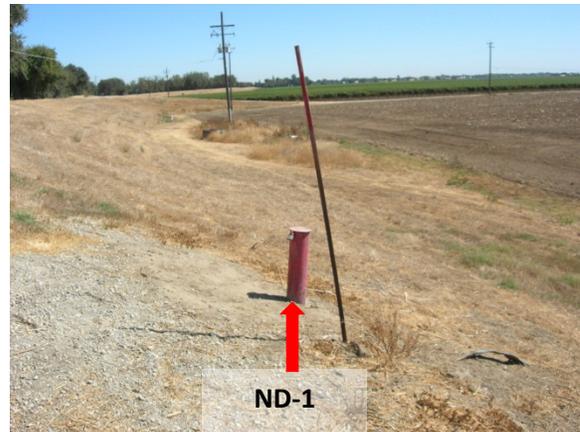
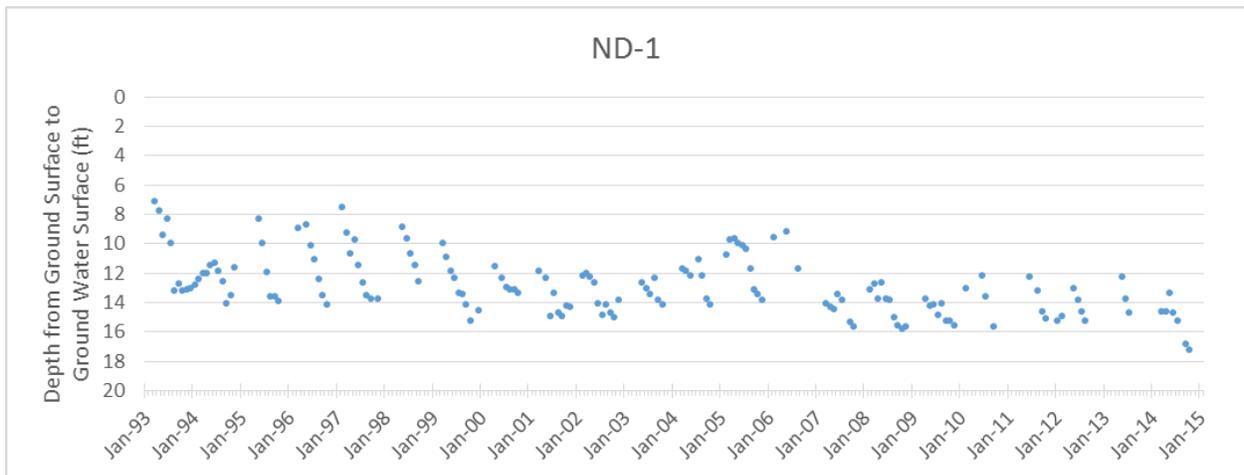
Comments: Well located next to levee access ramp, mid-way down, marked with red t-post. The t-posts frequently removed by farmers and replaced by field technician.

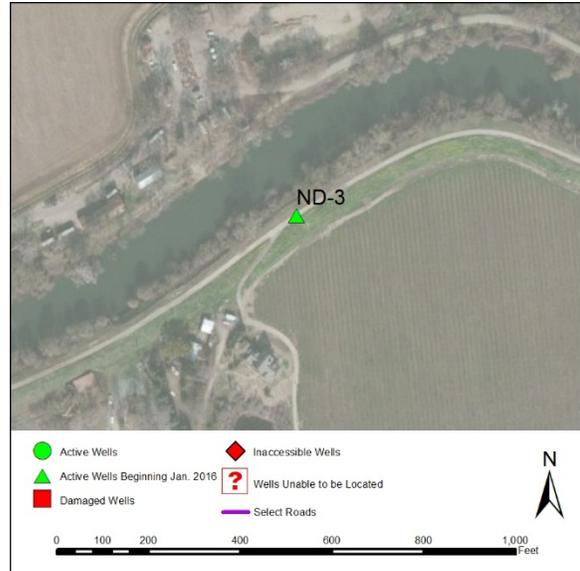
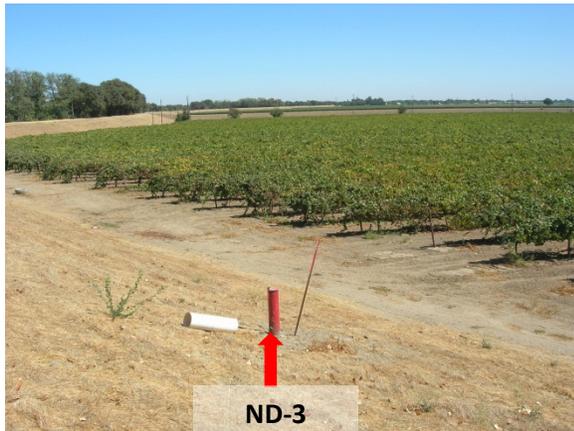
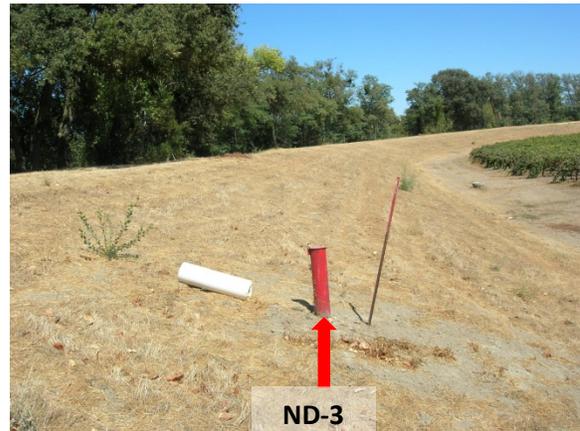
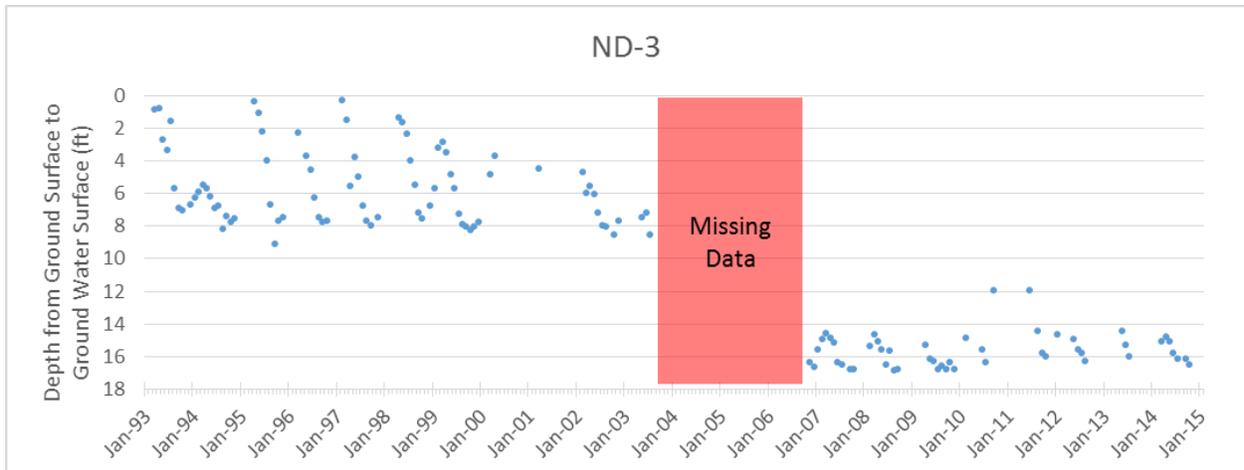
ND-3

Comments: Well is located mid-slope, marked with single red t-post. The PVC cover is not attached. The property owners have refused to sign the TEP. Beginning January 2016 this well will no longer be monitored until access is granted by owner.

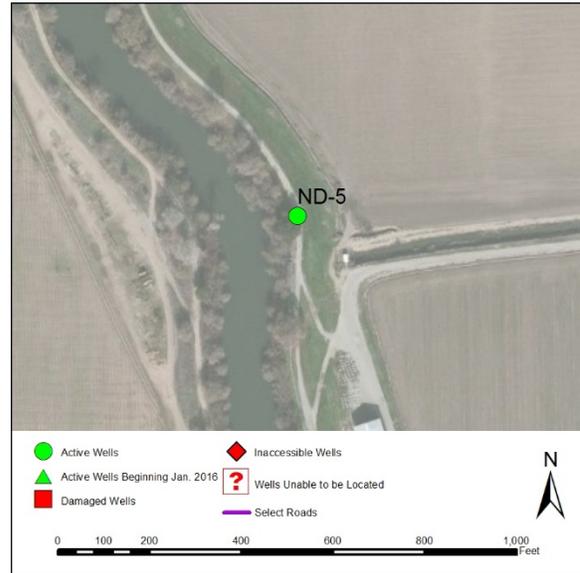
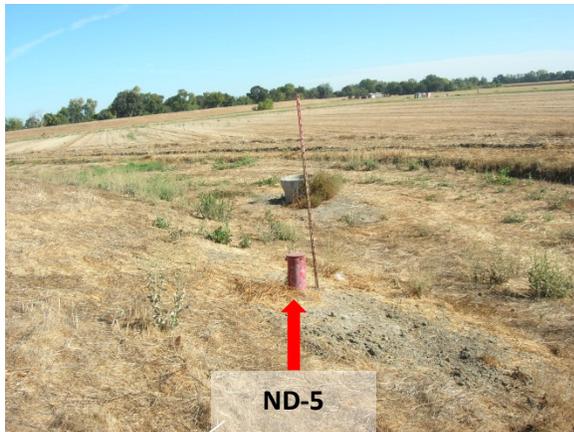
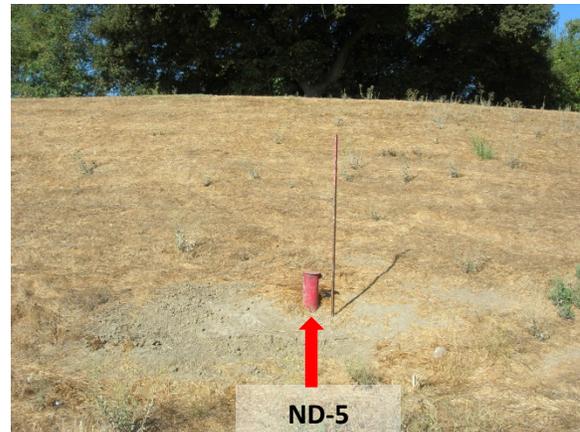
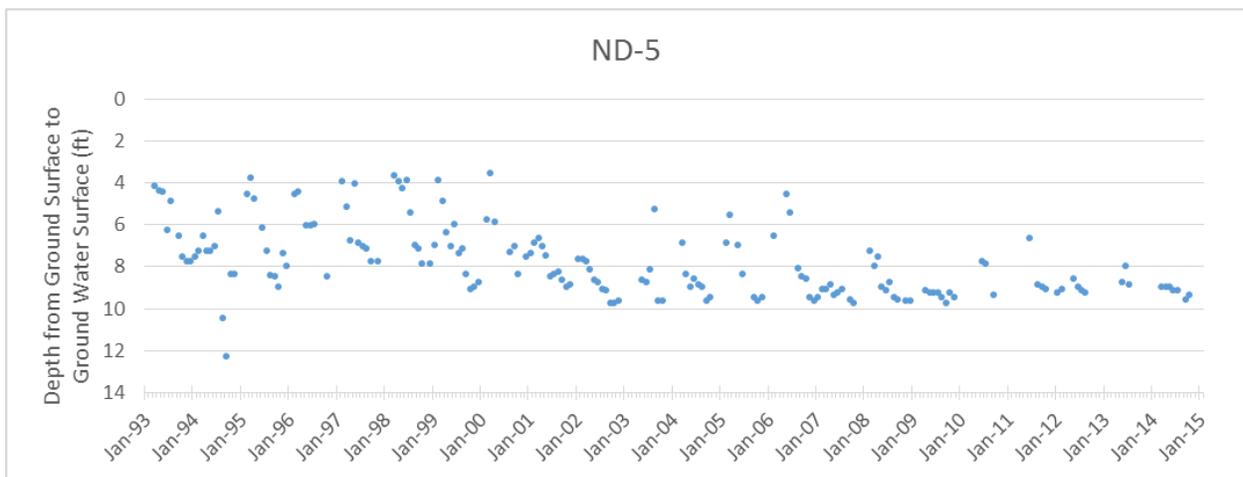
ND-5

Comments: Well is located at the levee toe, near a shed (not pictured), and marked by a red t-post.

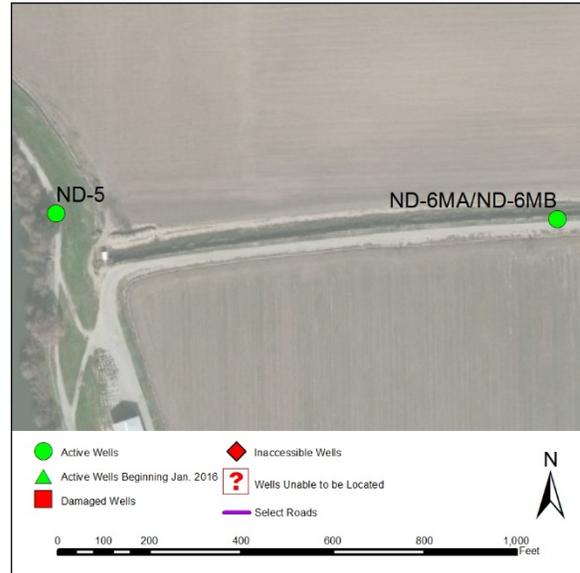
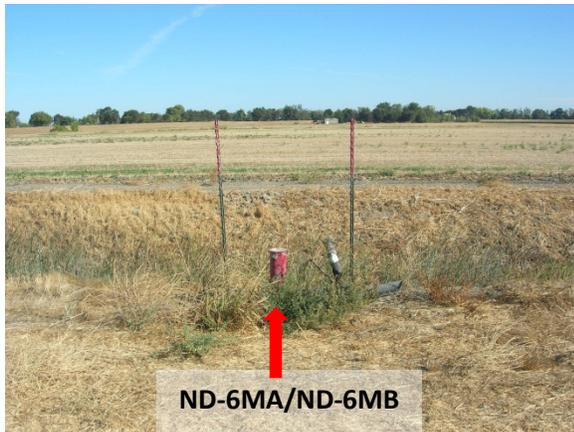
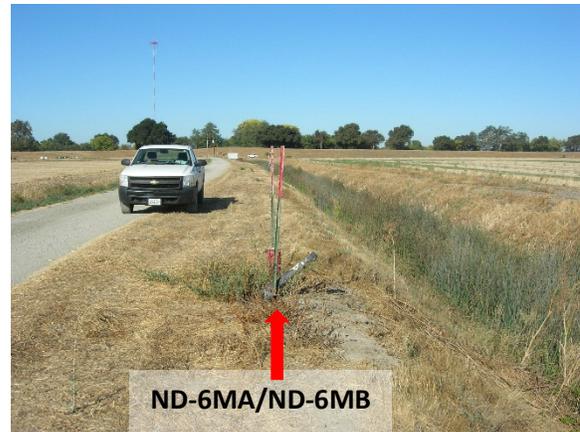
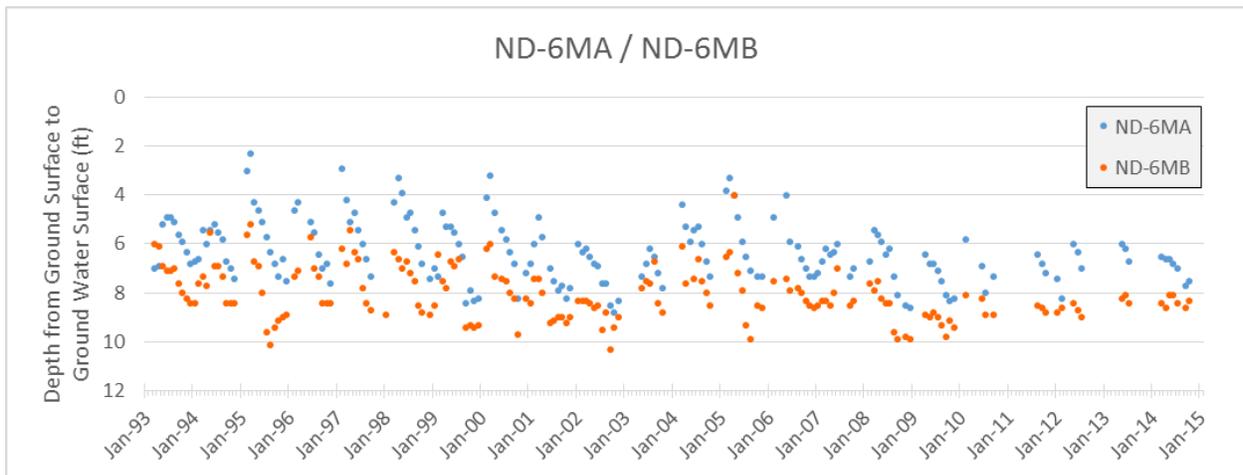
ND-6MA/ ND-6MB

Comments: Well located approximately 1000ft from levee toe on the south side of the ditch, and marked by two red t-posts.

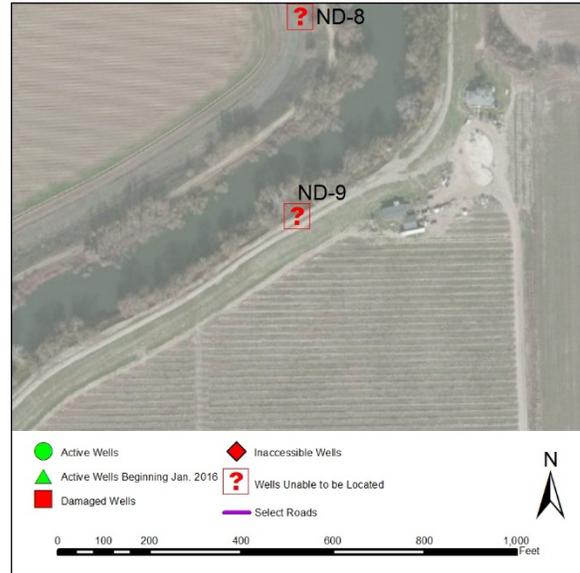
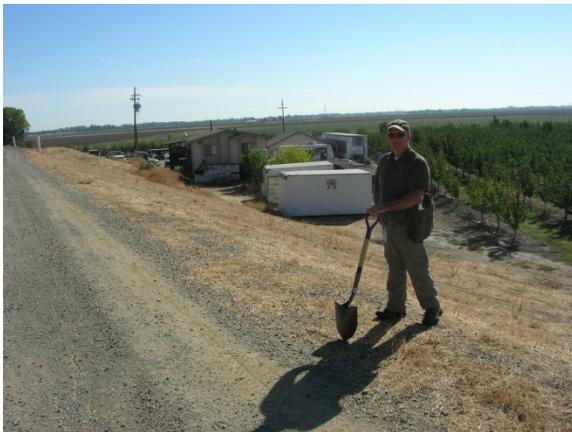
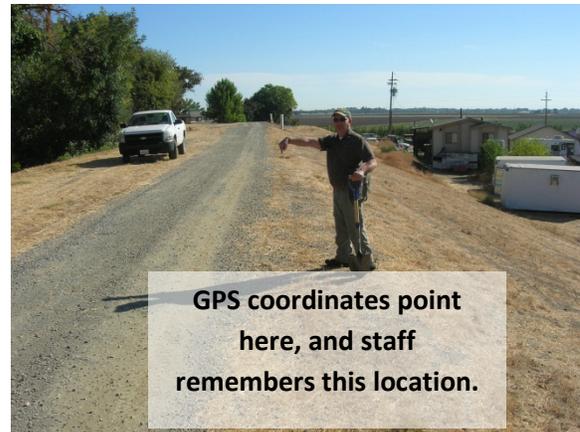
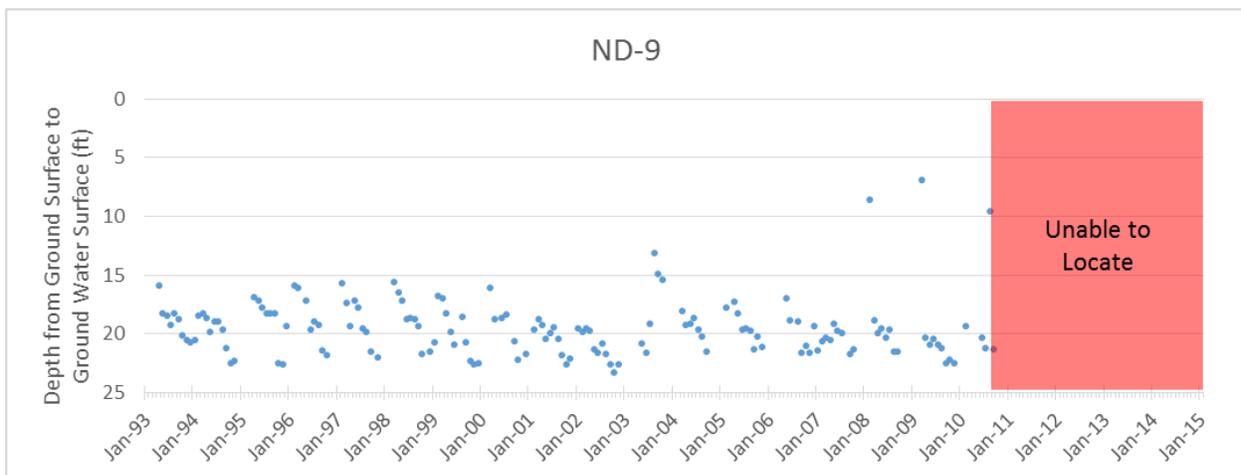
ND-9

Comments: The well was unable to be located.
The well was located on the top of the levee, near house in background.

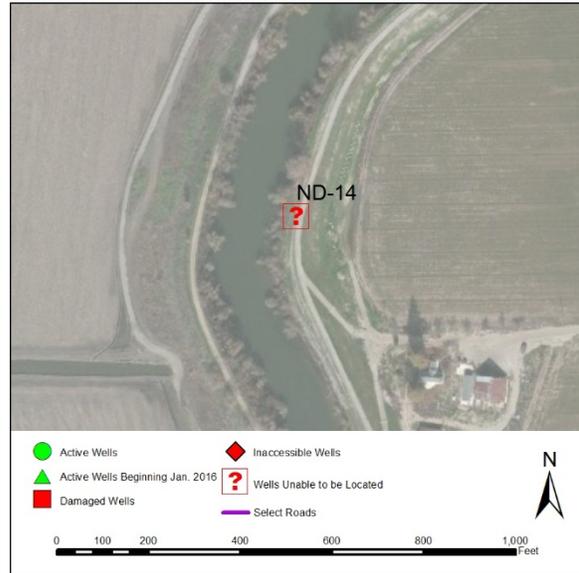
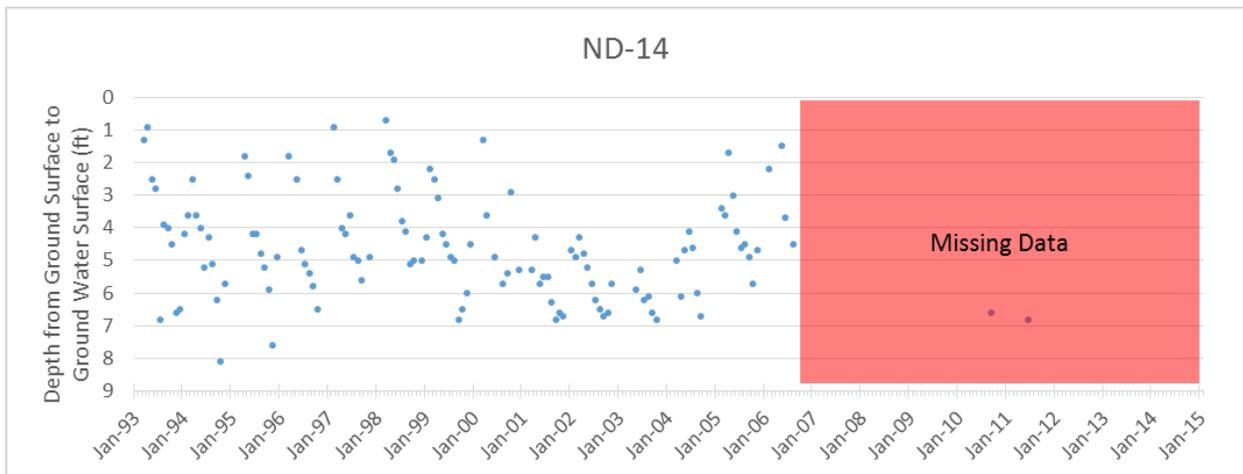
ND-14

Comments: The well was unable to be located.

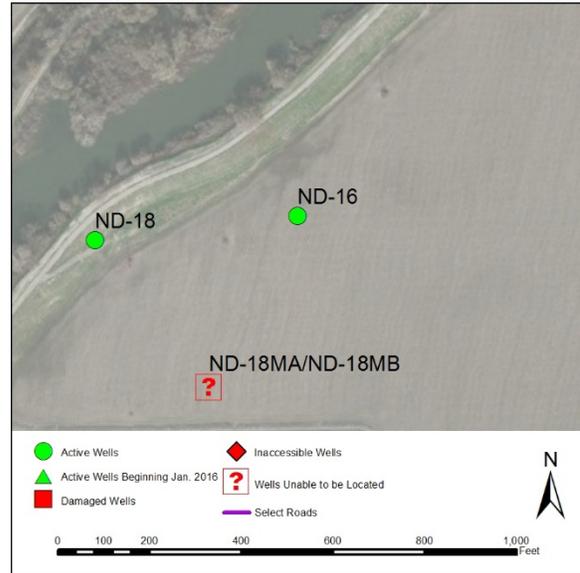
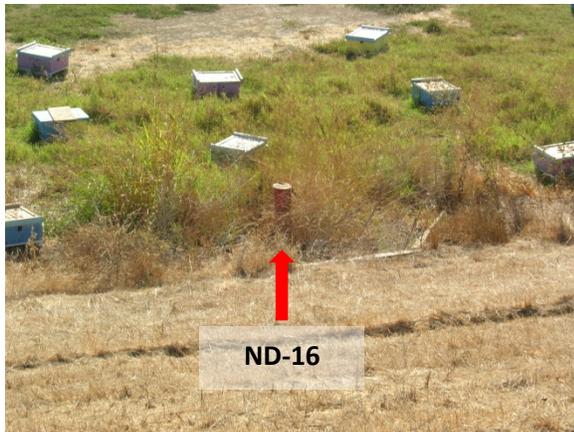
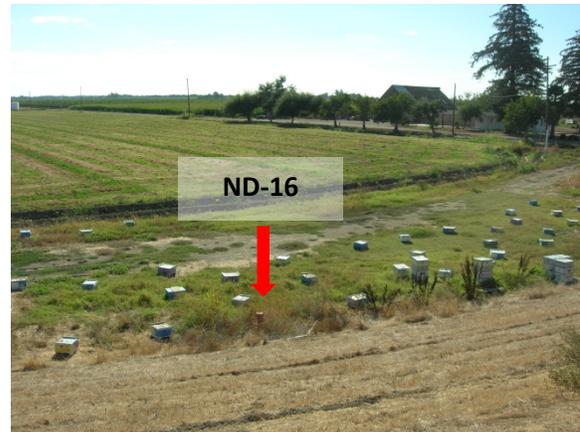
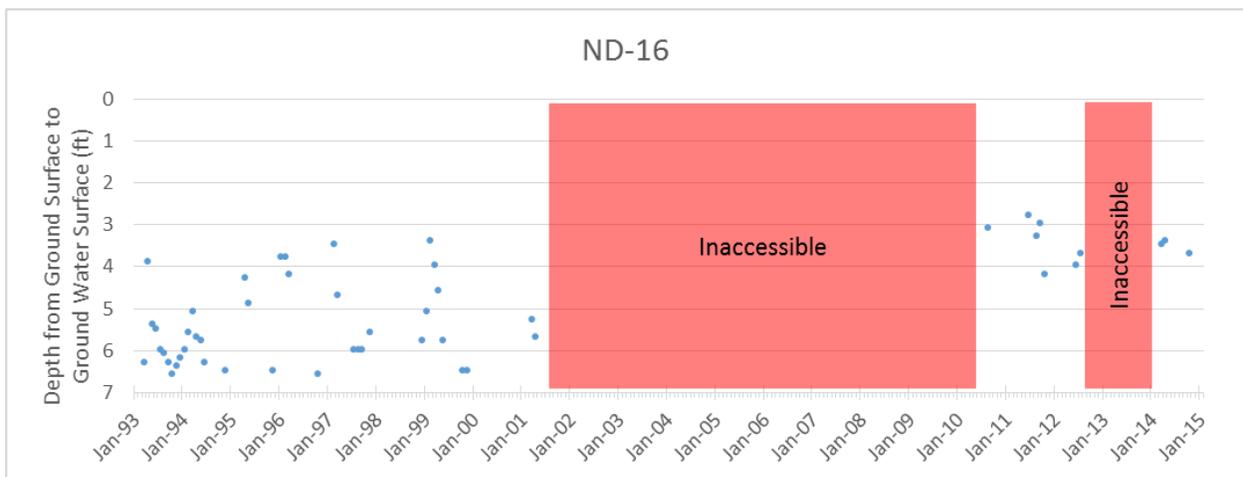
ND-16

Comments: Bee boxes frequently placed near well. Not monitored when bee boxes are present

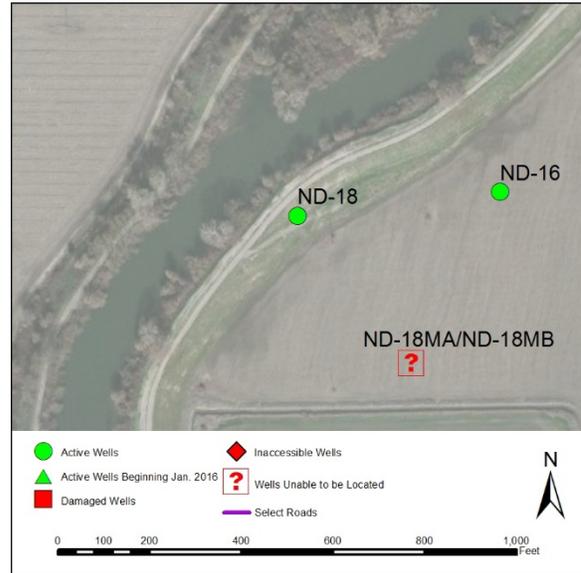
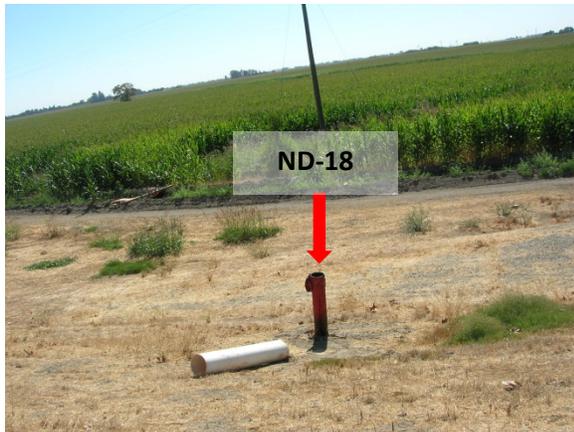
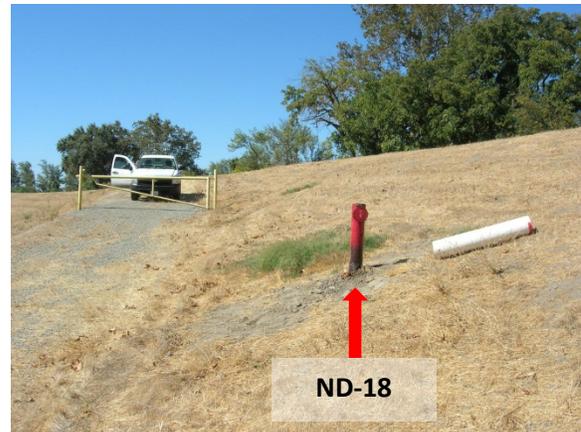
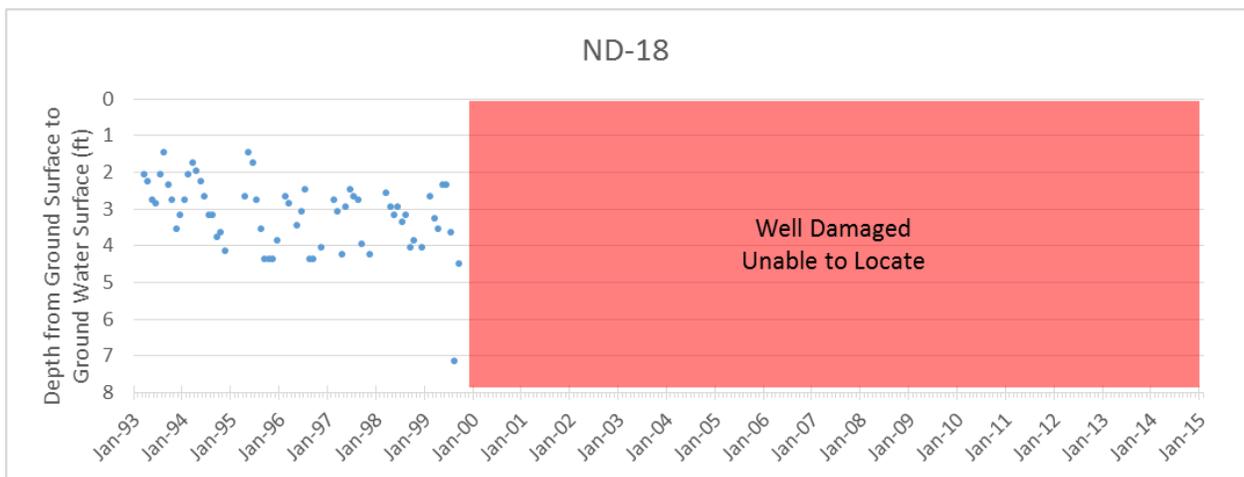
ND-18

Comments: Well located at mid-slope, near gate on levee access ramp. Protective PVC pipe not attached.

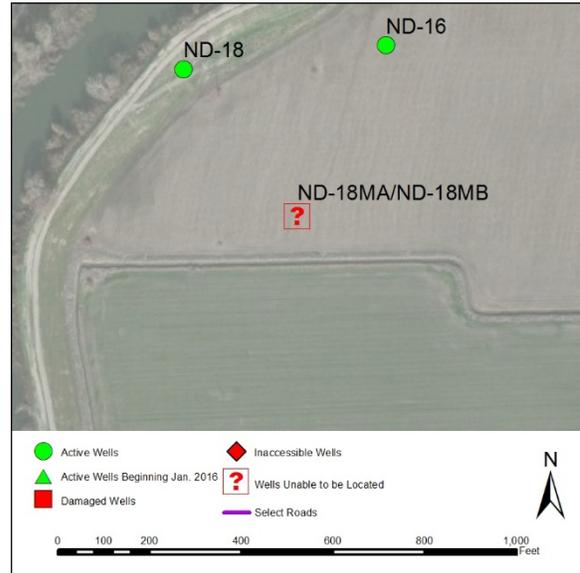
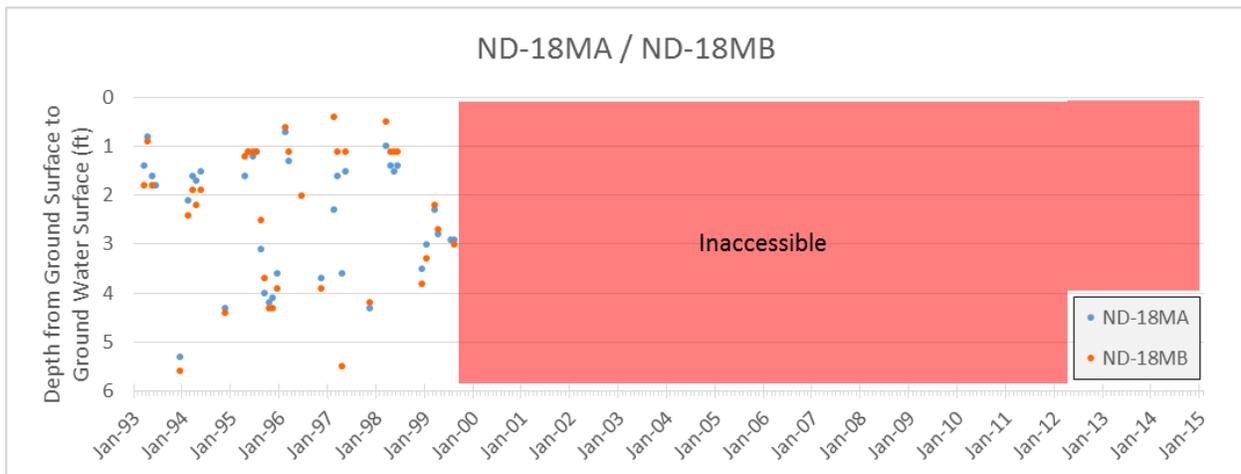
ND-18MA/ ND18-MB

Comments: The well was unable to be located.

Map location based on a 1993 paper map.

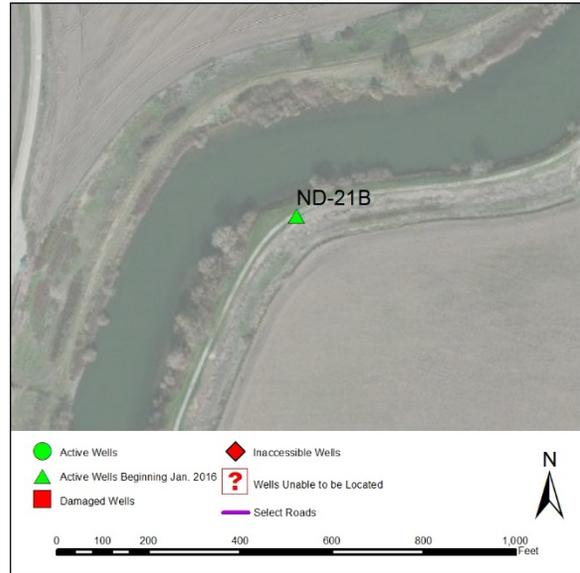
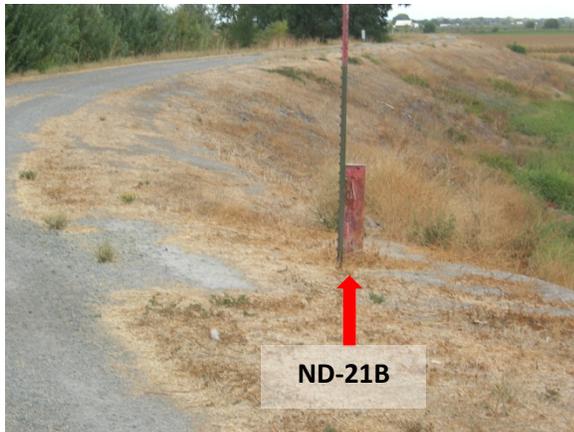
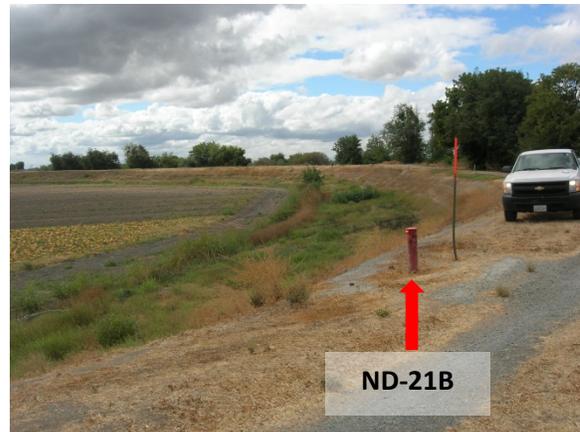
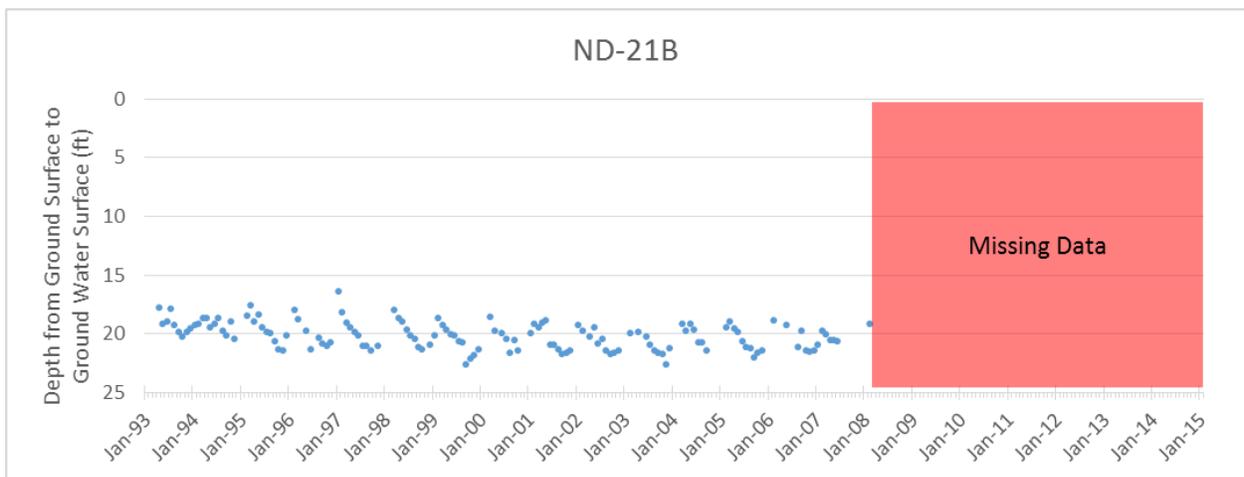
ND-21B

Comments: This well will begin being actively monitored in January 2016 when monitoring of the network resumes. Well located on the top of the levee marked with a red t-post.

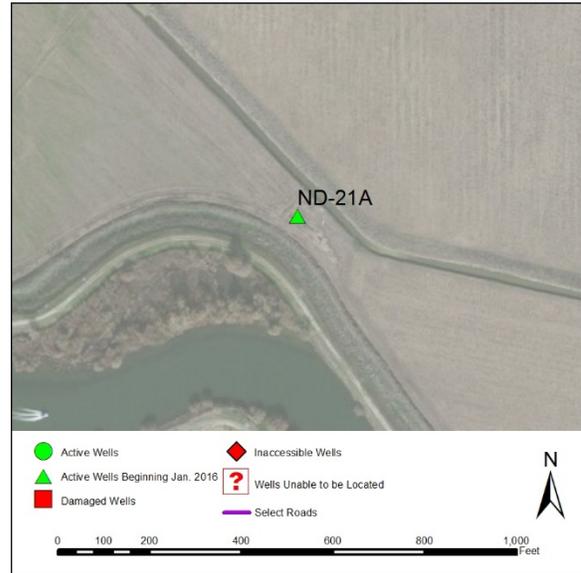
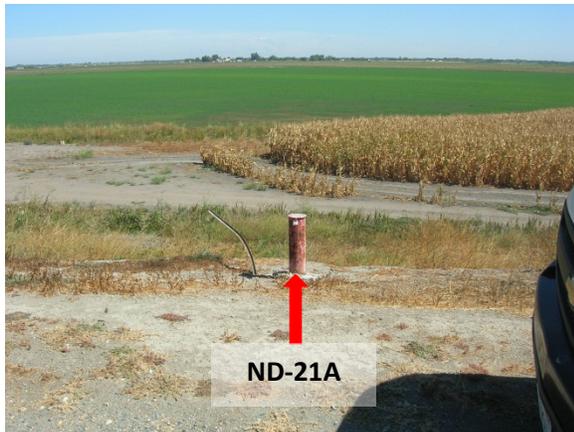
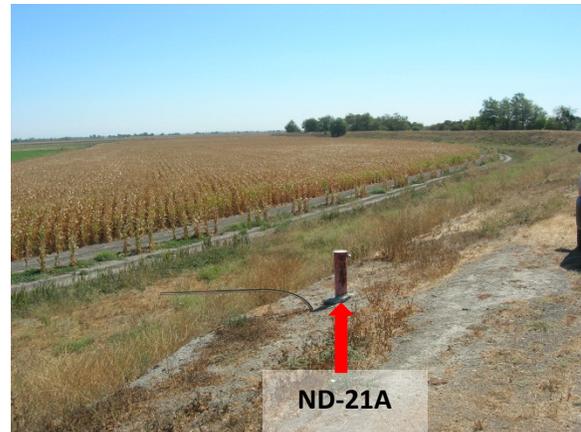
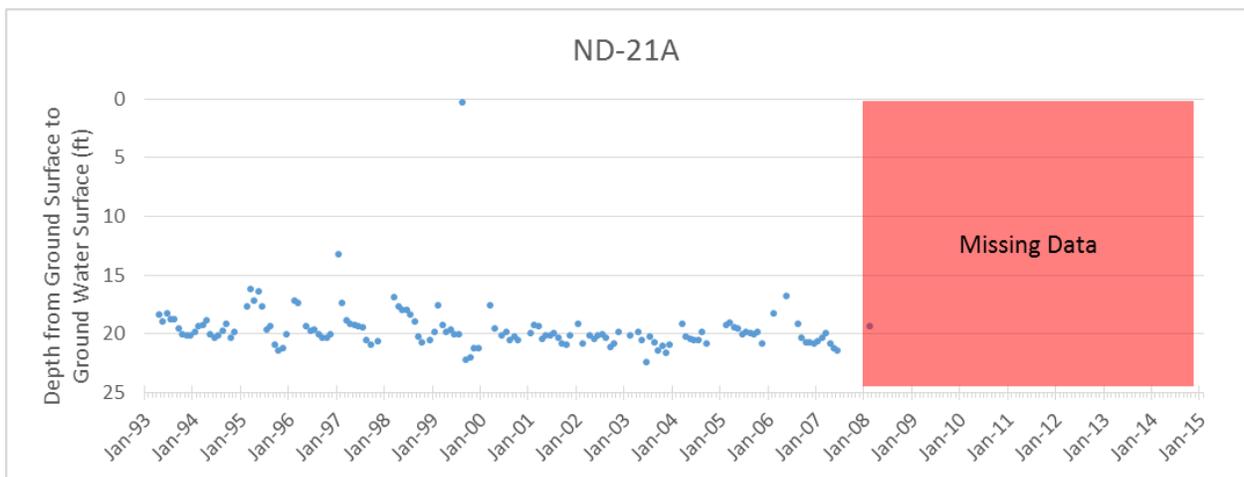
Comments: This well will begin being actively monitored in January 2016 when monitoring of the network resumes. Well located on the top of the levee marked with a bent t-post.

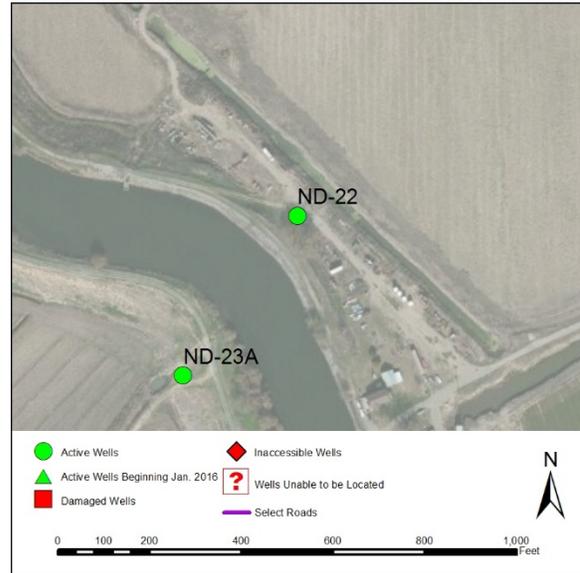
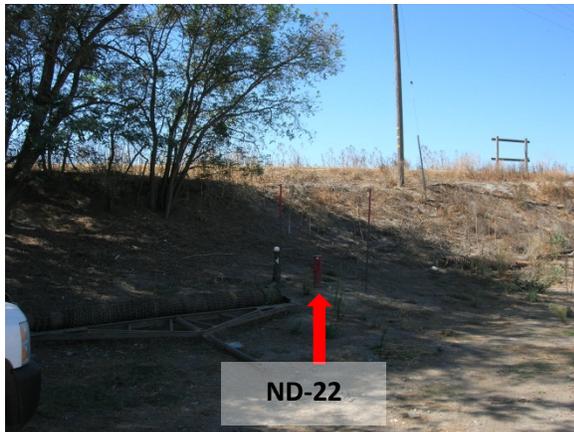
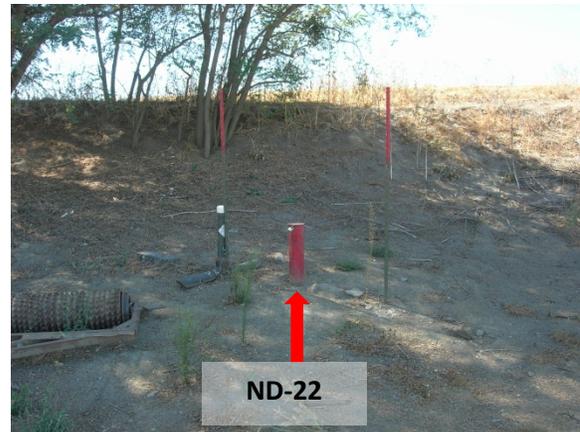
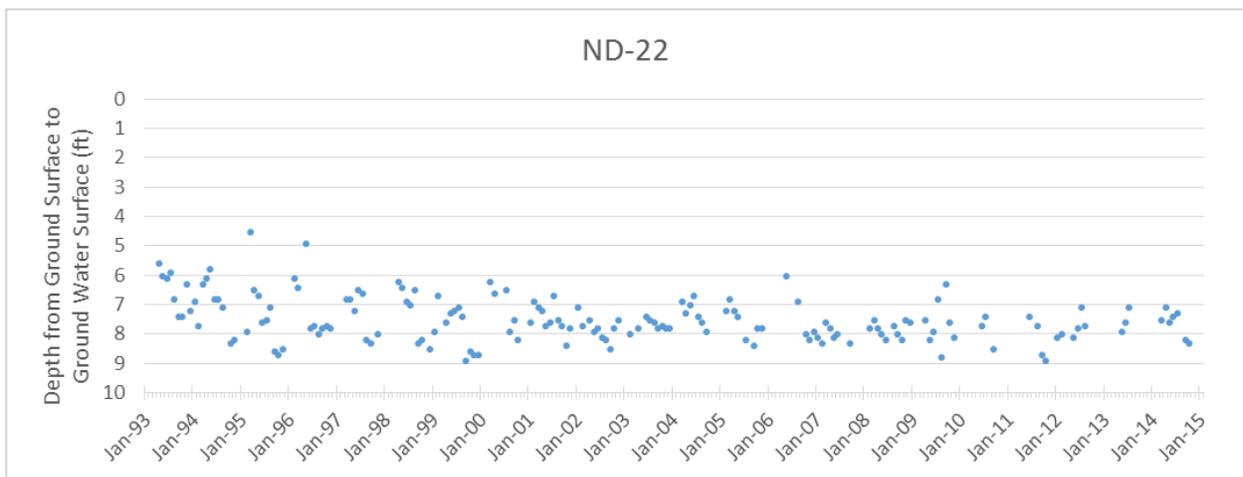
ND-22

Comments: Well located on levee toe, marked by two red t-posts.

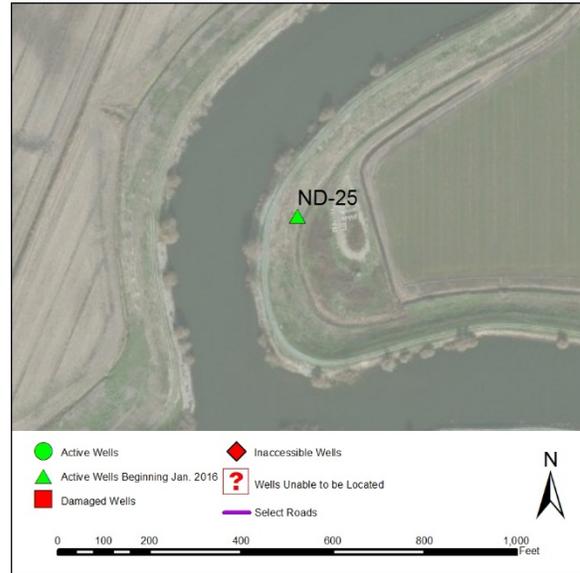
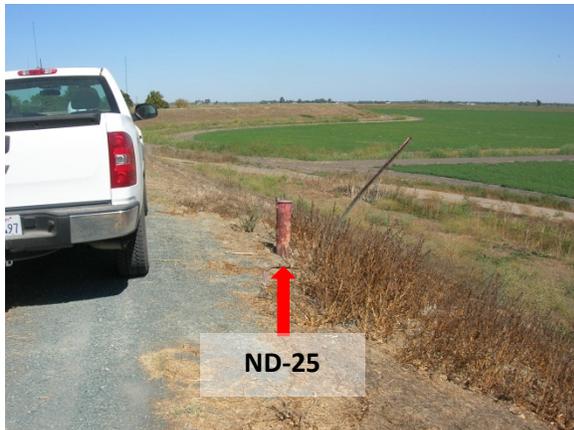
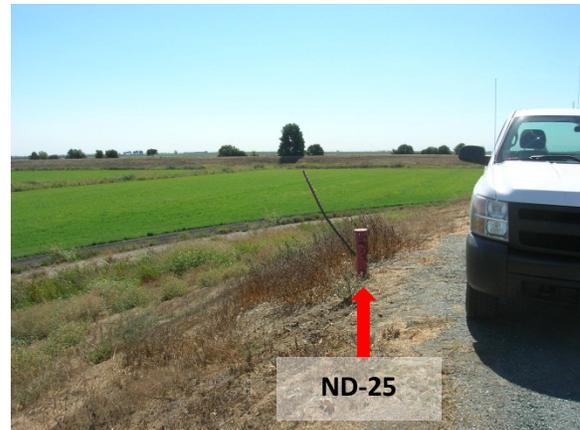
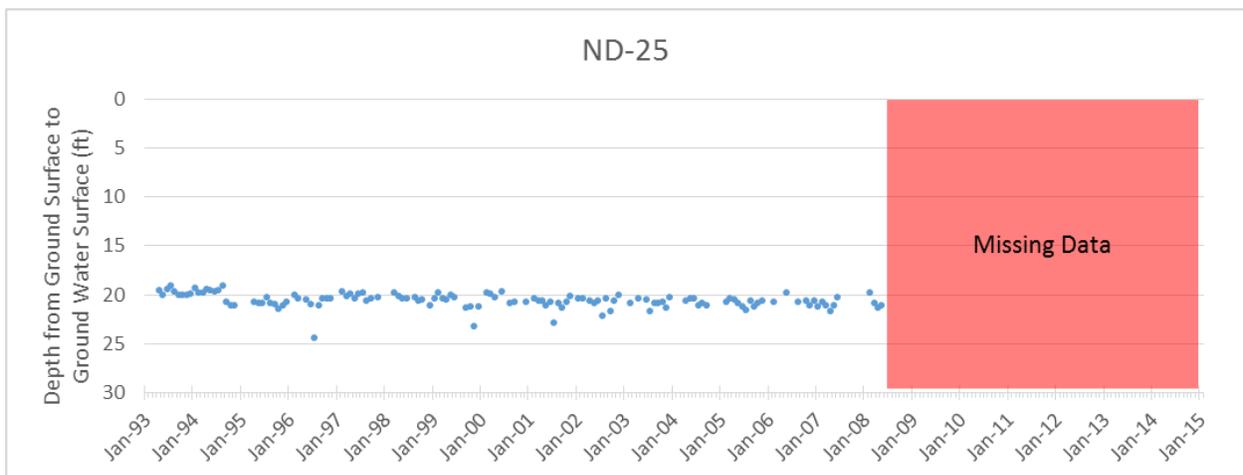
ND-25

Comments: This well will begin being actively monitored in January 2016 when monitoring of the network resumes. The well located on the top of the levee marked by a bent t-post.

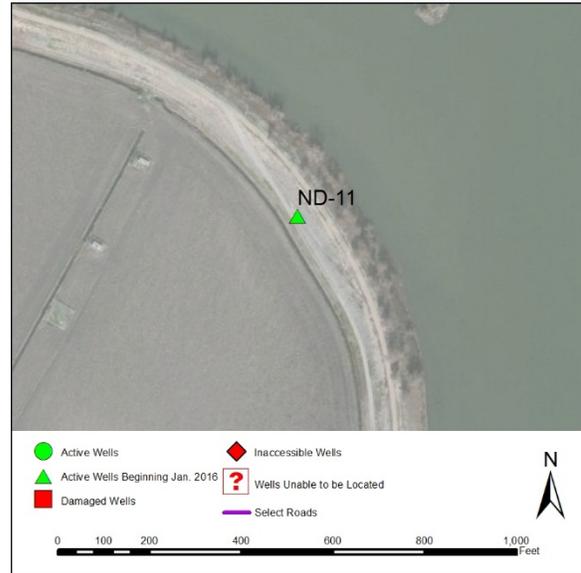
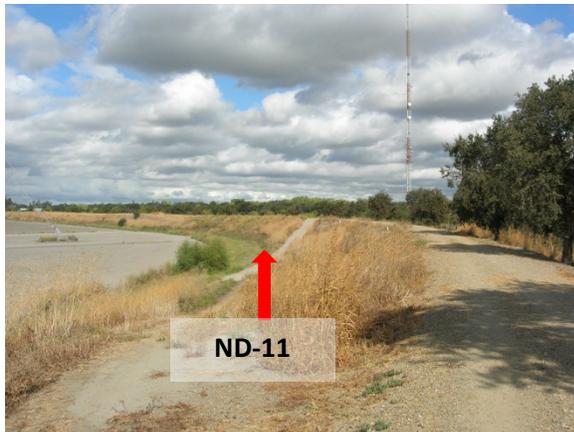
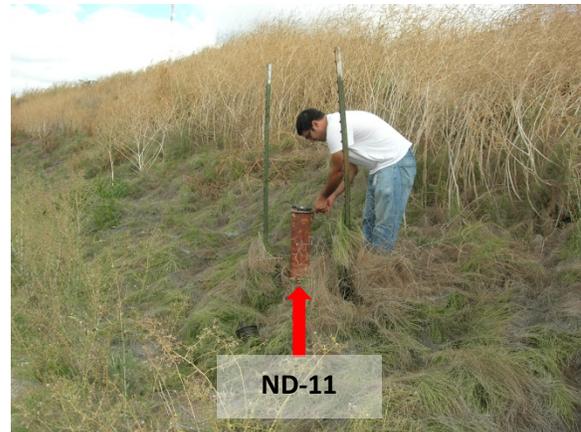
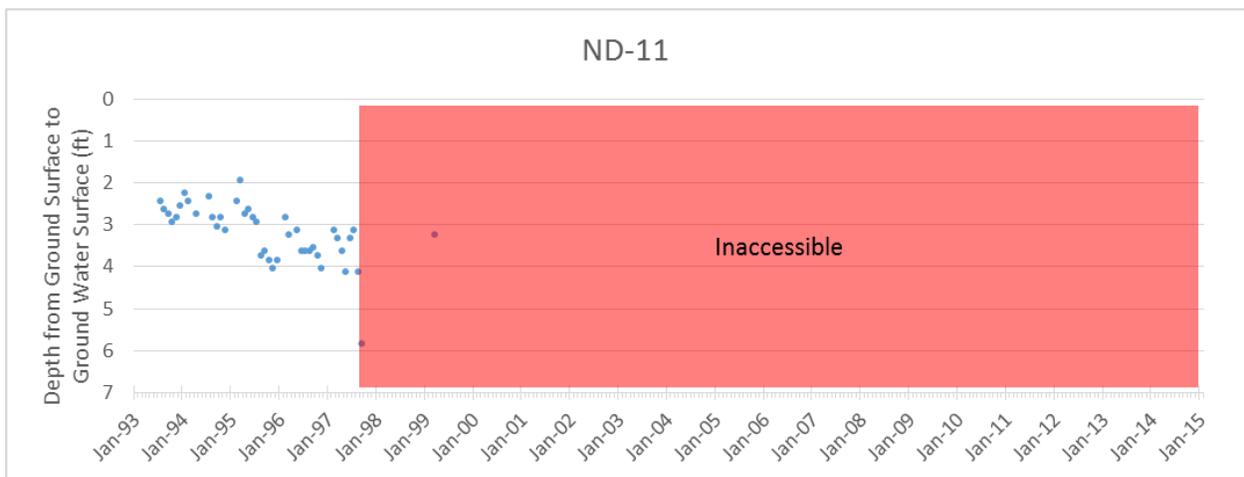
Comments: This well will begin being actively monitored in January 2016 when monitoring of the network resumes. Well located on levee toe, marked by two t-posts. Follow dirt access road to get to well and continue back onto the levee.
