North and South Delta Seepage Well Monitoring Network Update

Memorandum Report
April 2015

Subject: North and South Delta Seepage Monitoring Program Well Status Update

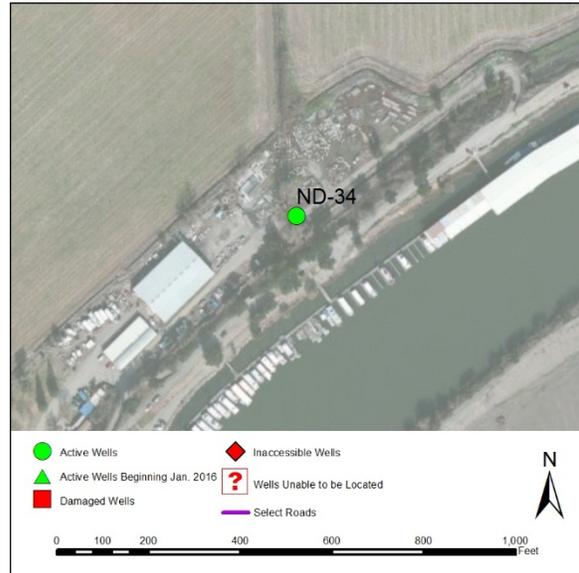
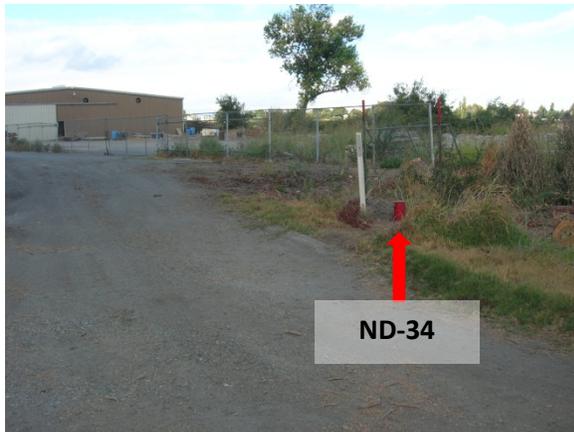
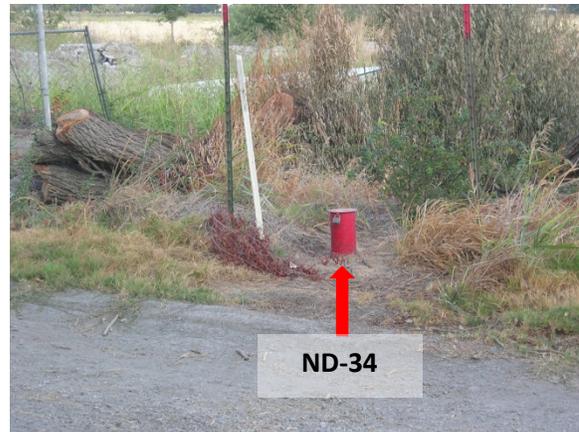
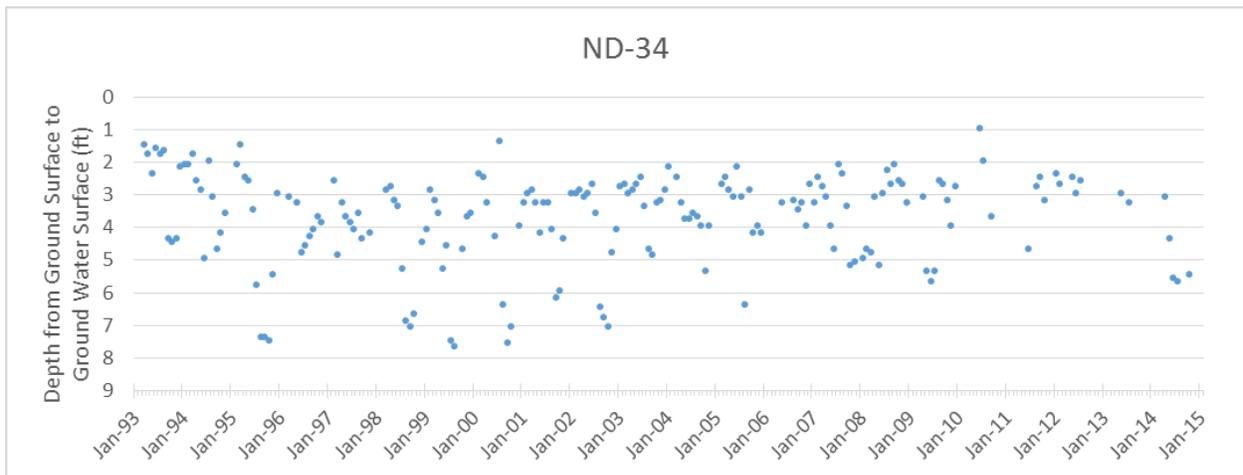
ND-34

Comments: Well located on levee toe, marked by two t-posts. Accessed from southern side of warehouse.

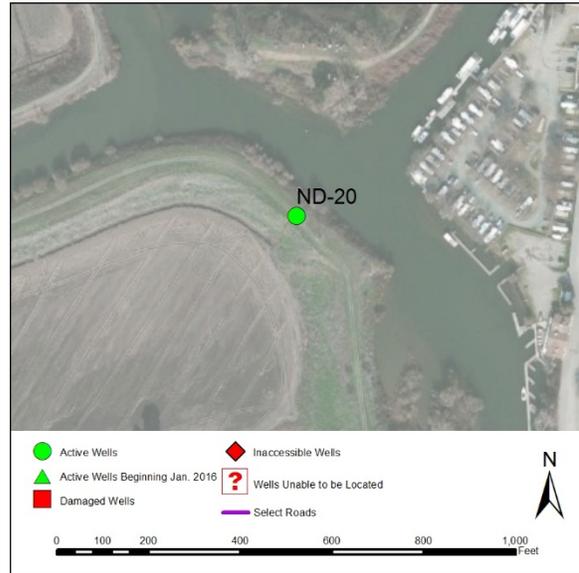
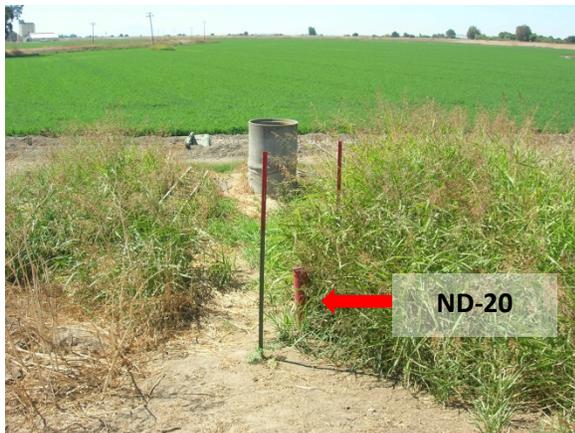
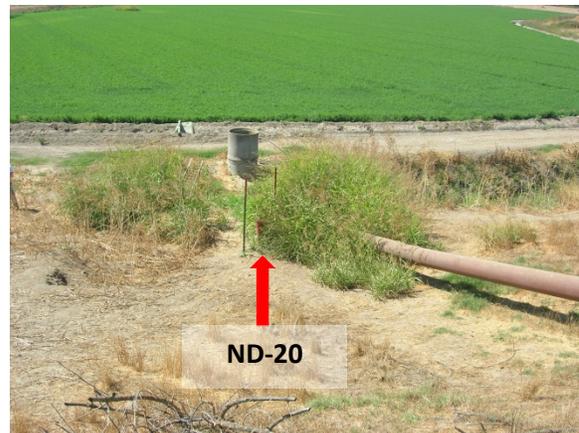
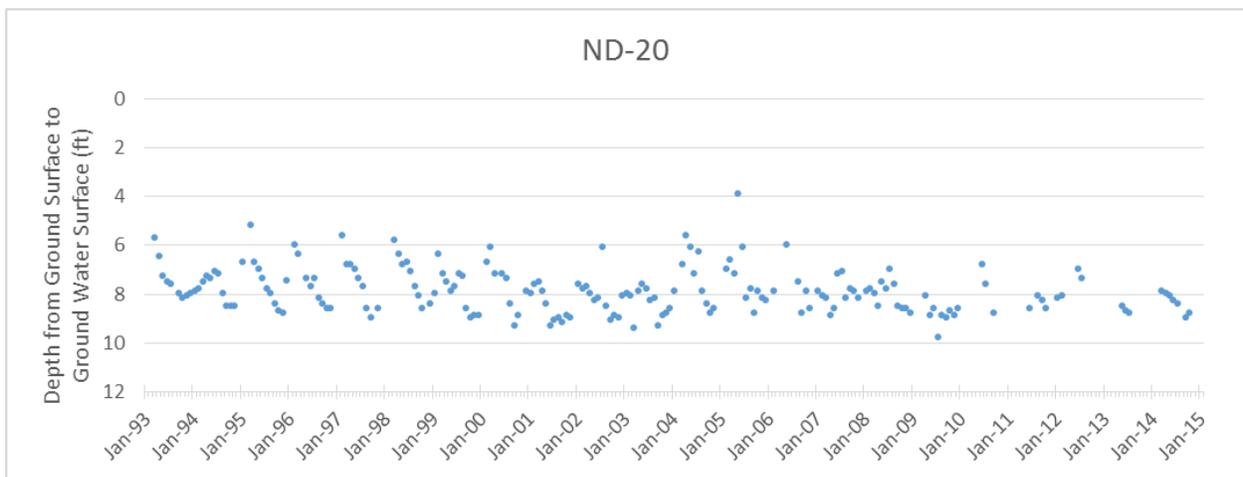
Comments: Well located on levee toe, marked by two red t-posts, and next to a siphon pipe.

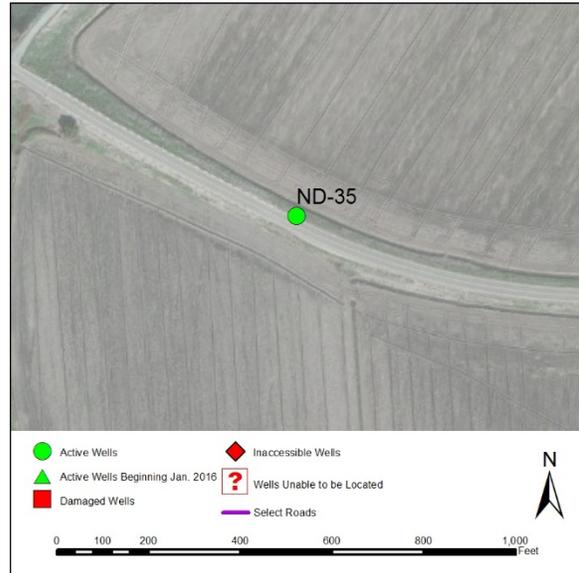
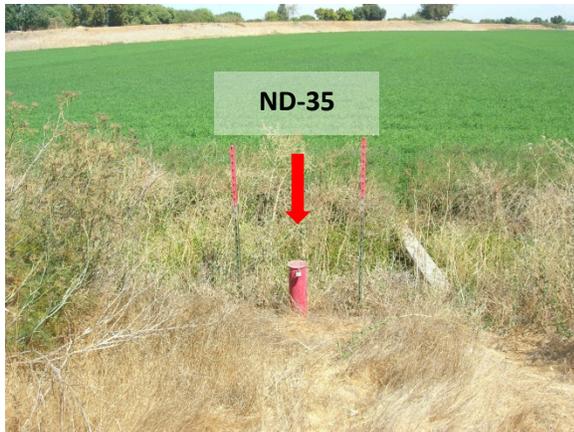
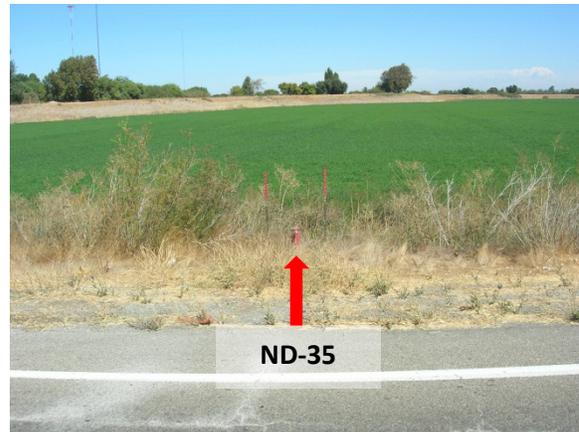
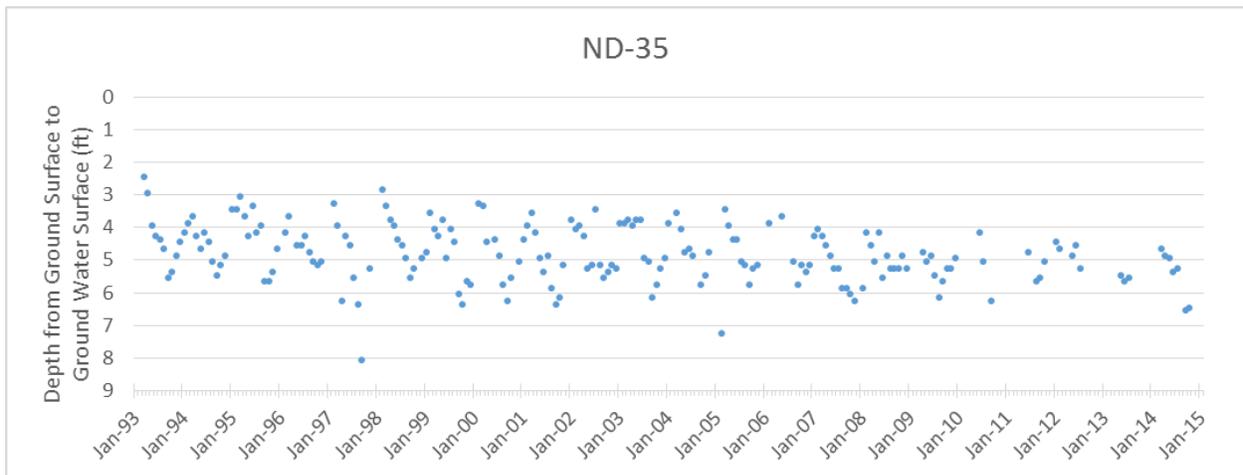
ND-35

Comments: Well located approximately 750ft from the levee, on the north side of road, marked by two red t-posts.

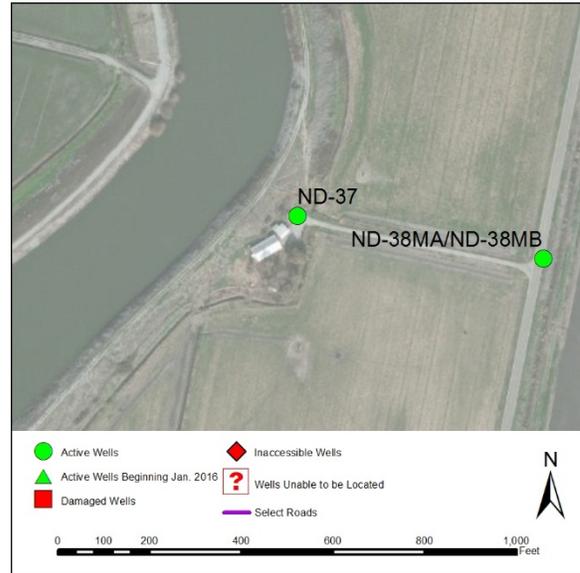
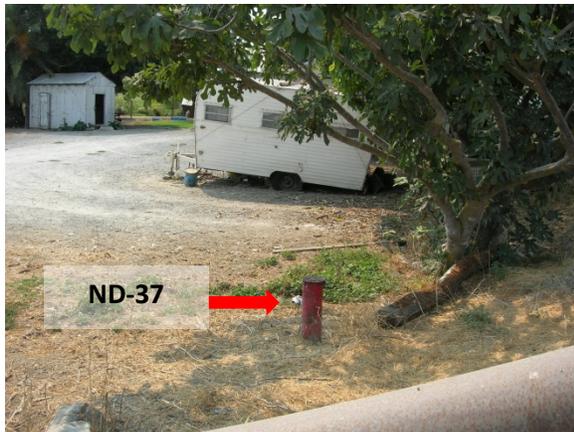
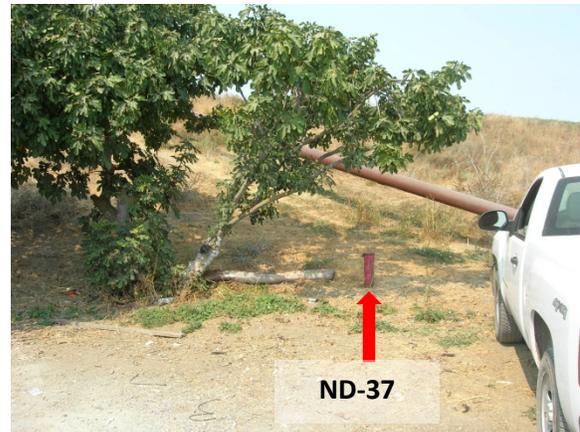
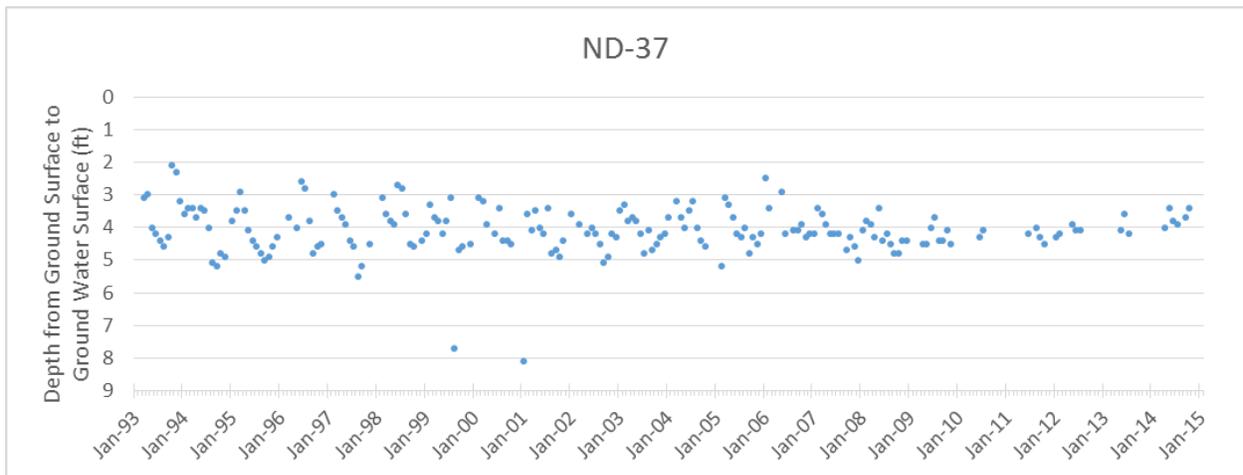
ND-37

Comments: Well located on levee toe, under tree, and adjacent to siphon.

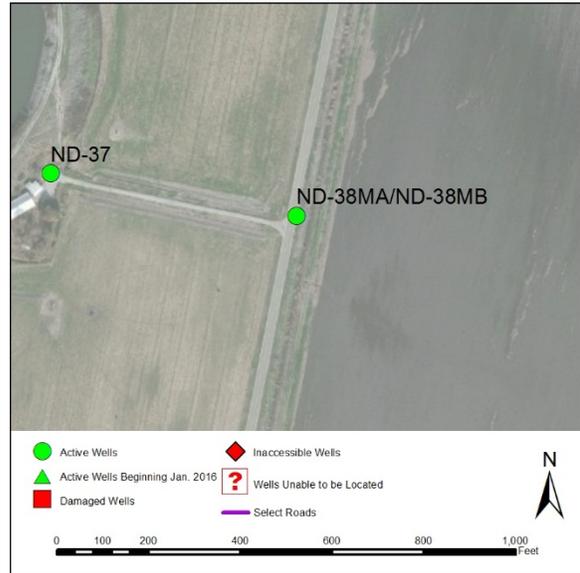
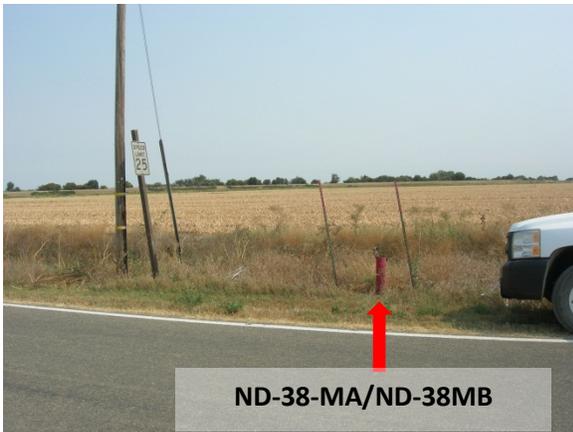
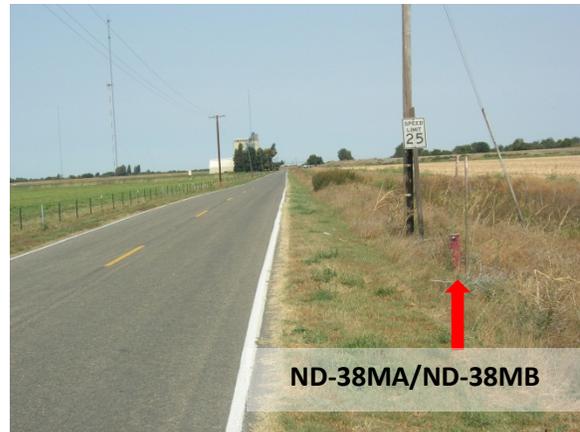
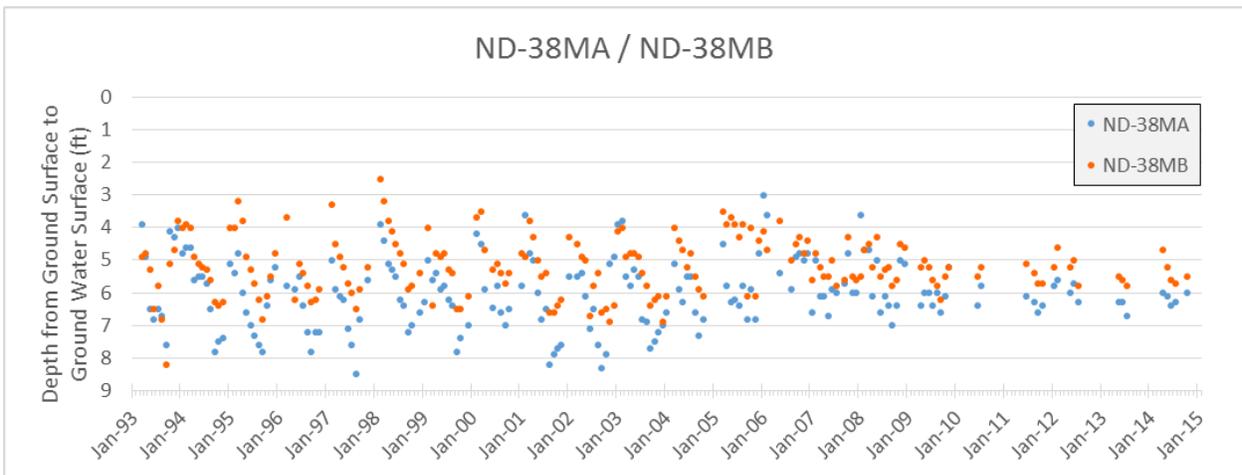
ND-38MA/ ND-38MB

Comments: Well located at the intersection of the road going to ND-37, just in front of the speed limit sign, and marked by two red t-posts.

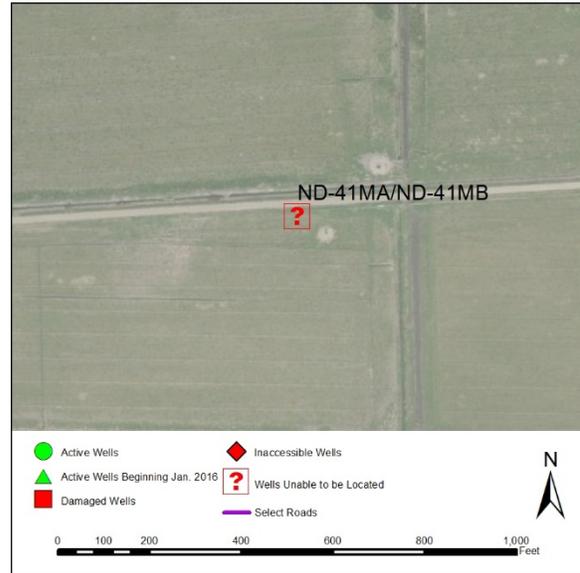
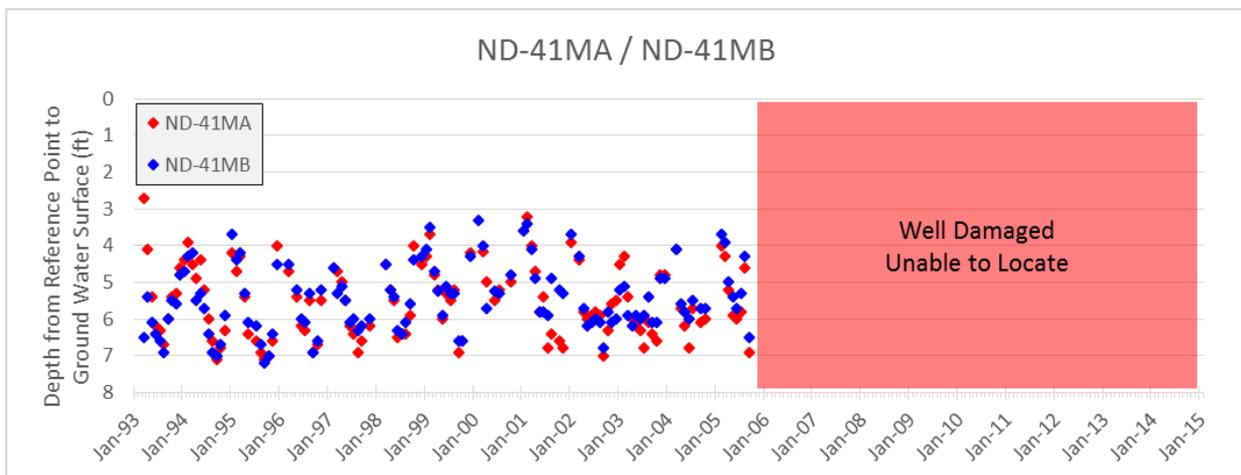
ND-41MA/ ND-41MB

Comments: The well was unable to be located

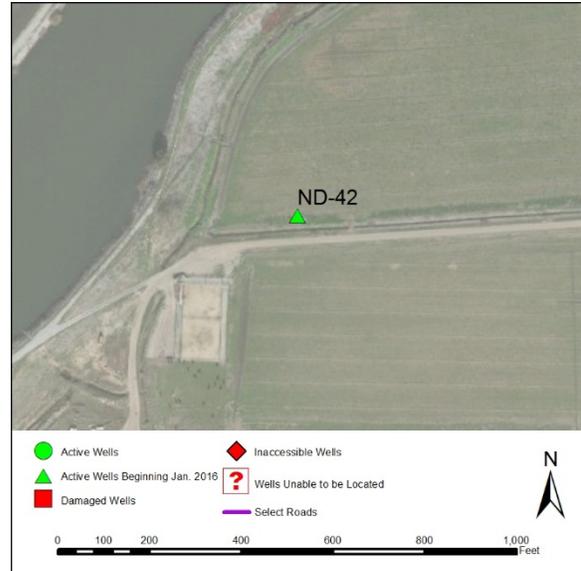
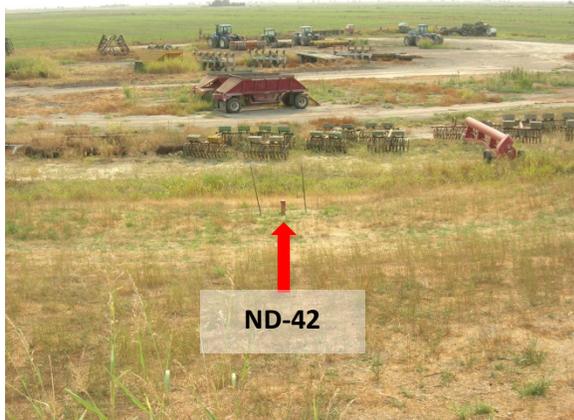
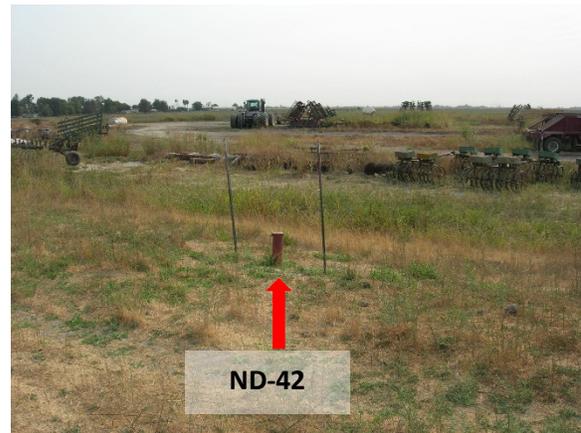
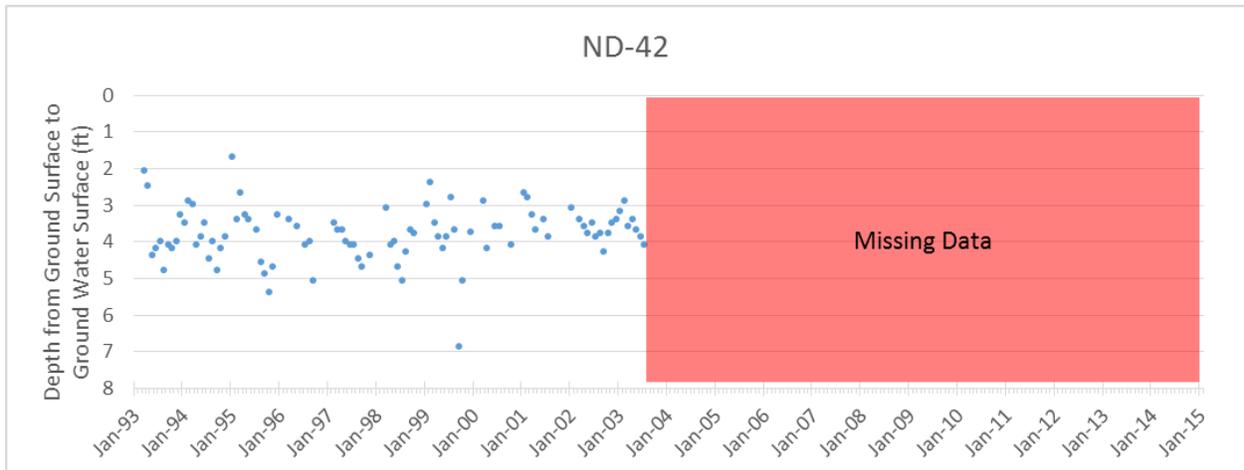
Comments: This well will begin being actively monitored in January 2016 when monitoring of the network resumes. Well located on levee toe, marked by two t-posts.

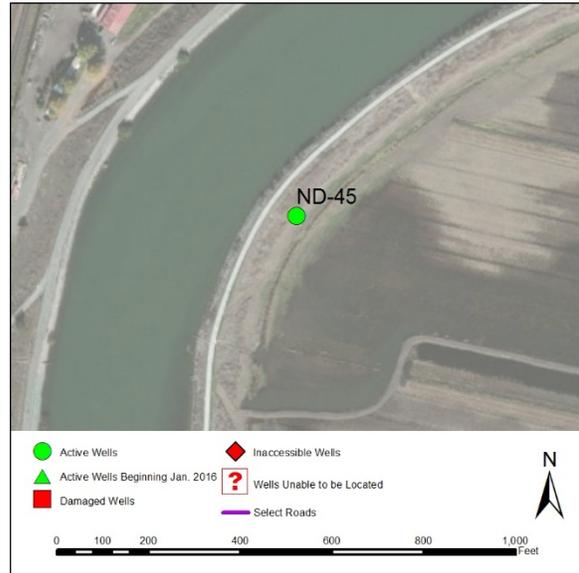
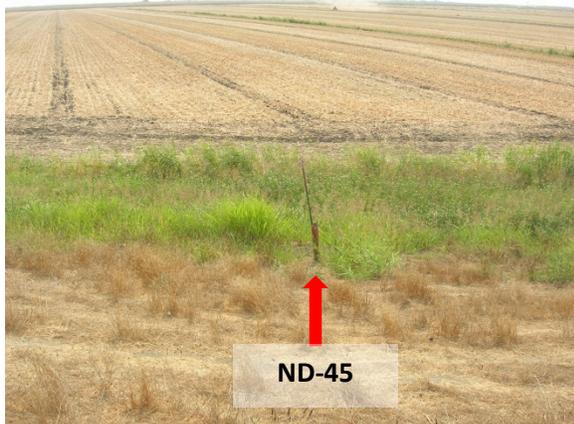
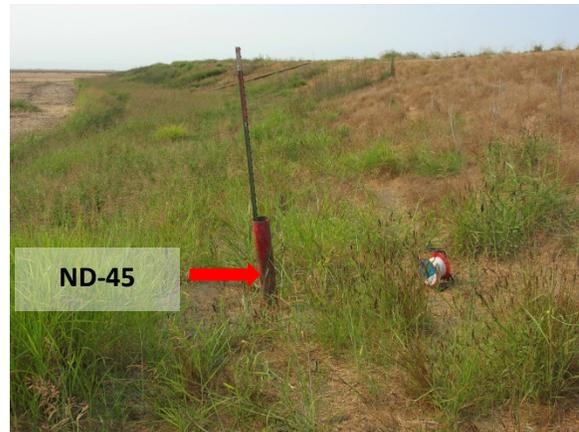
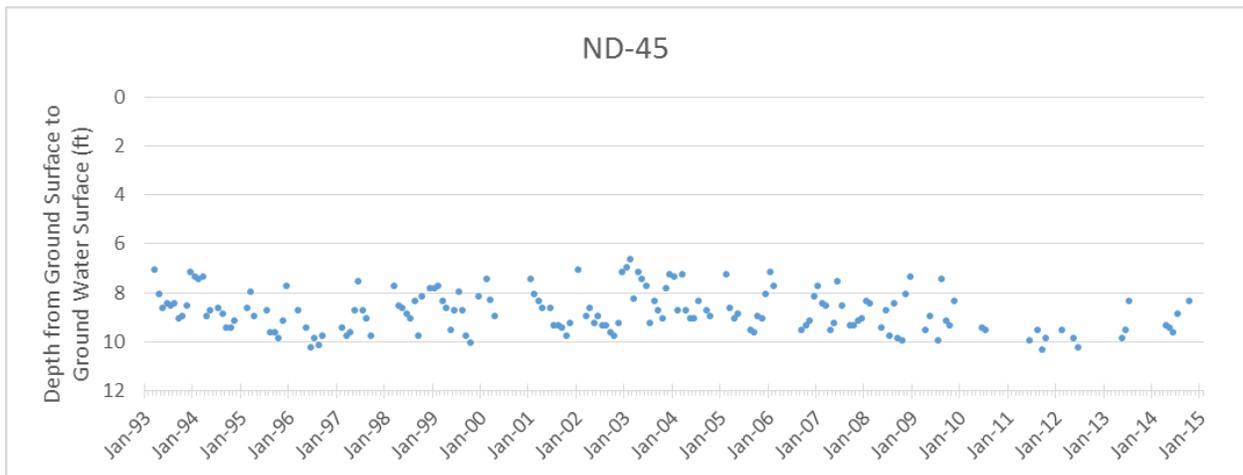
ND-45

Comments: Well located on levee slope, marked by my single red t-posts.

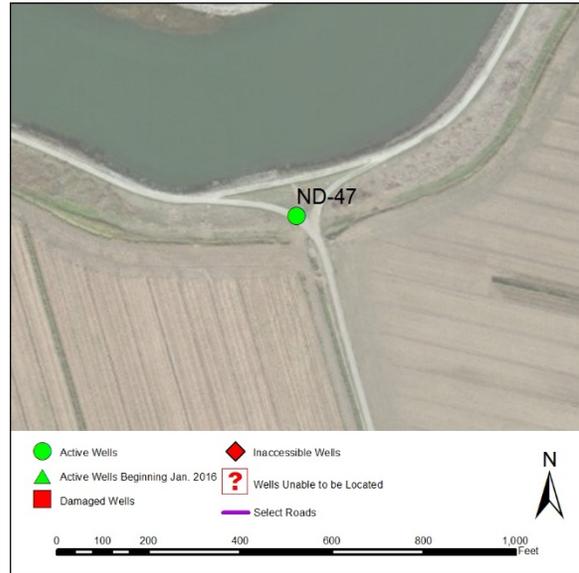
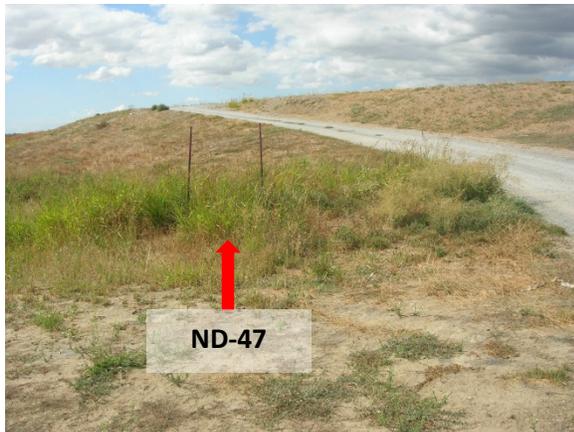
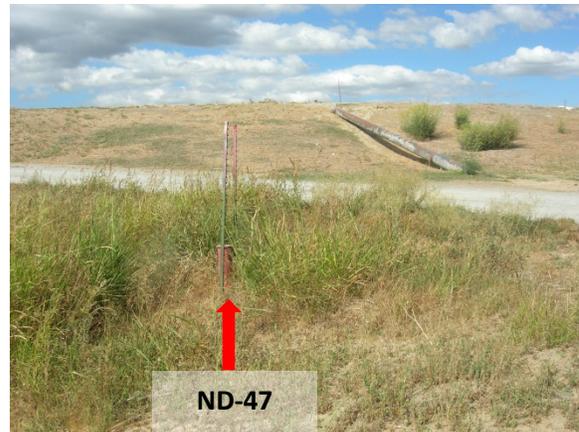
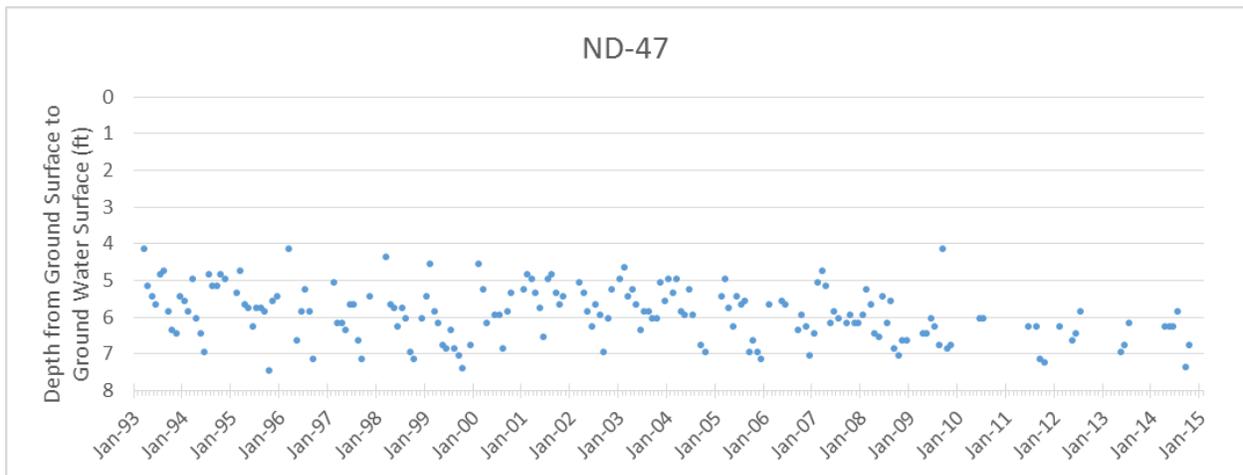
ND-47

Comments: Well located on levee toe, approximately 10ft off the access road. Marked by two red t-posts.

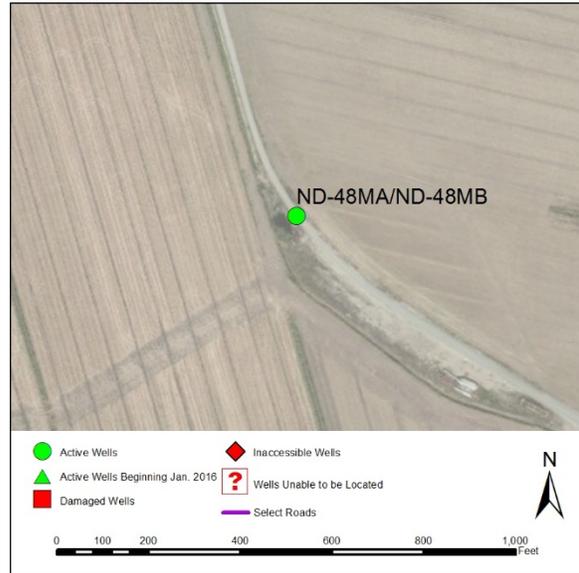
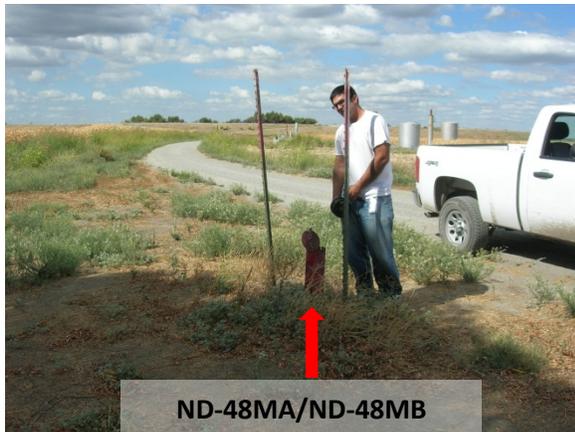
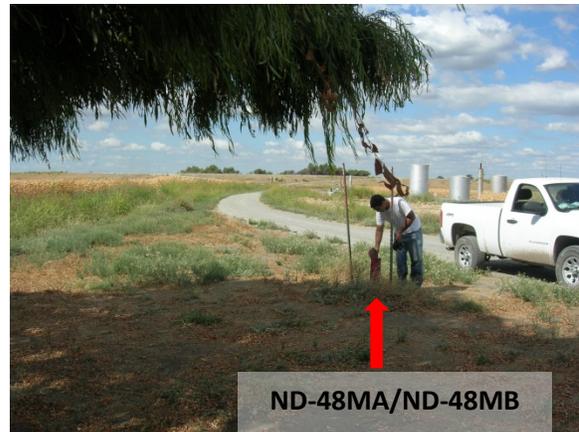
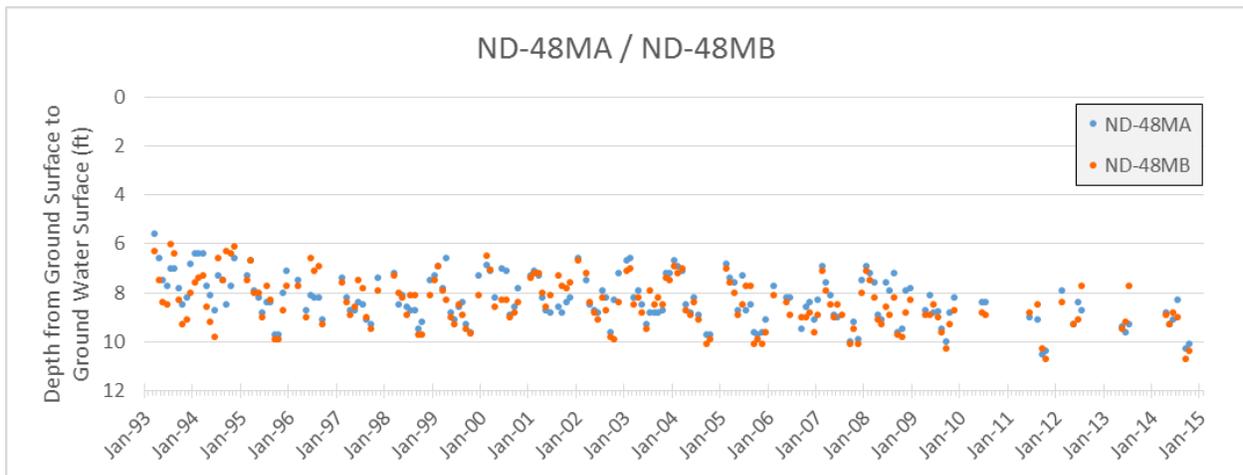
ND-48MA/ ND-48MB

Comments: Well located near a willow tree and marked by two red t-posts.

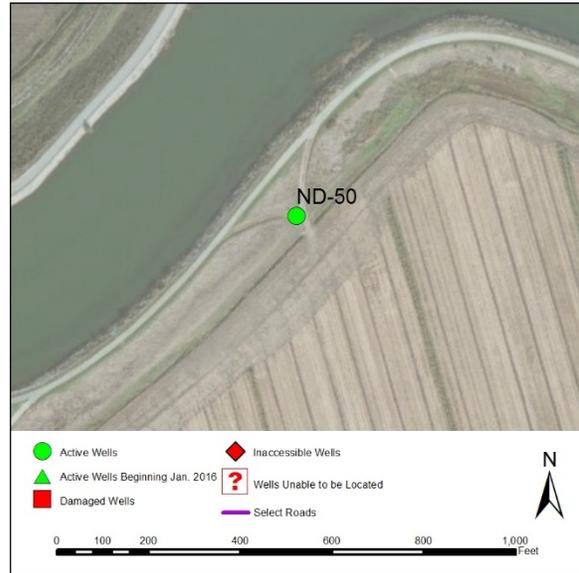
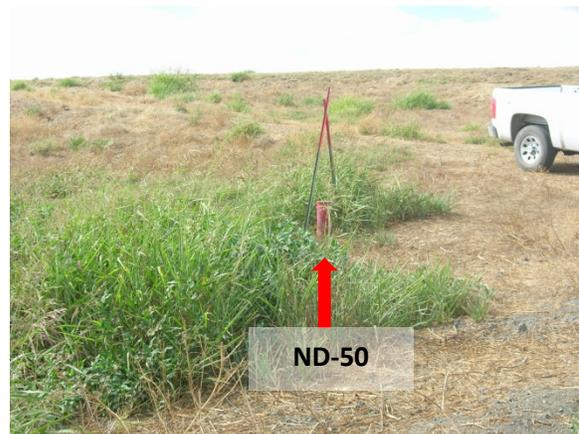
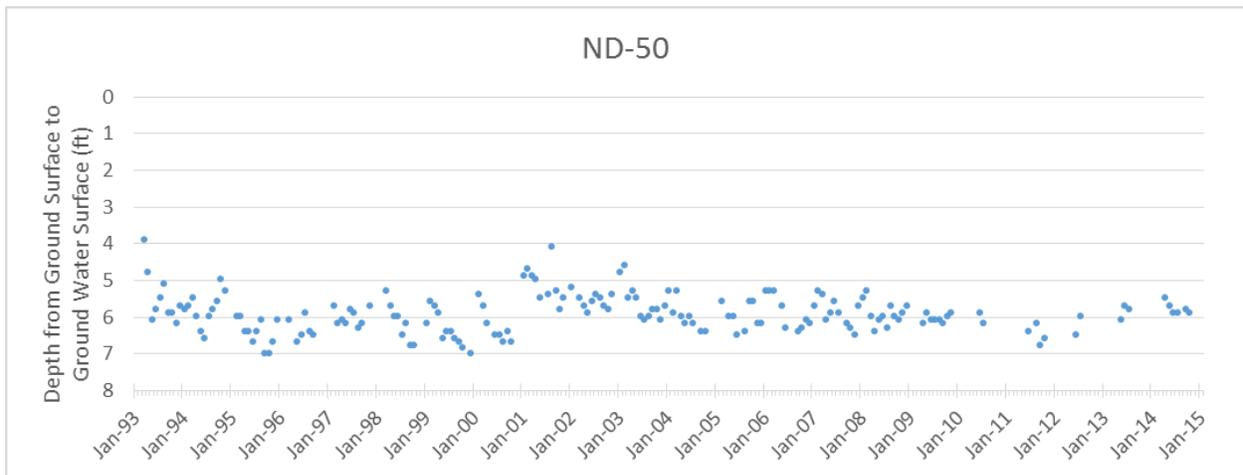
ND-50

Comments: Located near levee toe next to access ramp, and marked by two red t-posts.

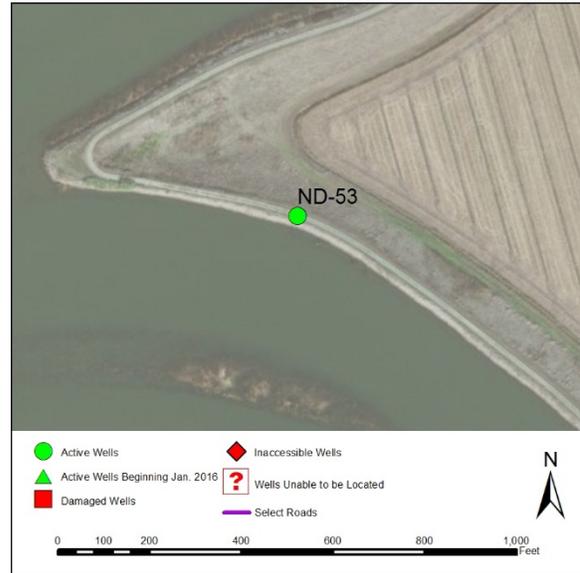
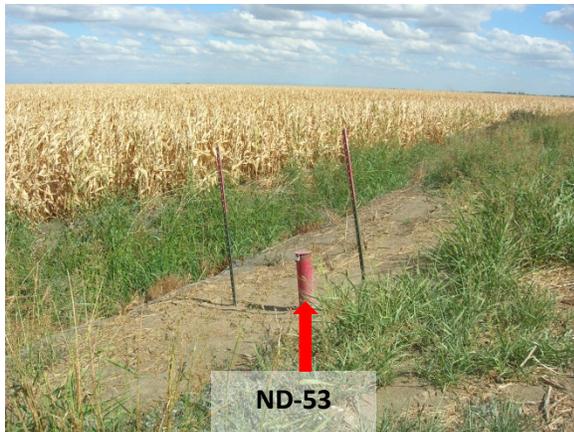
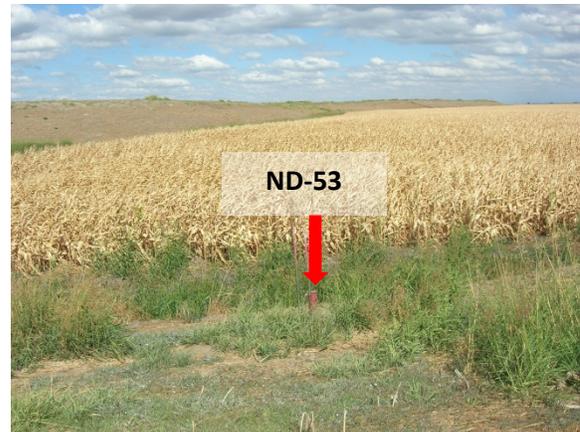
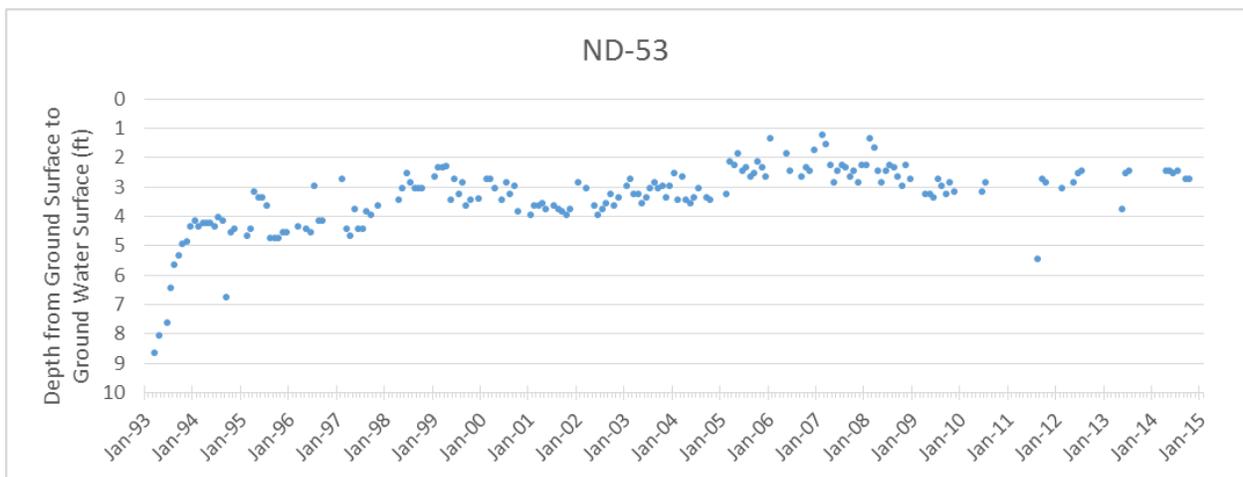
ND-53

Comments: Well located on levee toe, next to ditch, marked by two red t-posts. No easy truck access to well.

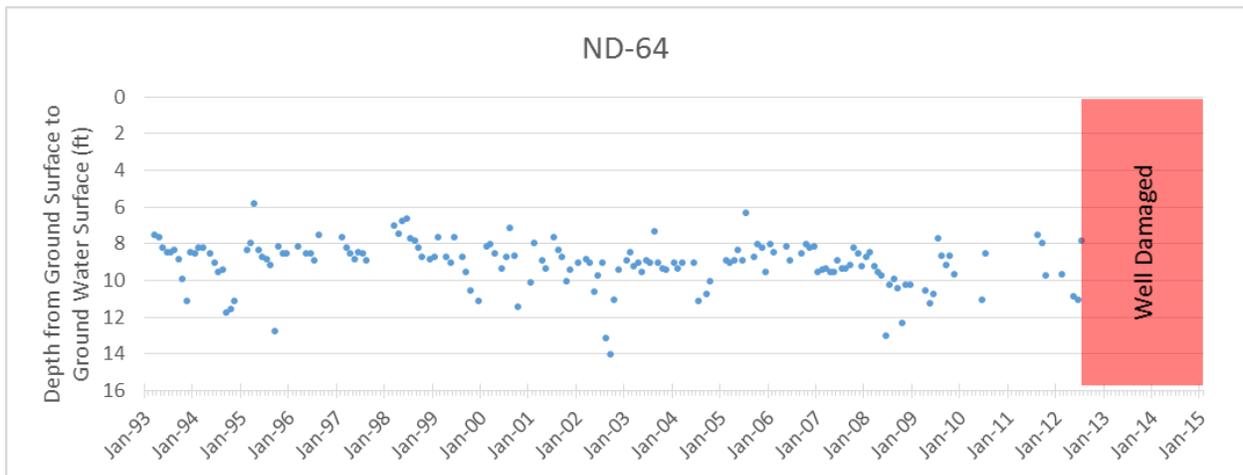
ND-64

Comments: This well has an obstruction approximately 8ft down from the reference point and the last accurate reading occurred in May 2013. The cap is missing.

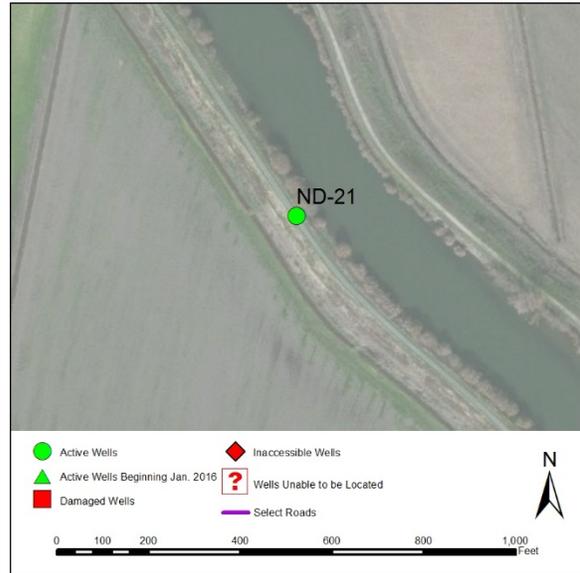
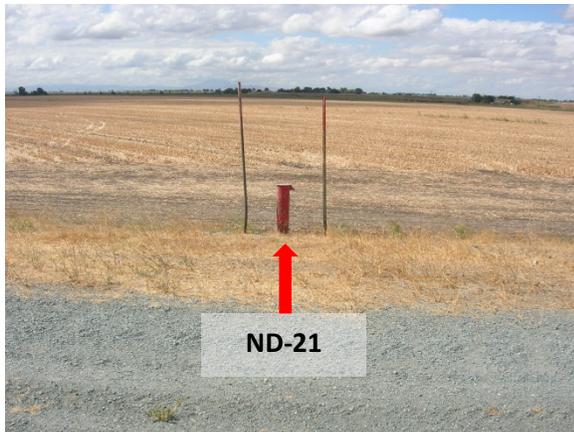
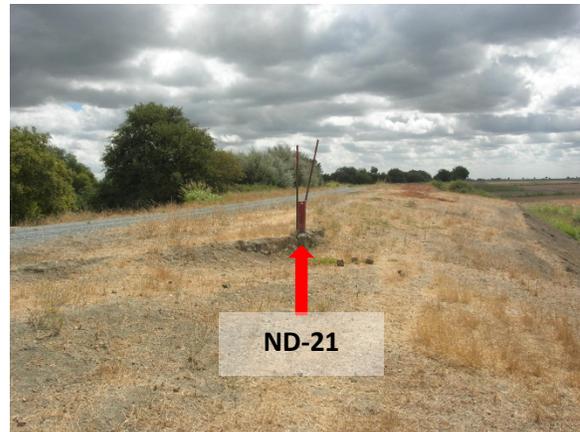
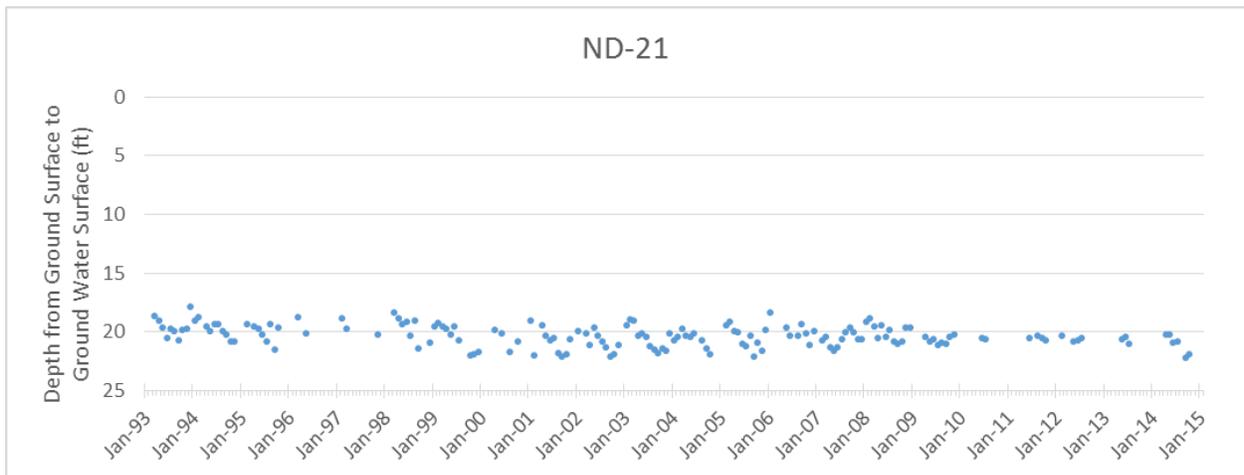
ND-21

Comments: Well located on the top of the levee on the land side, and marked by two red t-posts.

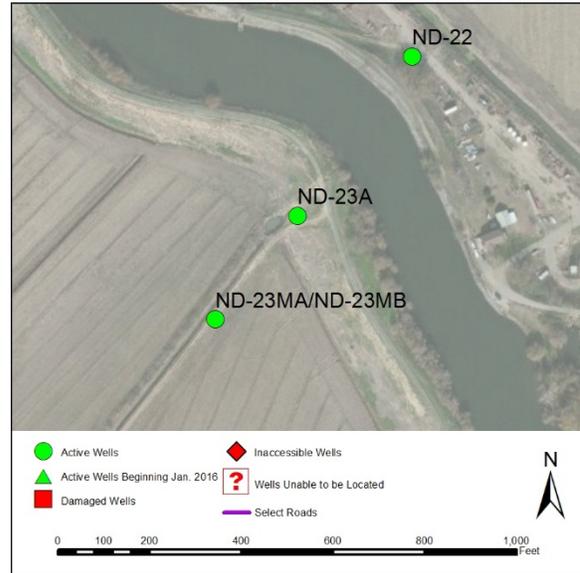
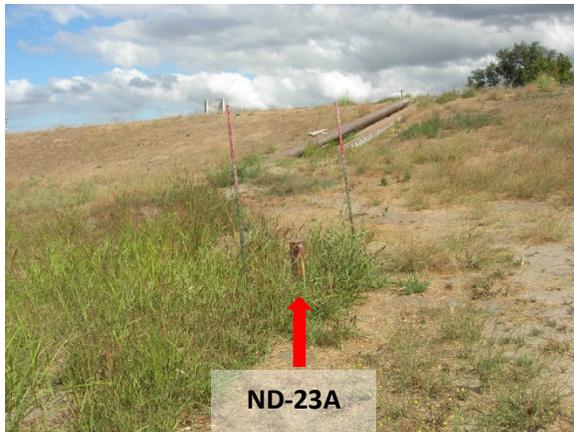
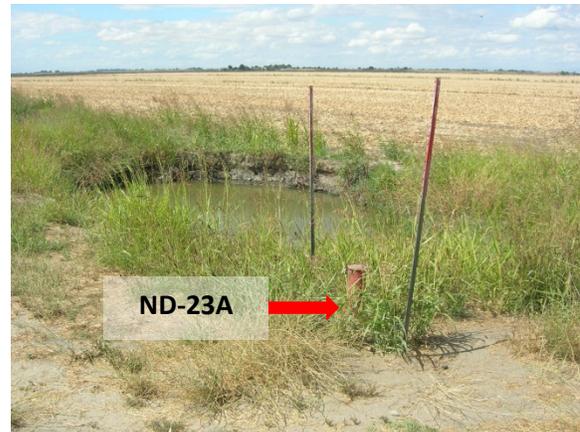
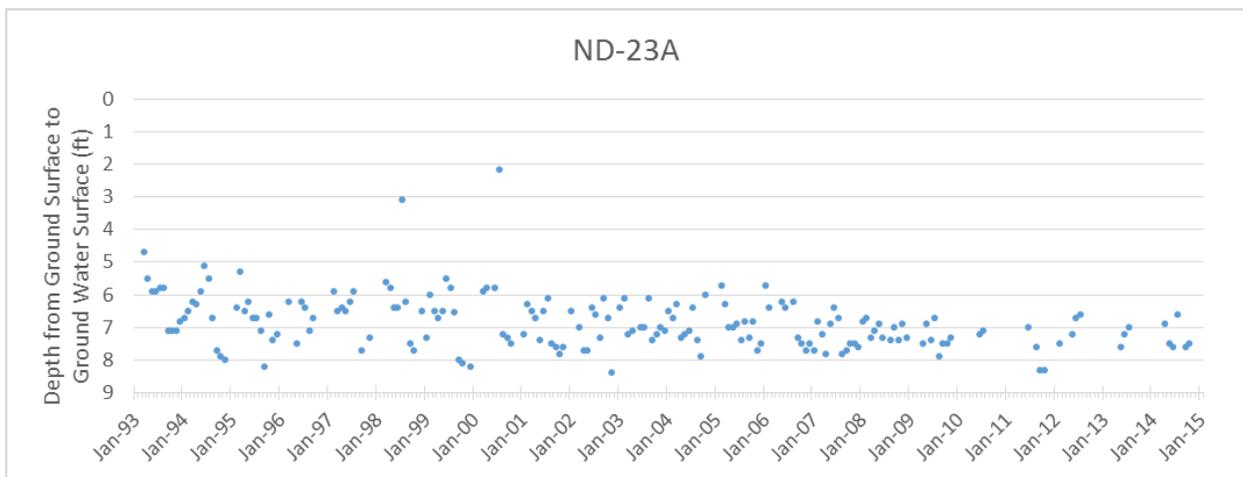
ND-23A

Comments: The well is located on the levee toe, near pool, marked by two red t-posts.

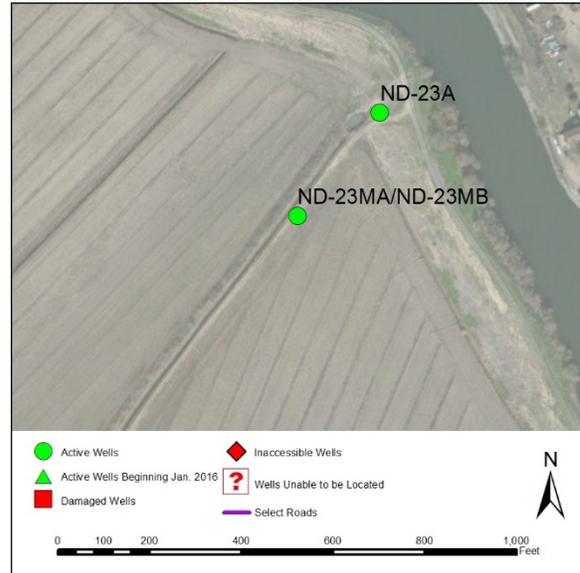
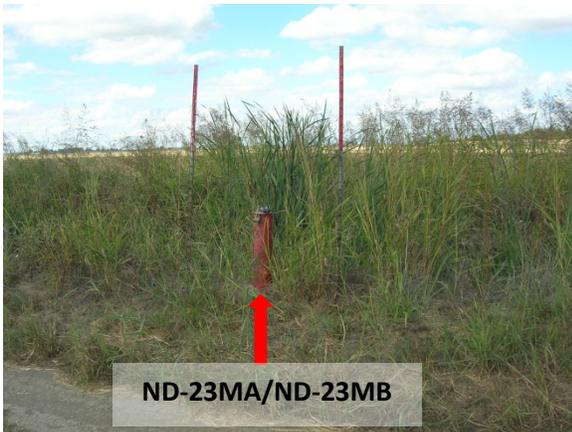
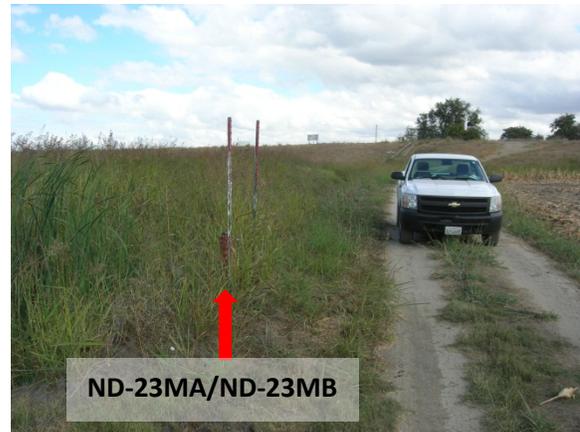
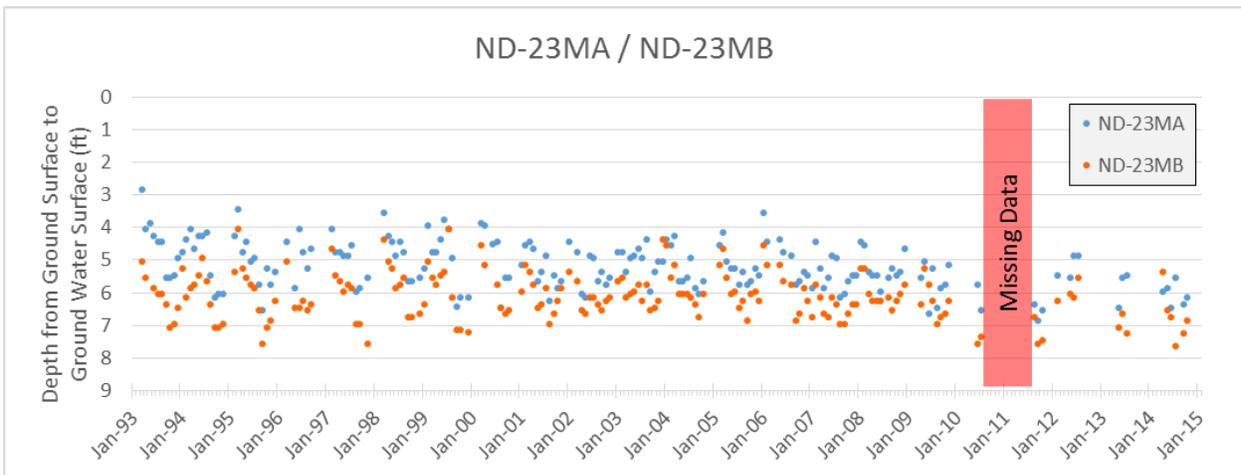
ND-23MA/ MD-23MB

Comments: Well is located approximately 300ft from ND-23A, on the eastern side of the ditch, marked by two red t-posts.

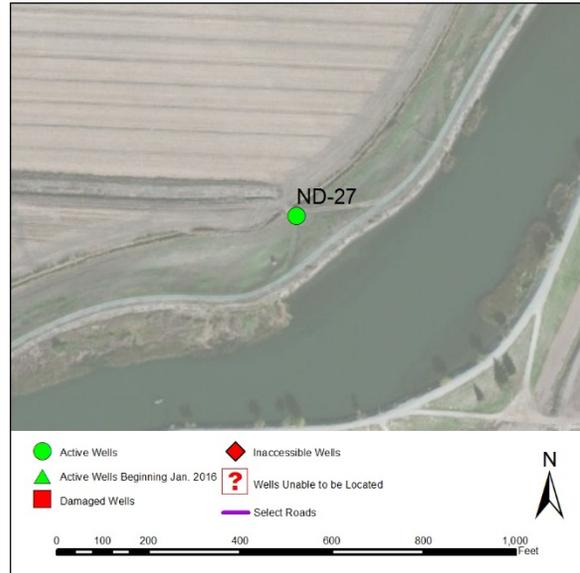
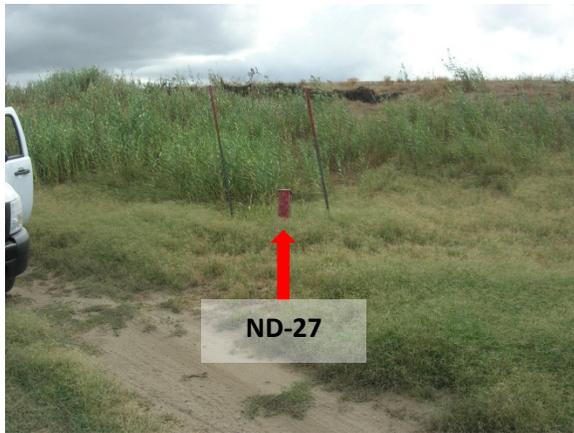
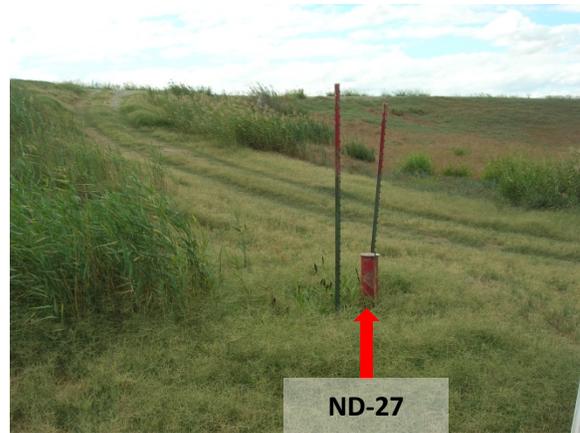
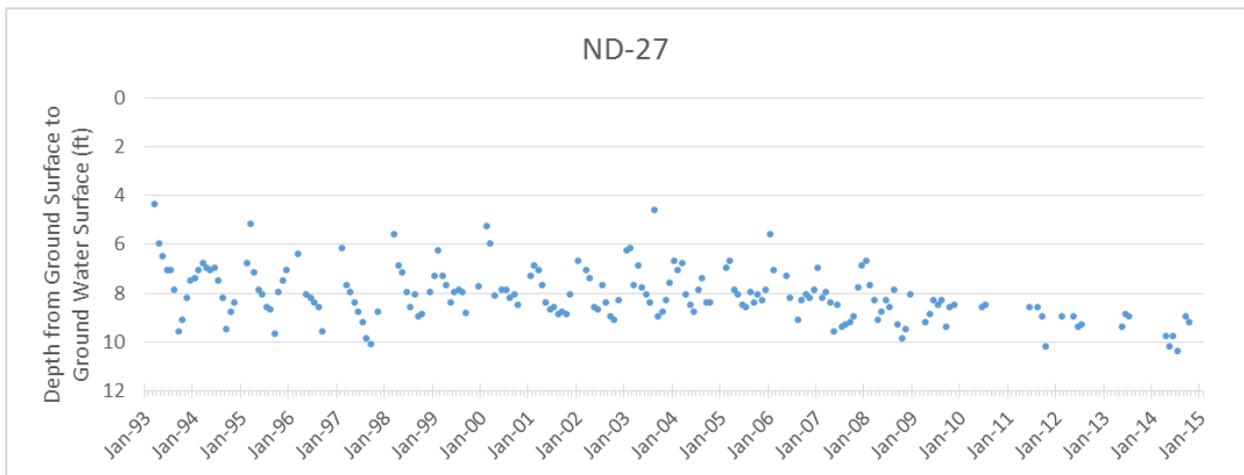
ND-27

Comments: Well located at the toe of levee at the intersection of two access roads, marked with two red t-posts.
