North and South Delta Seepage Well Monitoring Network Update

Memorandum Report
April 2015

Subject: North and South Delta Seepage Monitoring Program Well Status Update

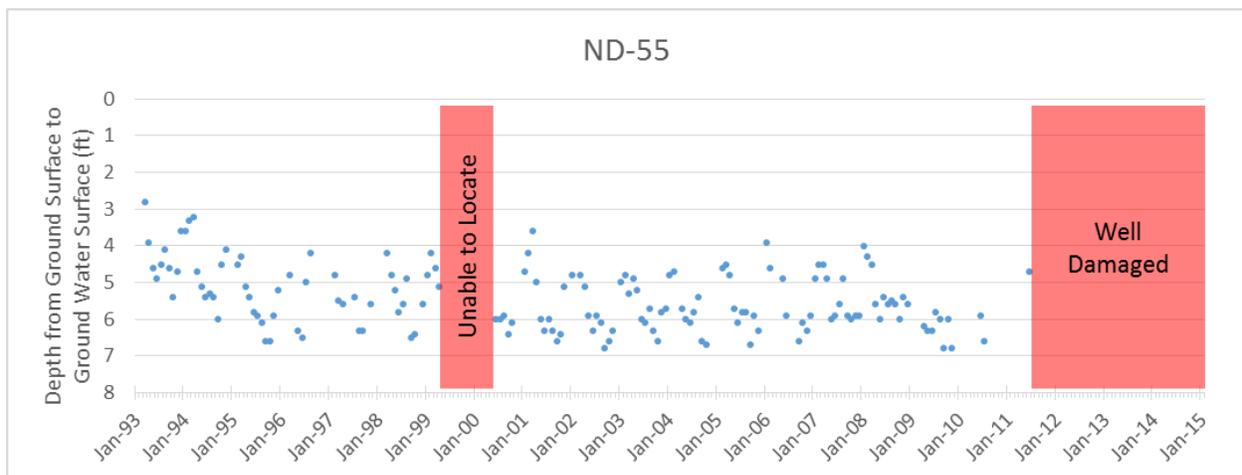
ND-55

Comments: The well has been damaged. Well was hit by something in September 2011.

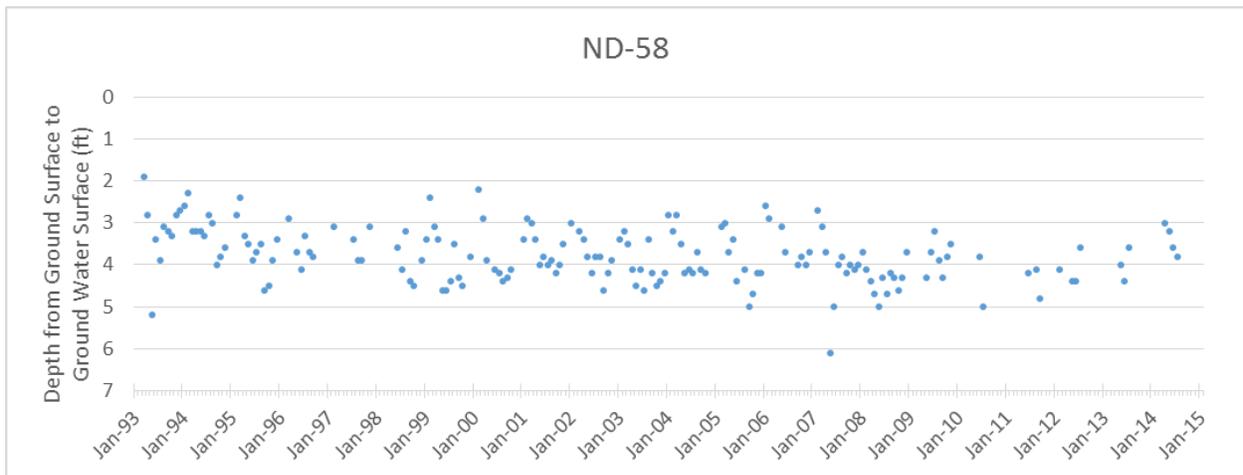
ND-58

Comments: The well has been damaged. Last accurate measurement was July 2014. The well was damaged between July and September 2014. Located on the levee slope.

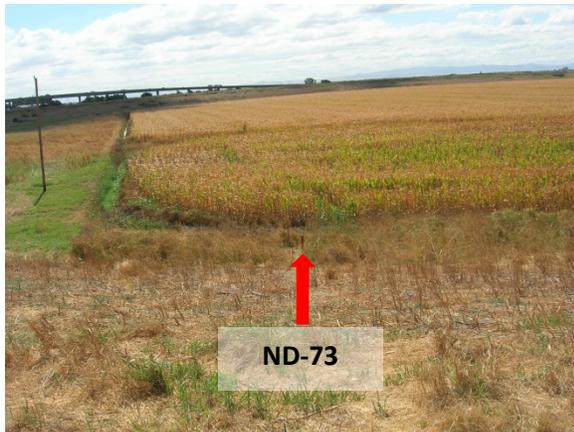
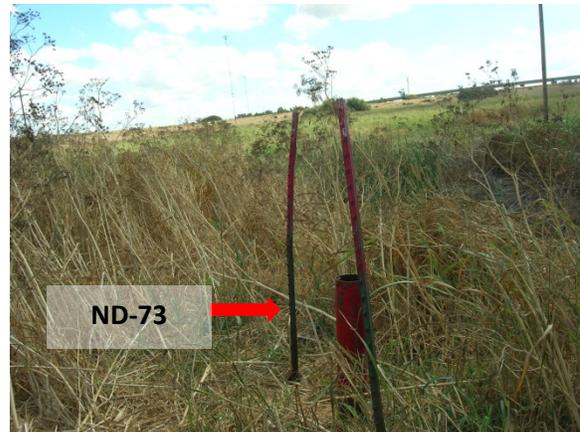
ND-73

Comments: Well located on levee toe, near ditch, marked with two red t-posts.

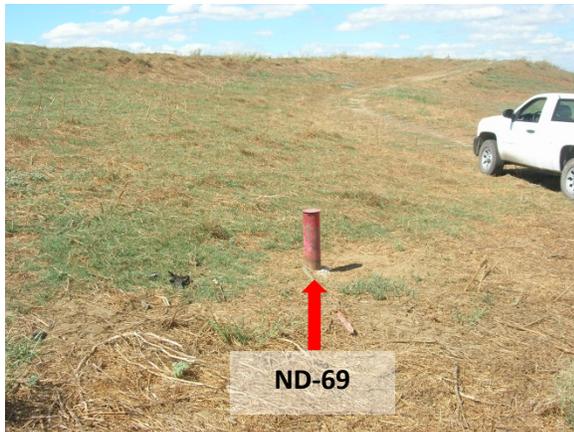
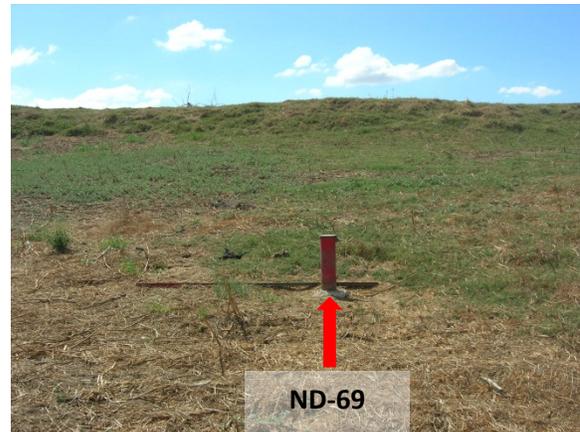
ND-69

Comments: Located on levee toe near levee access ramp. Every time t-posts are put in place they get removed. Red steel casing approximately 2ft high.

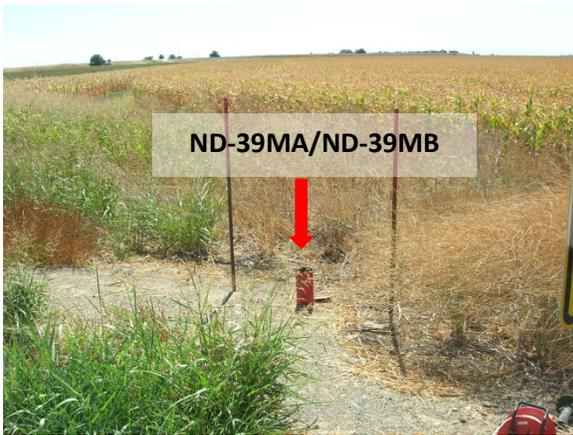
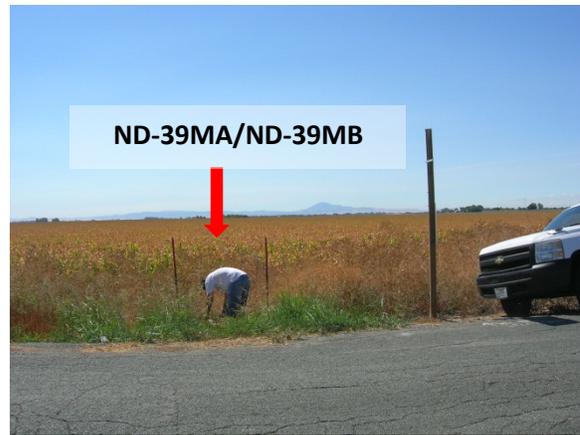
Comments: Well is located approximately a half mile from the levee, near the fork in the road. Marked with two red t-posts.

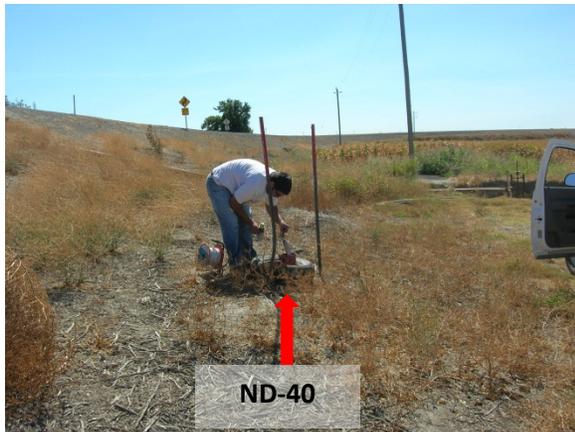
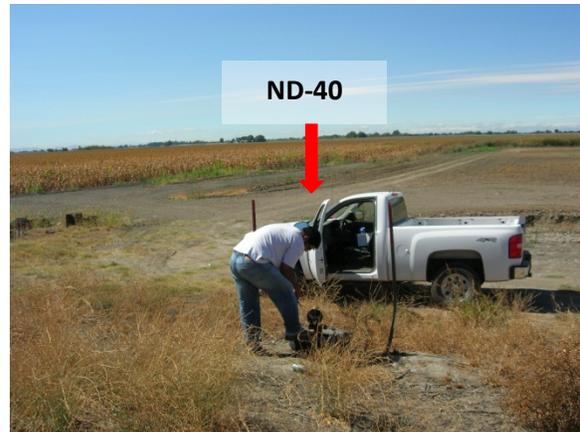
ND-40

Comments: Well located at levee toe, marked with two red t-posts. There is a tire around the well.

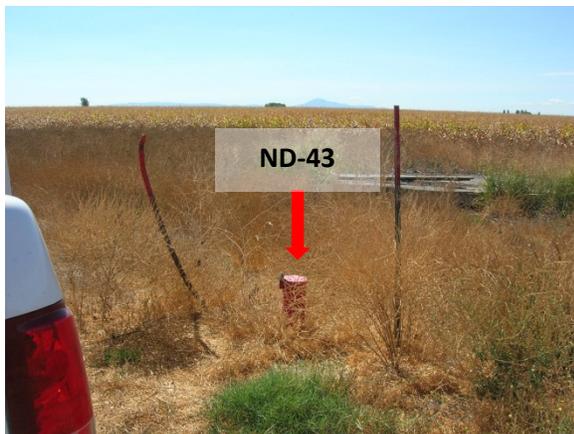
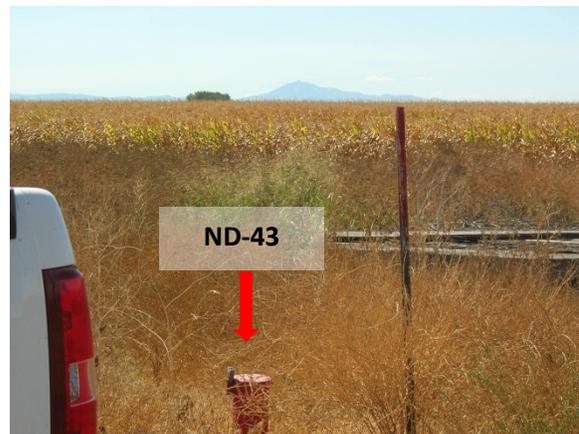
ND-43

Comments: Well located at levee toe, down assess road, and marked by two red t-posts.

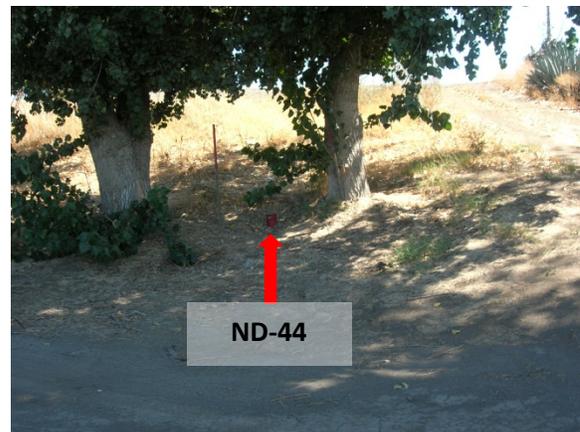
ND-44

Comments: The well is located mid-slope, between two trees. The casing is a few inches out of the ground and marked by a red t-post.

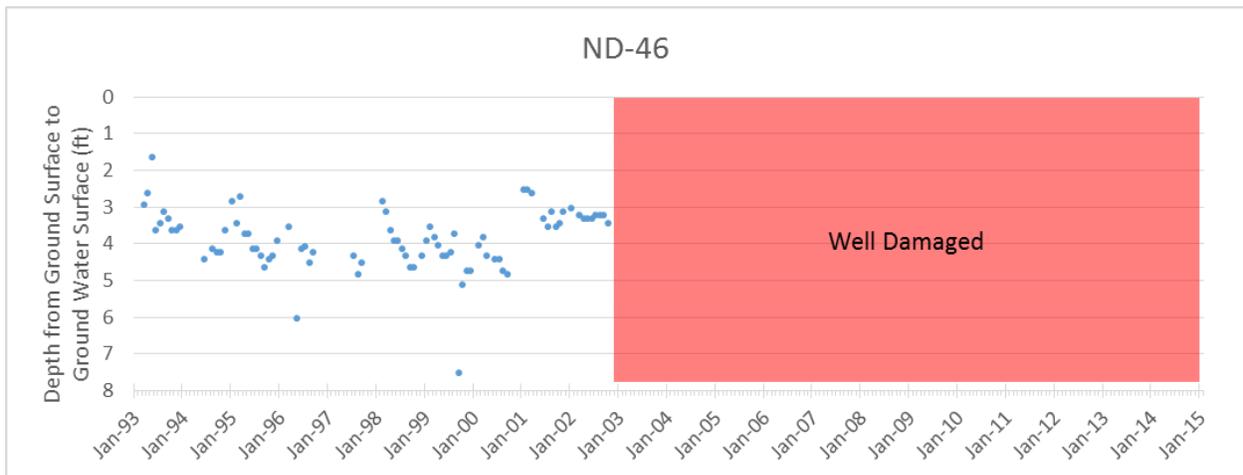
ND-46

Comments: The well has been damaged. The well is located at the levee toe, next to the access ramp.

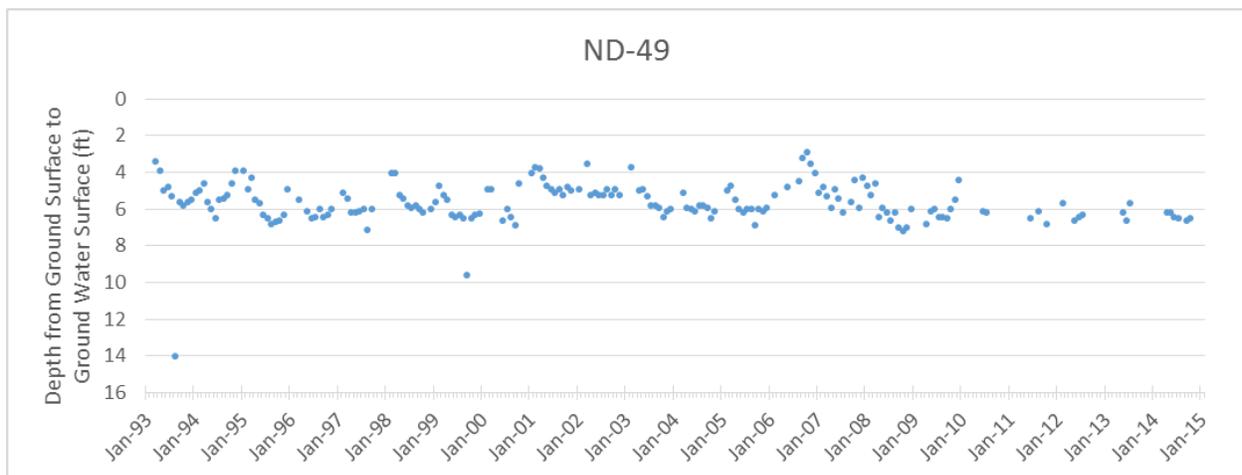
ND-49

Comments: The well is located at the bottom of the access ramp, and marked by two red t-posts. The casing cap is missing.

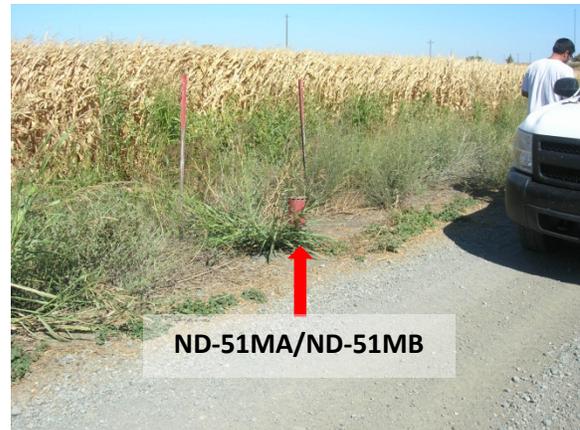
ND-51MA/ ND-51MB

Comments: Well is located approximately 1000ft from levee, and marked by two red t-posts. Data gap is the result of a frozen lock that has since been removed.

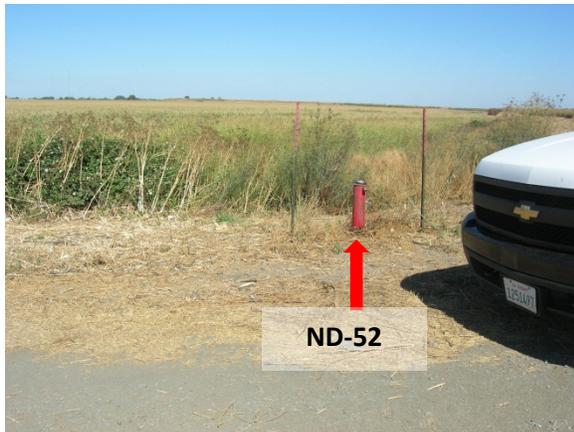
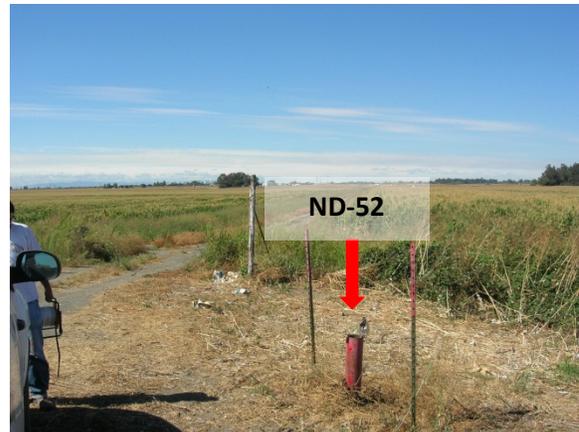
ND-52

Comments: Well located at the base of an access ramp, near ditch, and marked by two red t-posts.

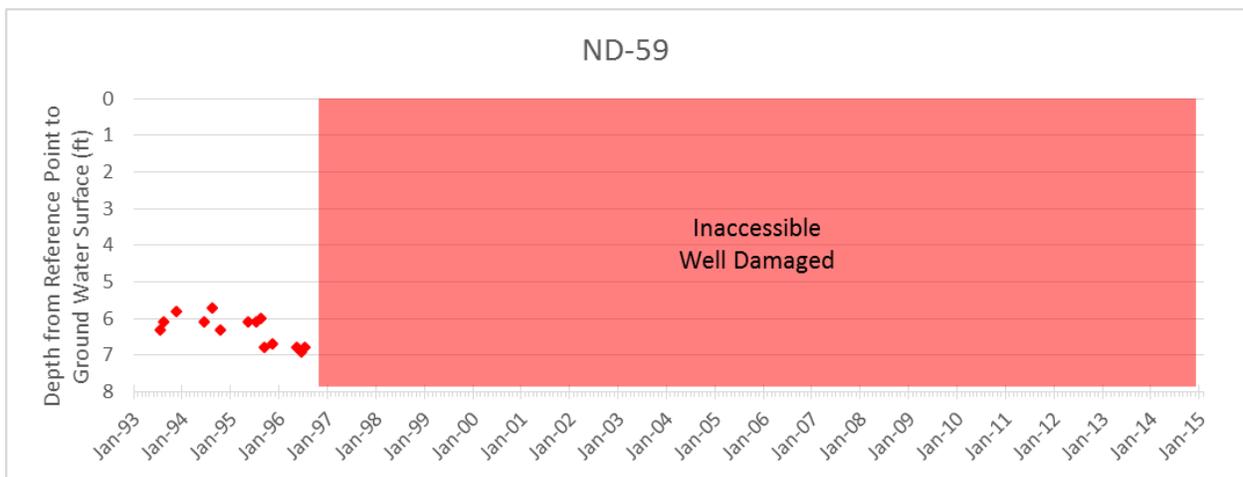
Comments: The well has been damaged. The well is marked by a single t-post.

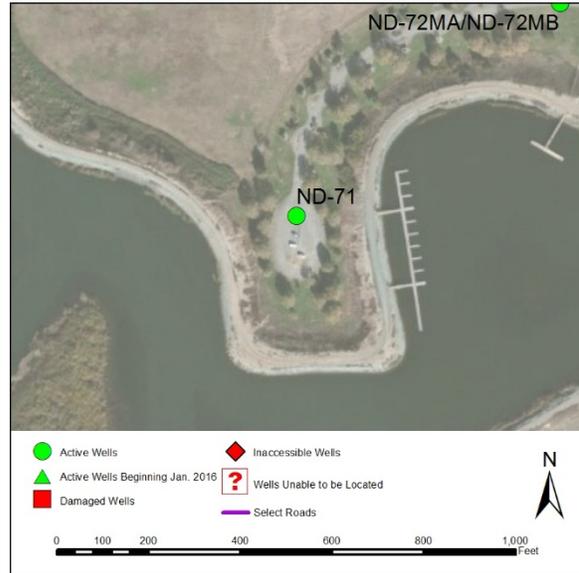
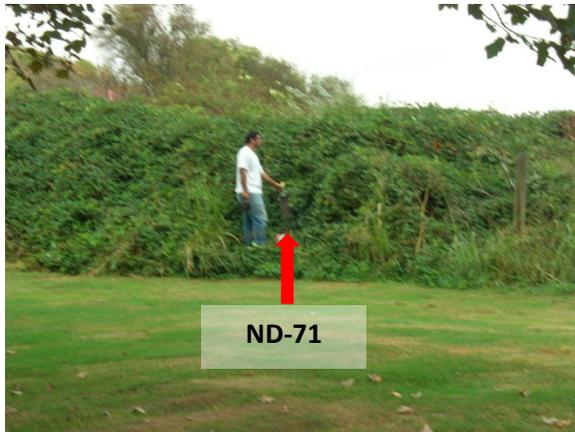
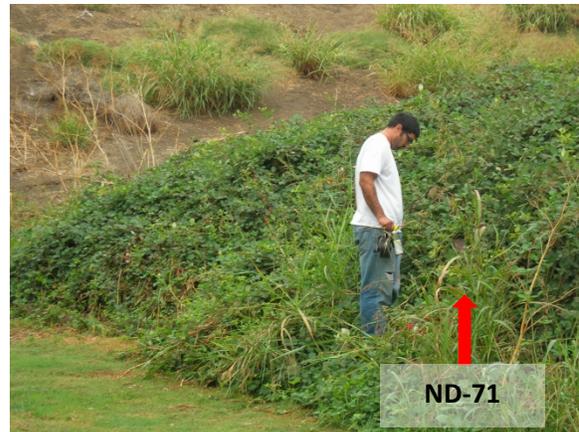
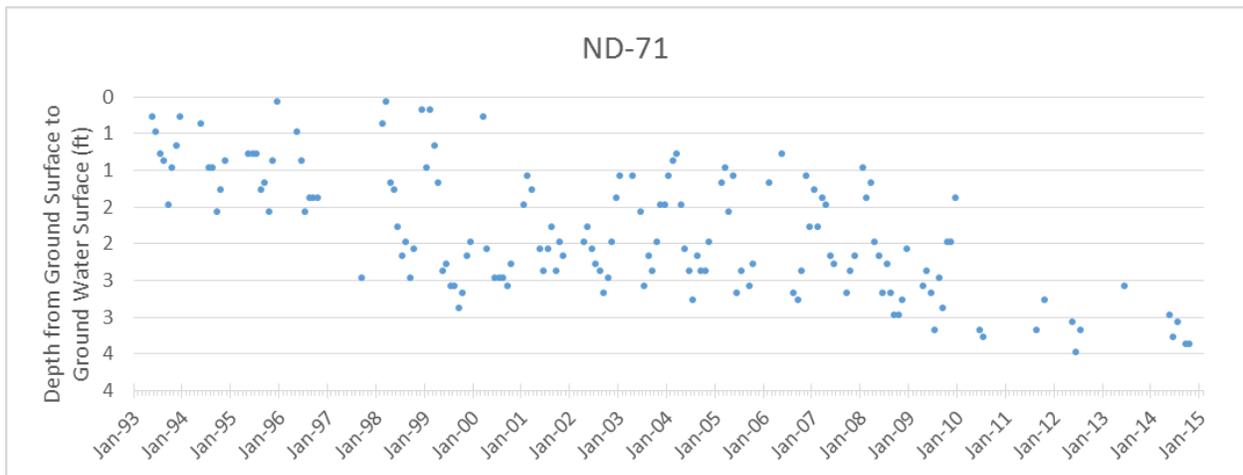
ND-71

Comments: The well is located in Westgate Landing Park. The casing is brown, and approximately 3ft tall.

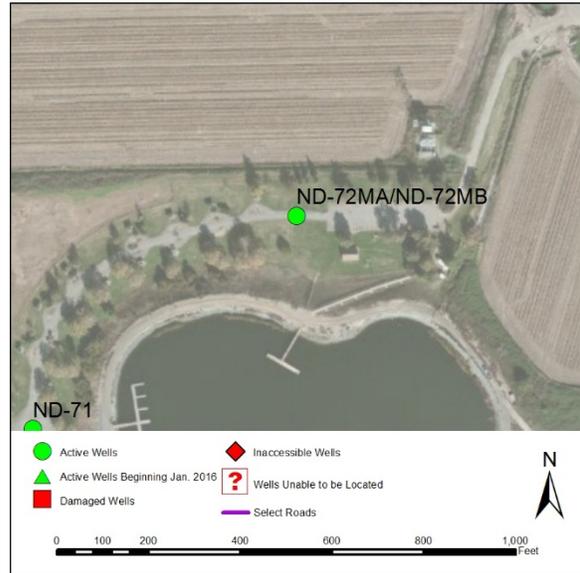
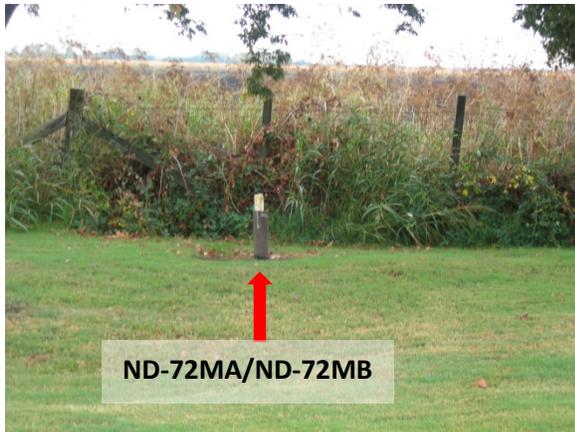
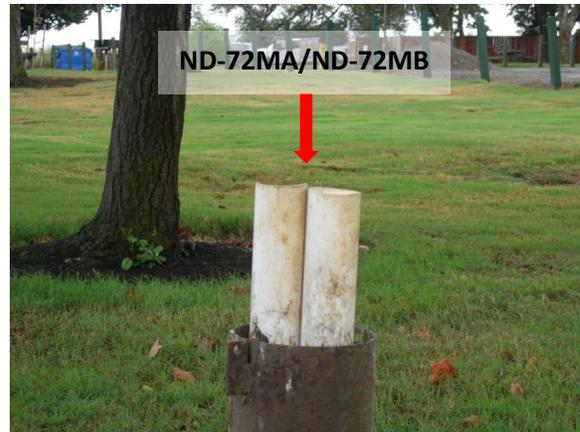
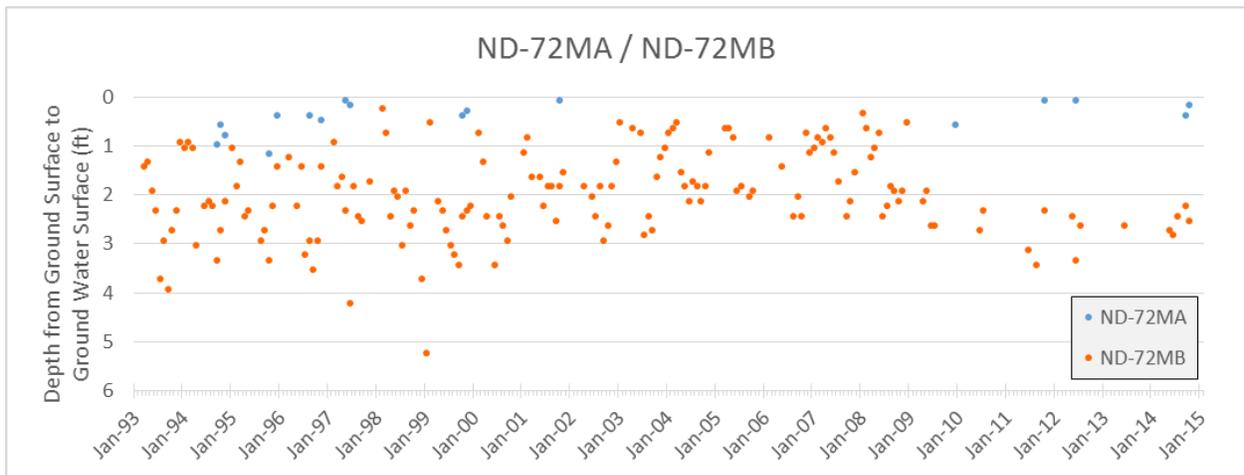
ND-72MA/ ND72-MB

Comments: Wells are located in Westgate Landing Park. There is no cap to the cases. Park staff have modified/shortened the PVC pipes approximately 1ft over time.

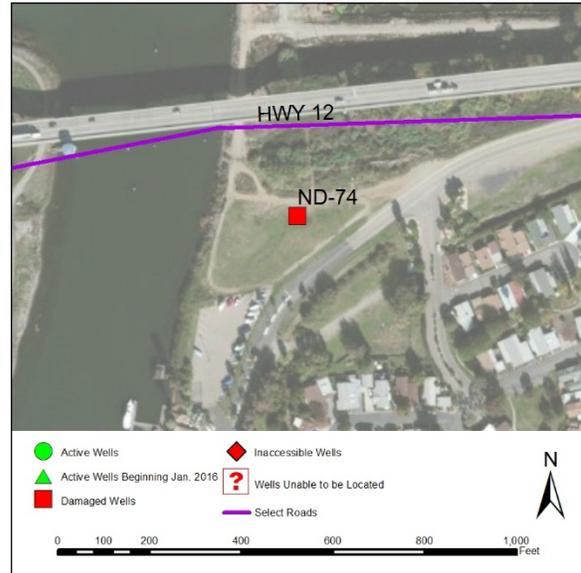
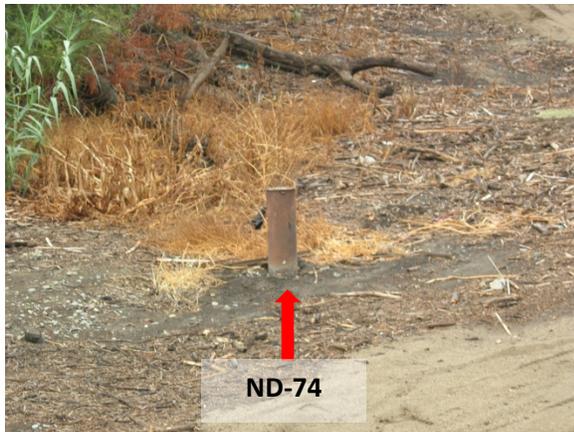
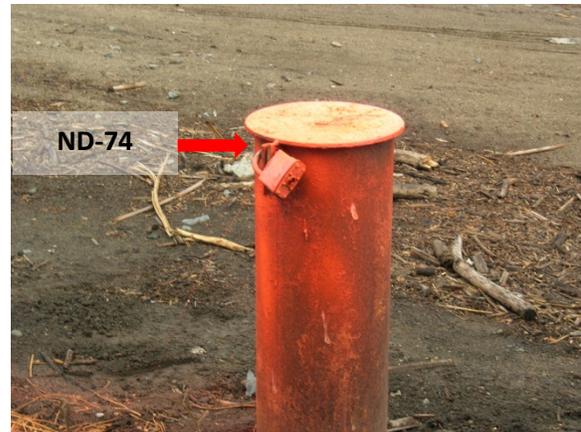
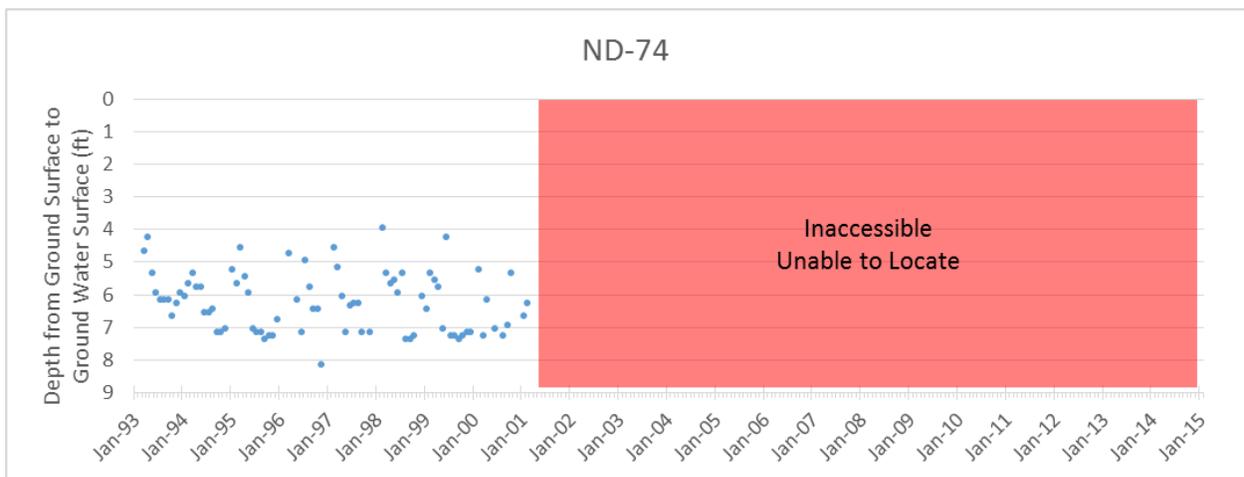
ND-74

Comments: The well is obstructed near the top of the well. Located near the base of highway 12 overpass and Potato Slough.

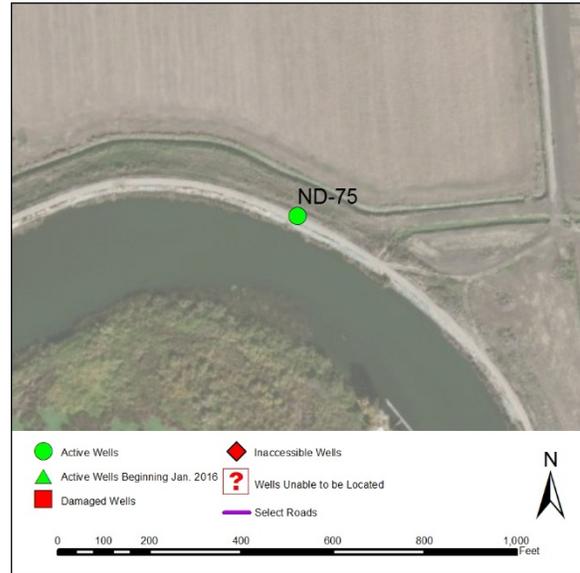
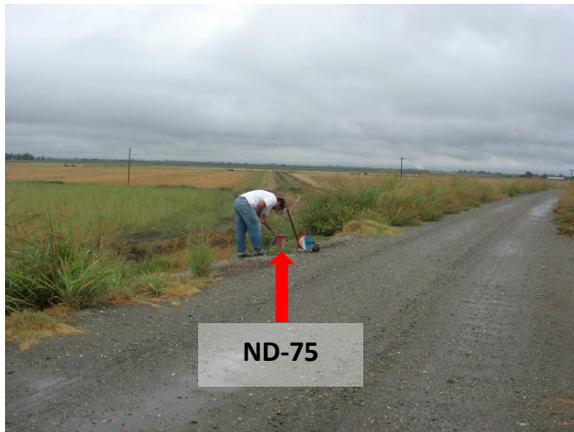
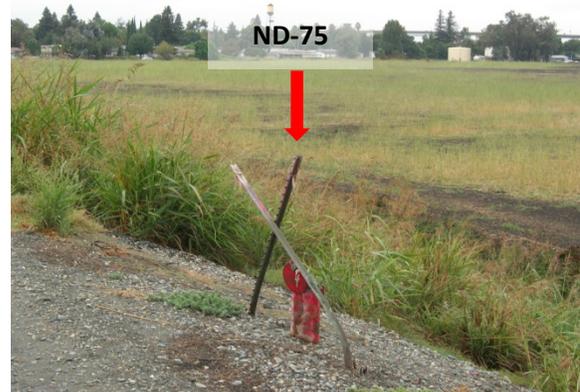
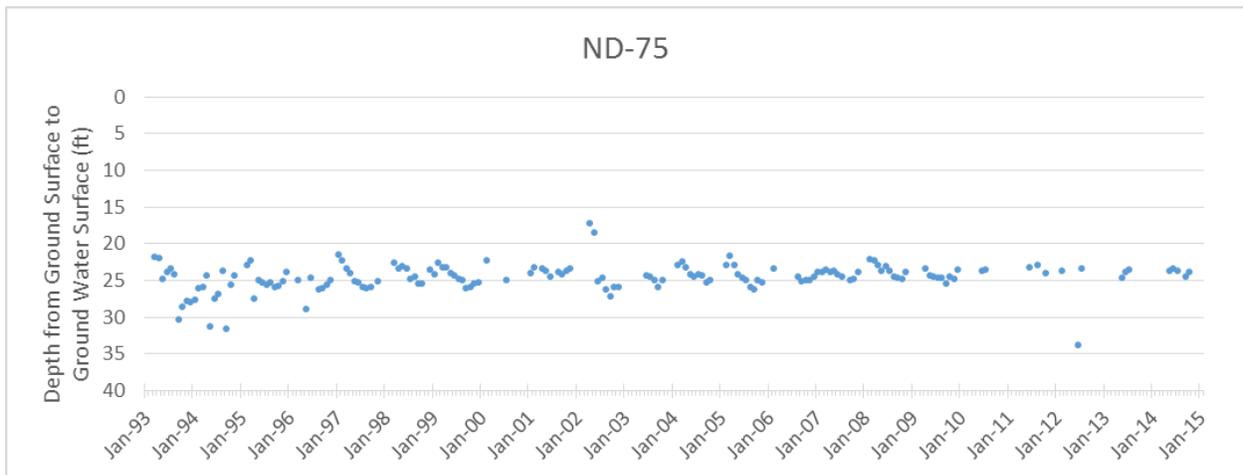
ND-75

Comments: Well located on levee crown, marked by two red t-posts. Access well through a yellow gate (access code 2543) in KOA campground.

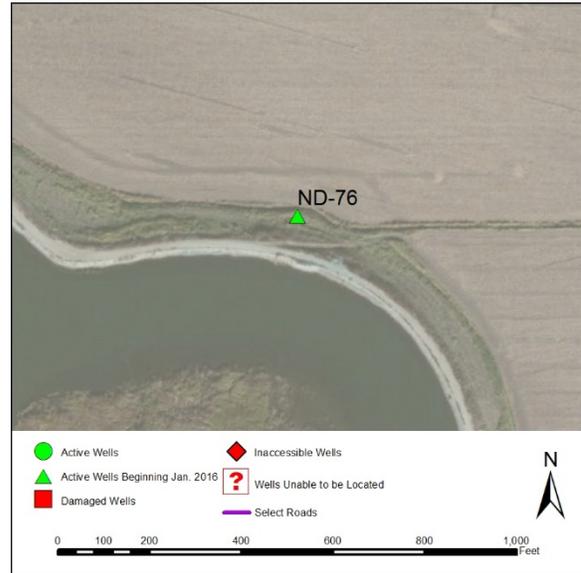
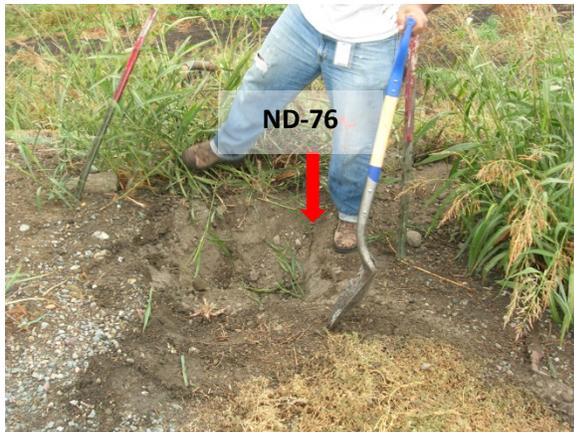
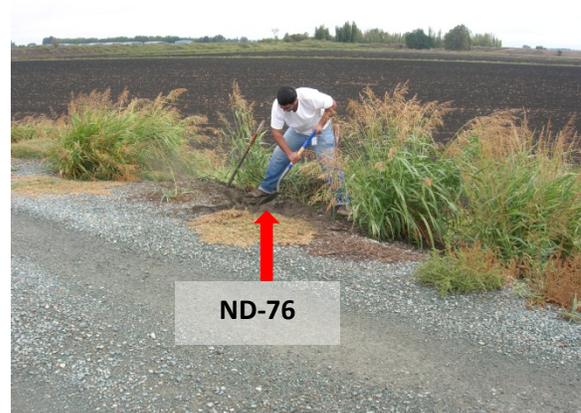
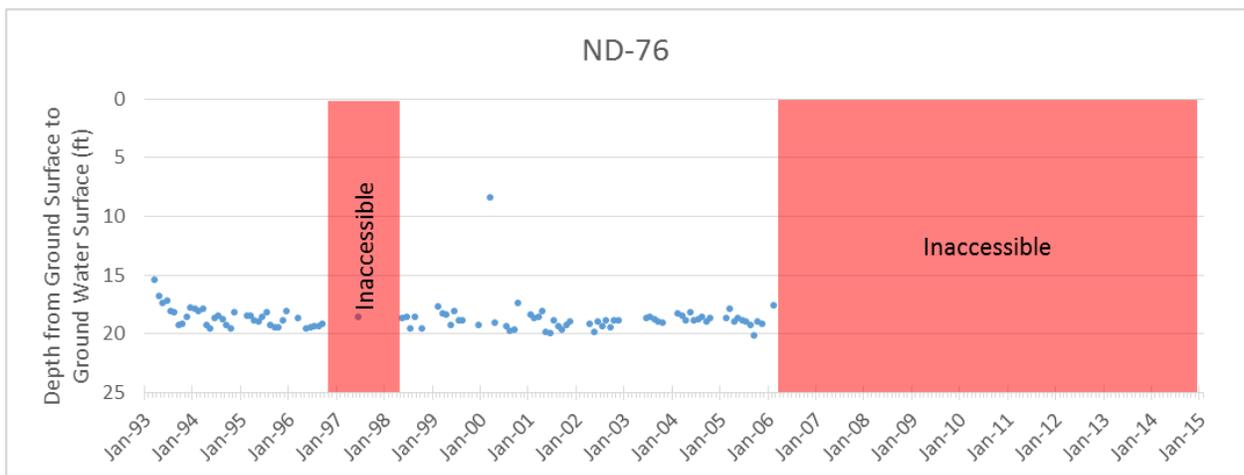
ND-76

Comments: This well will begin being actively monitored in January 2016 when monitoring of the network resumes. Well was originally buried, but was unburied in September 2014. A new lock was put on the well, and a reading was taken.

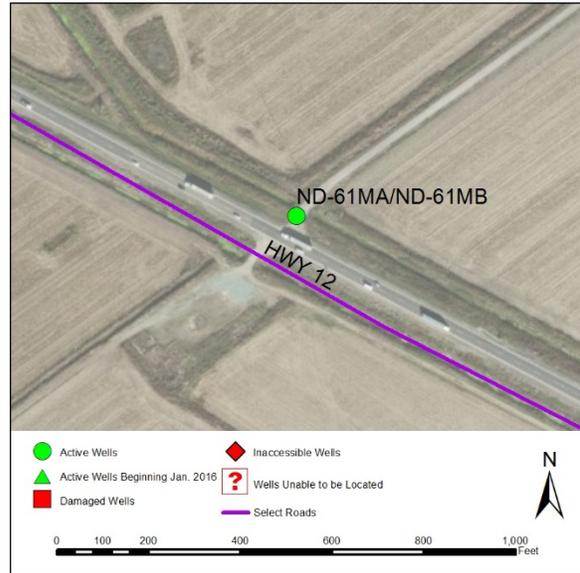
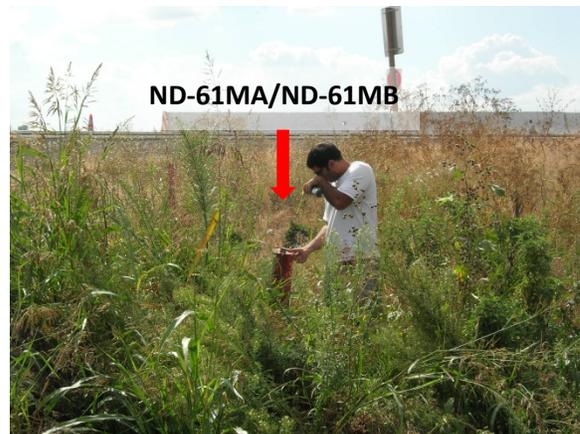
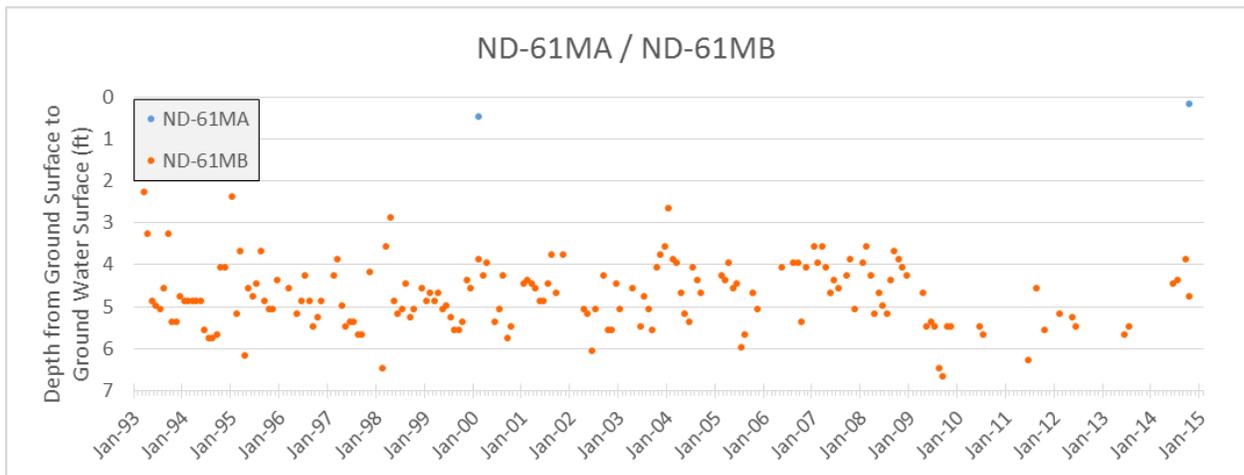
ND-61MA/ MD-61MB

Comments: Well located approximately 20ft off of the north side of Highway 12. Significant site maintenance required to keep access open.

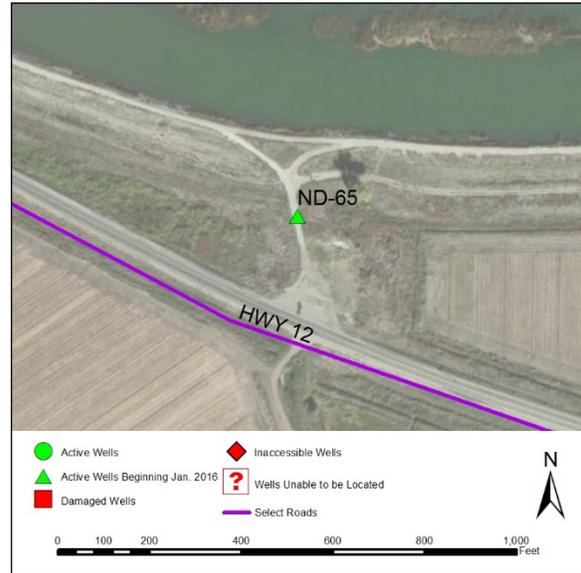
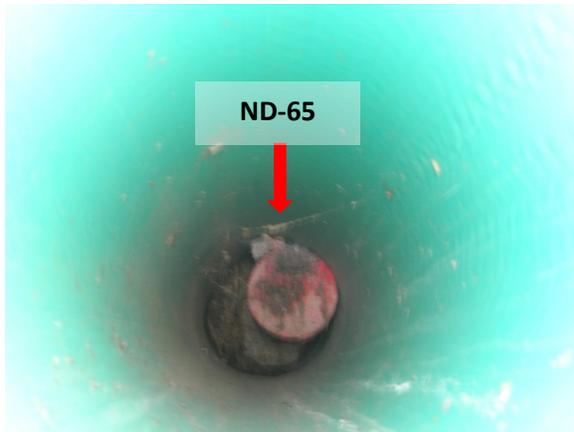
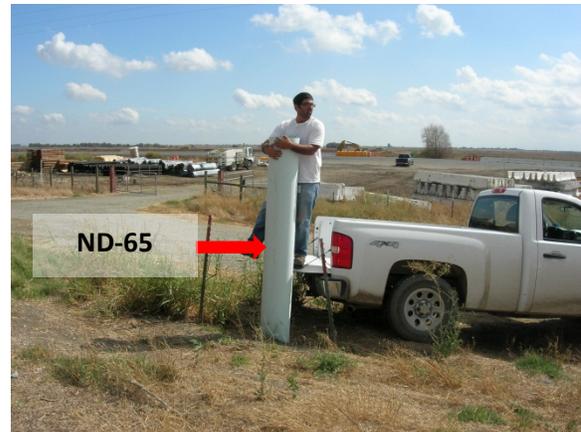
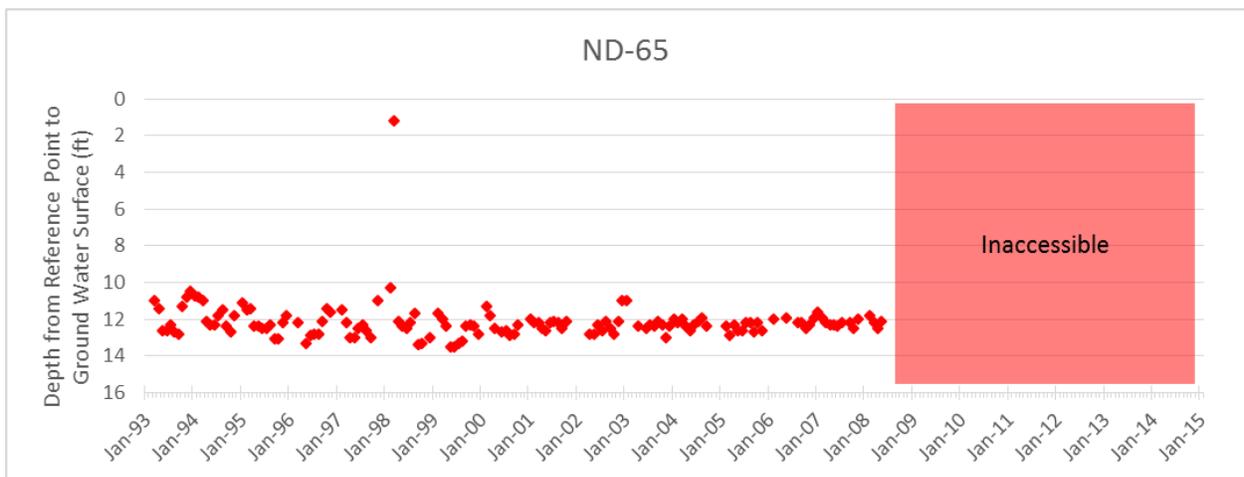
ND-65

Comments: This well will begin being actively monitored in January 2016 when monitoring of the network resumes. An 8ft PVC extension was placed over the well when work was done in the area. The pipe will be cut to provide access to the well.

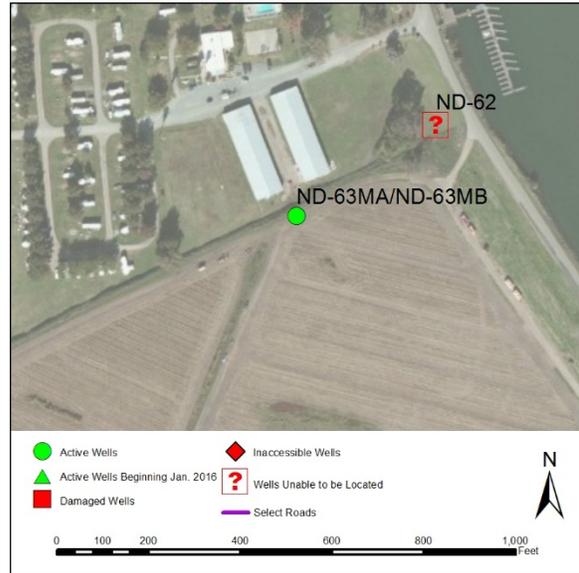
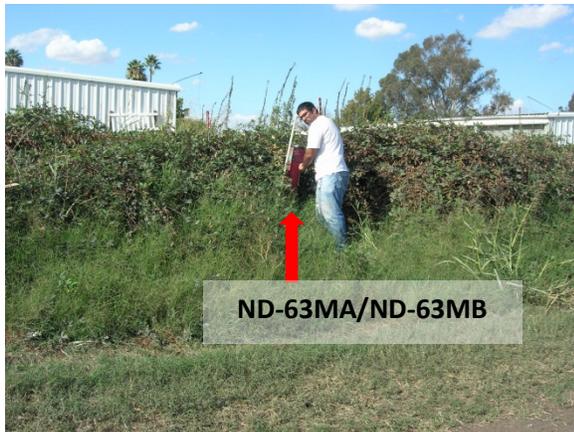
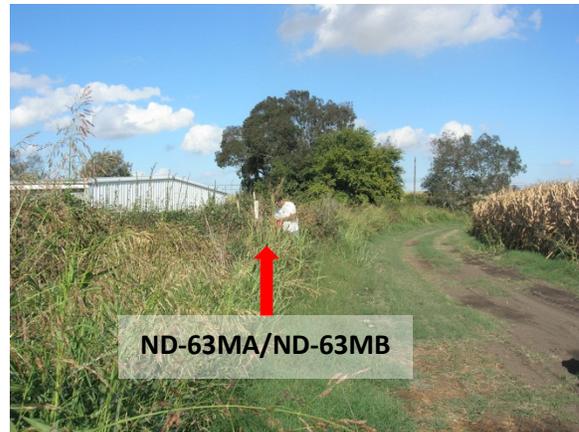
ND-63MA/ ND-63MB

Comments: Well located off access road, in berry bushes, near back the of the boat storage buildings. The well is marked by a reflective post. The site needs constant maintenance to keep access clear.

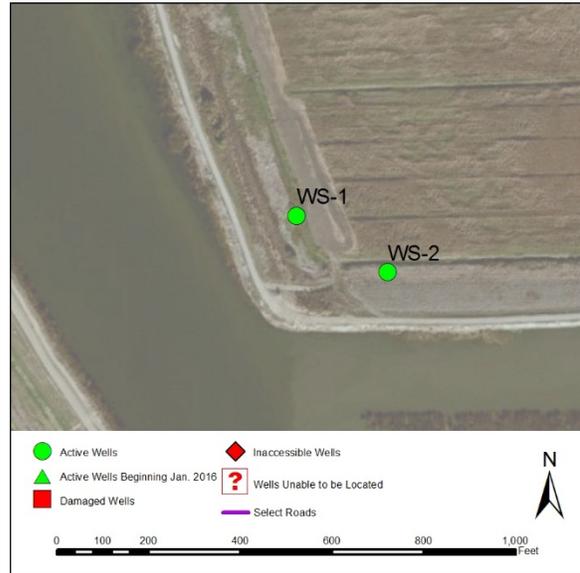
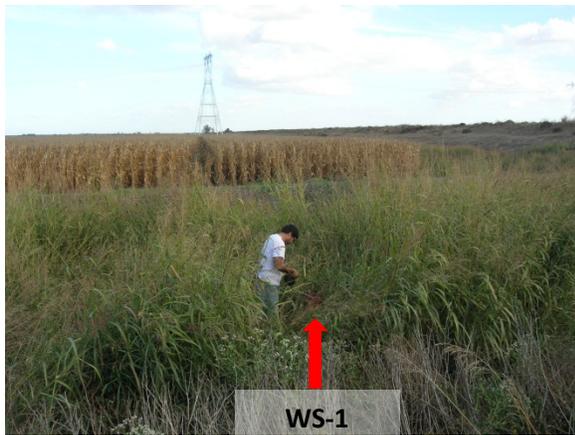
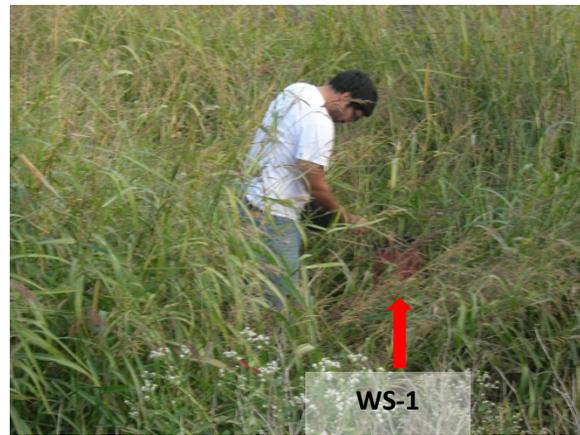
Comments: Well located at the levee toe, near ditch. The well casing is red and approximately 3ft high. Casing has a lid, but it is not locked. Island is accessed by ferry only.

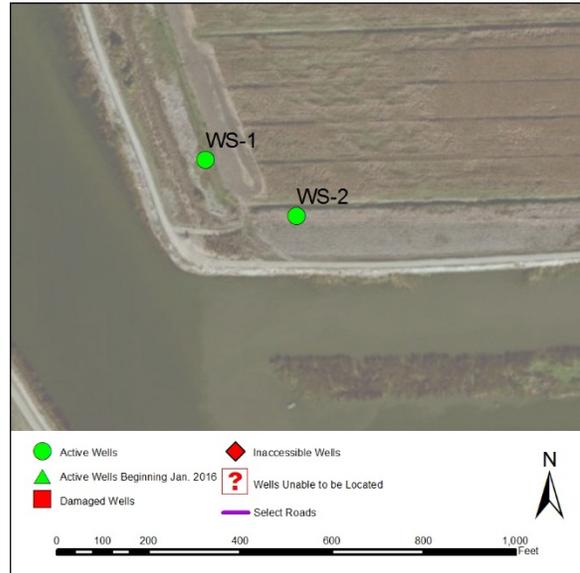
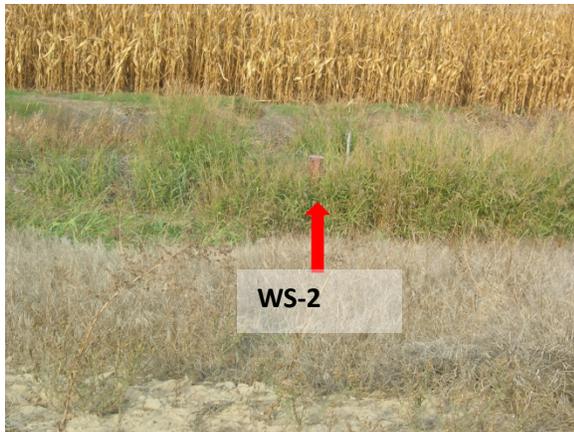
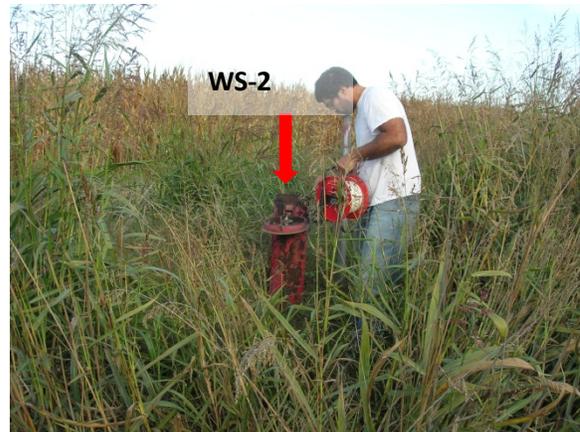
WS-2

Comments: Well located on levee toe, on the south side of the ditch, marked with a steel pipe painted red. Casing has a lid, but it is not locked. Island accessed by ferry only.

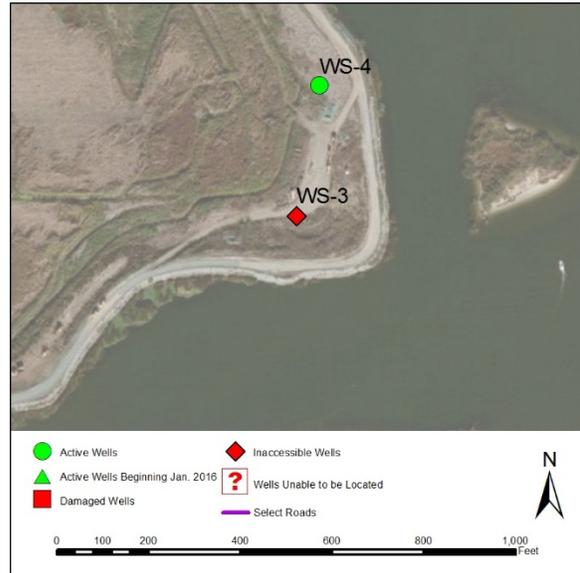
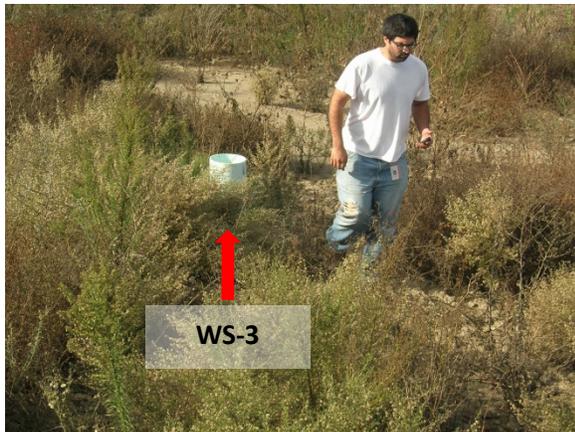
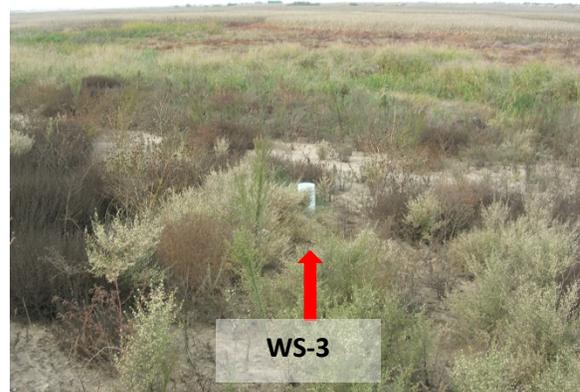
WS-3

Comments: Construction around site resulted in raising the ground level to a point the well could not be monitored. An extension tube was used to protect the well. Casing has a lid, but it is not locked. Island is accessed by ferry only.

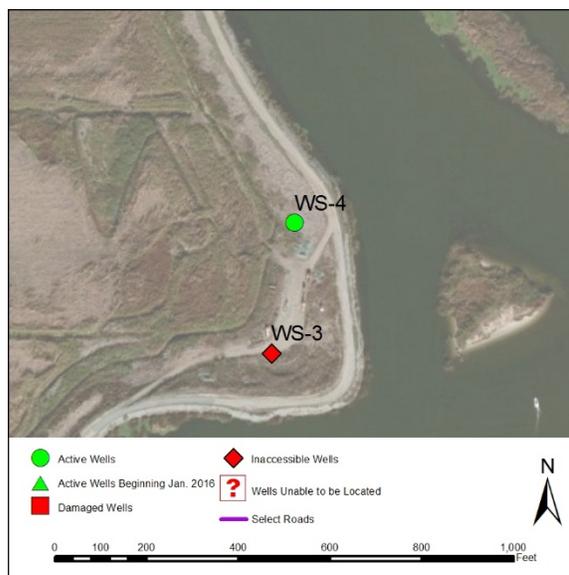
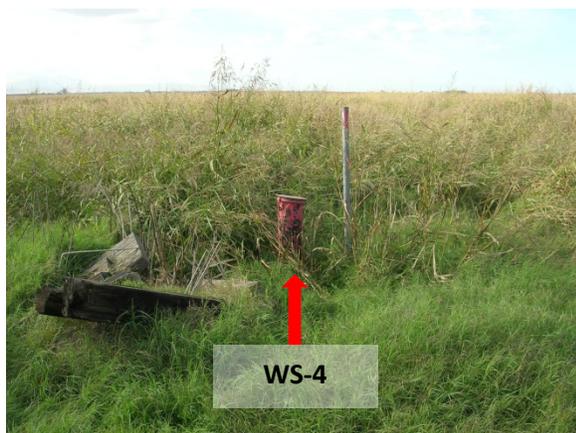
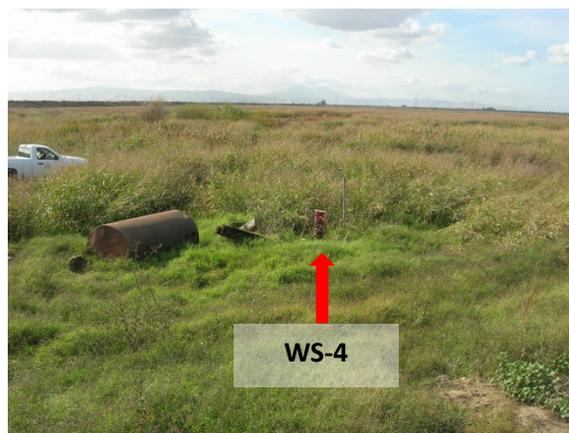
WS-4

Comments: Well located approximately 40ft from levee toe near abandoned metal debris. Well marked with steel pipe painted red at the top. Casing has a lid, but it is not locked. Island access by ferry only.

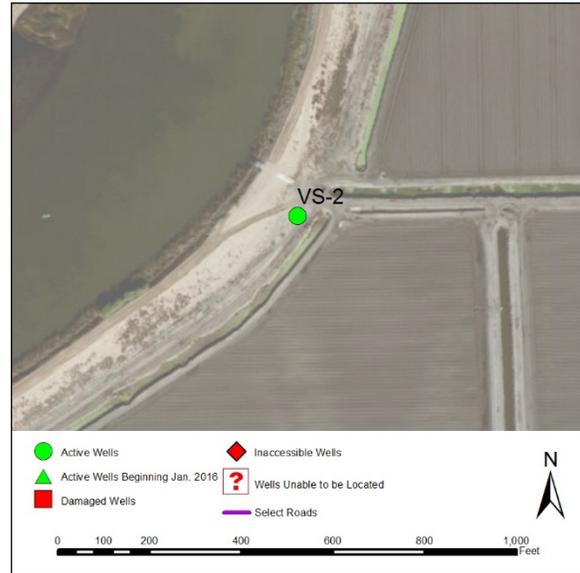
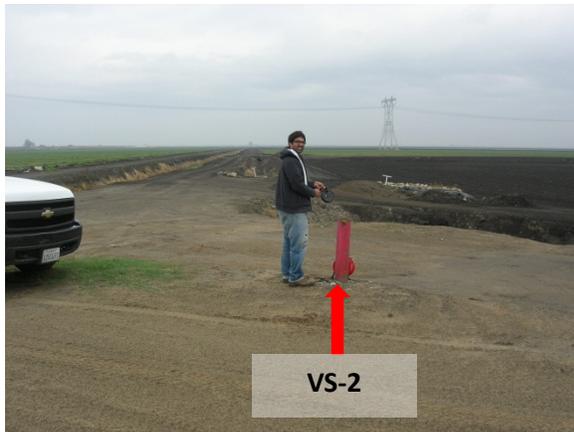
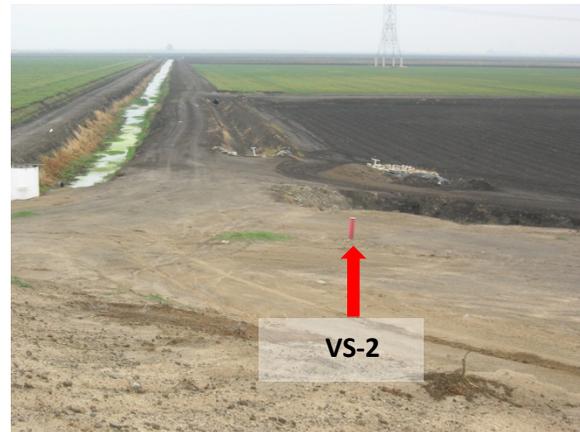
Comments: Well midway between levee toe and drainage ditch.

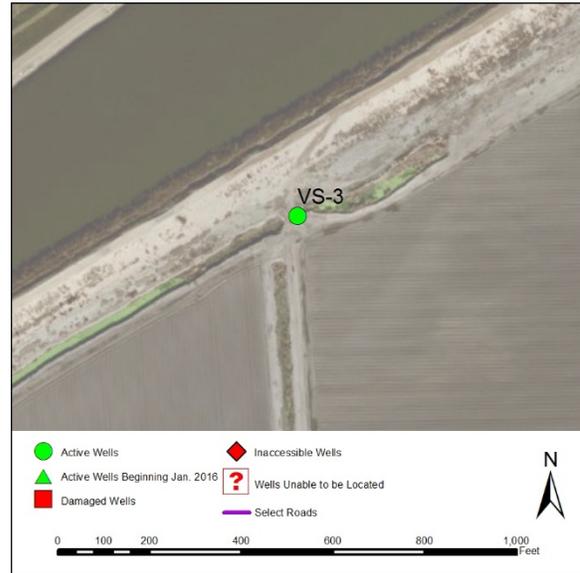
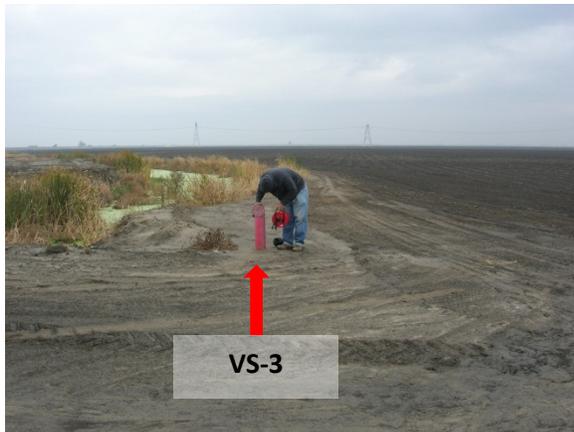
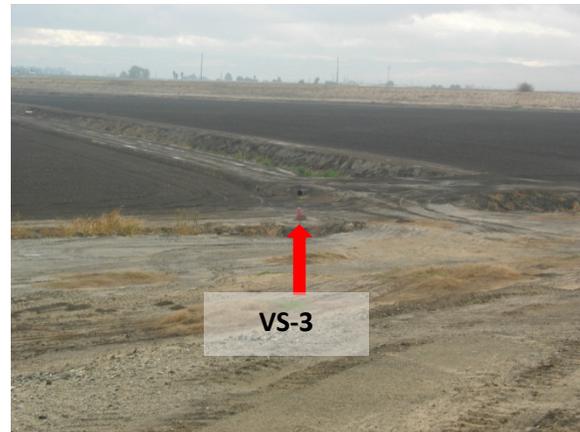
VS-3

Comments: Well adjacent to drainage ditch approximately 100ft from levee toe.
