North and South Delta Seepage Well Monitoring Network Update

Memorandum Report
April 2015

Subject: North and South Delta Seepage Monitoring Program Well Status Update

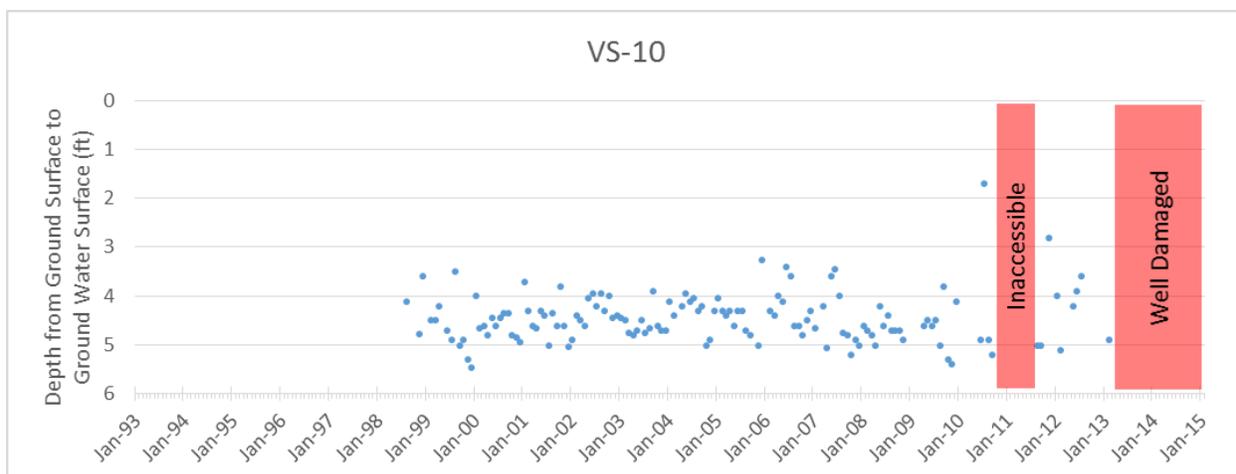
Comments: The well has been damaged, and has an obstruction in the casing. Well located at the base of the access ramp, near power/phone pole.

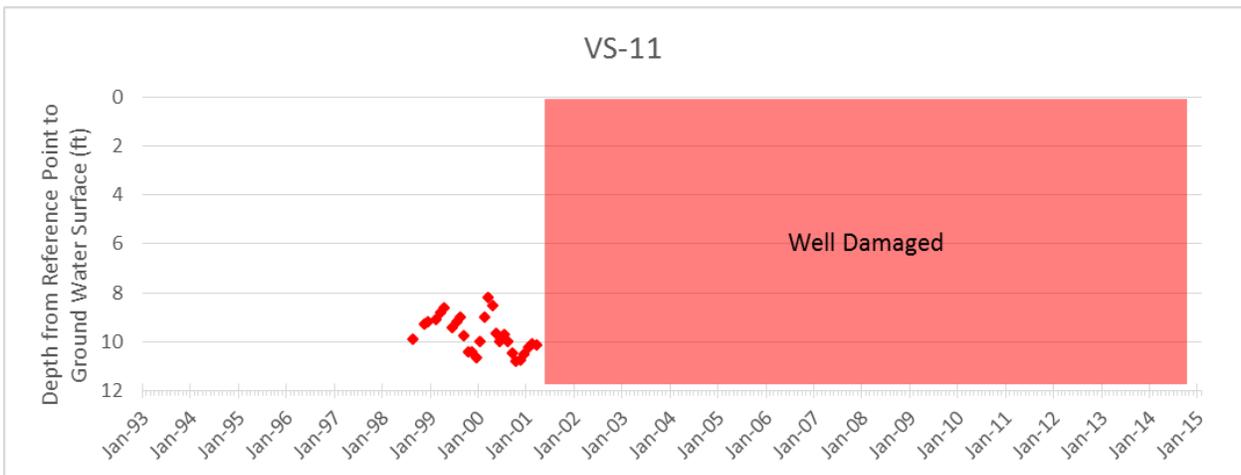
Comments: The well has been damaged.

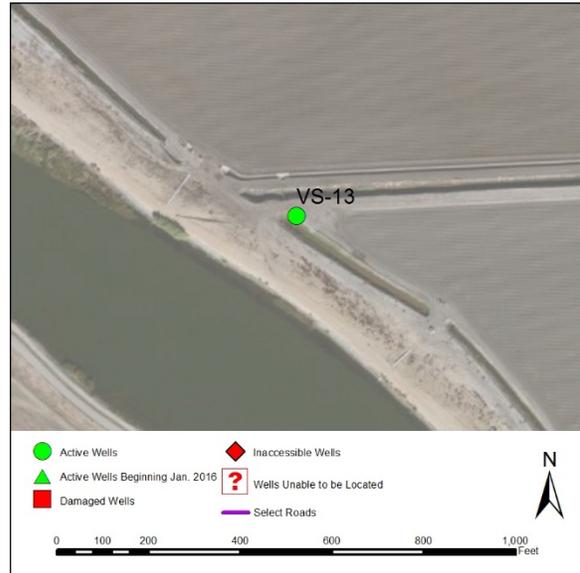
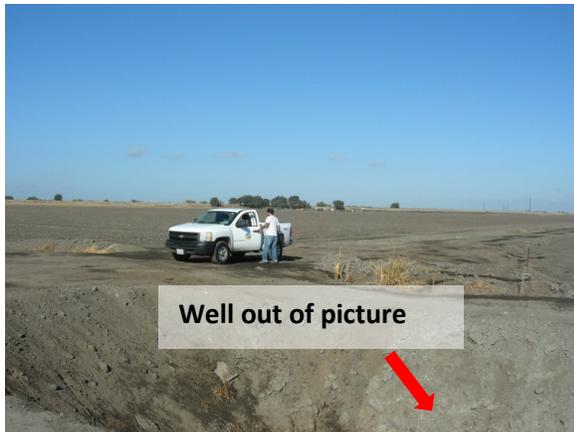
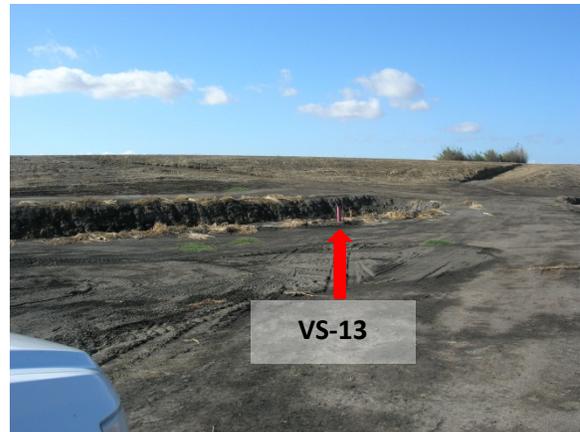
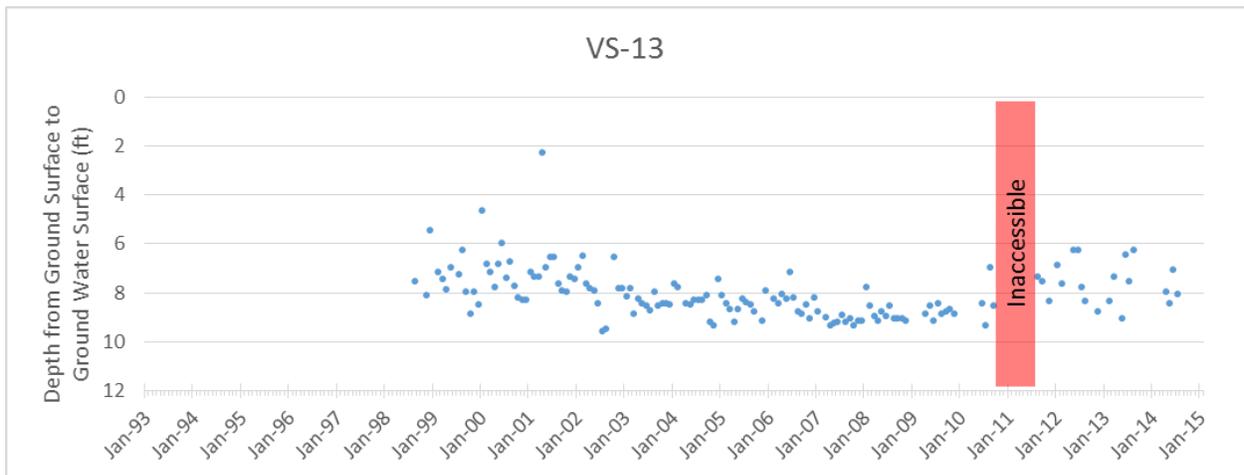
VD-3

Comments: Well located at the intersection of two farm roads, below grade. The well has been buried and has no data. Look at abandoning the well.

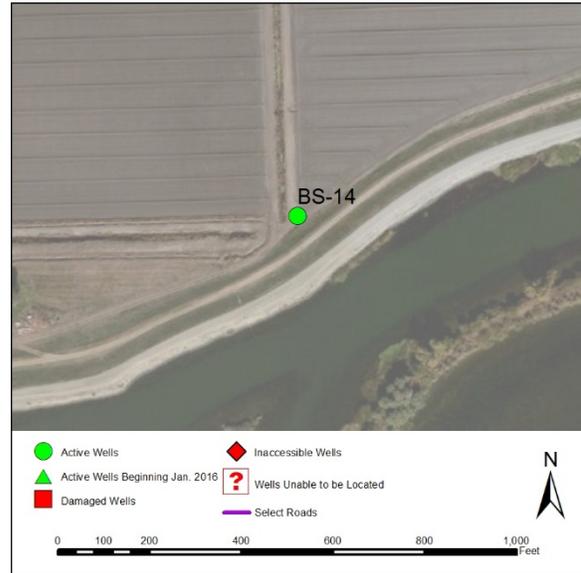
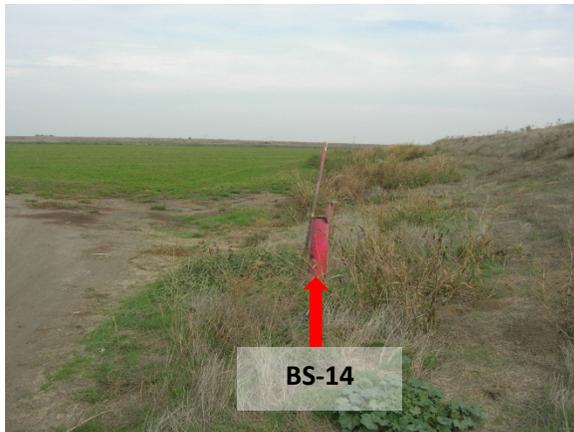
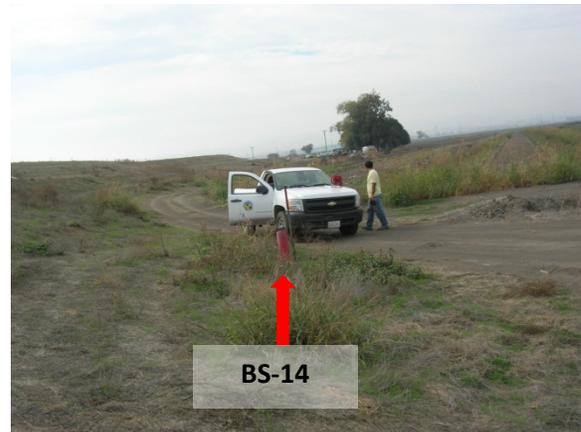
BS-14

Comments: The well is located on the levee toe, on the eastern side of the ditch just as the farm road turns north. Data gap in 2013 due to lost lock on gate.

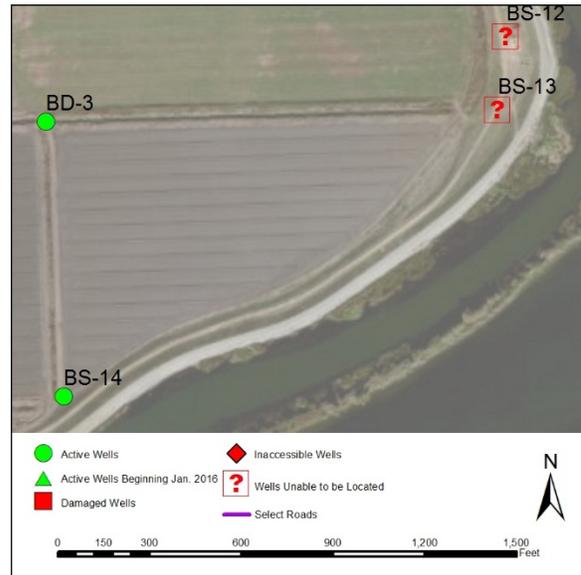
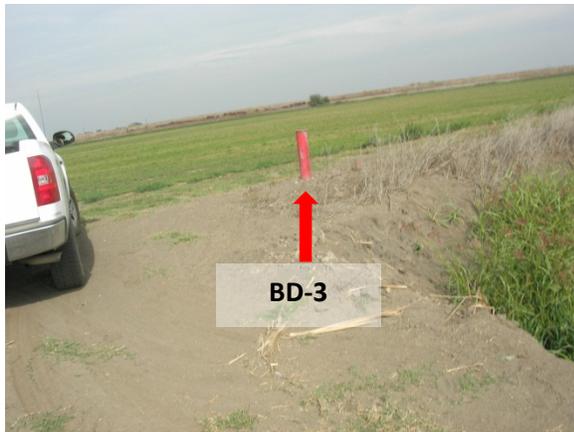
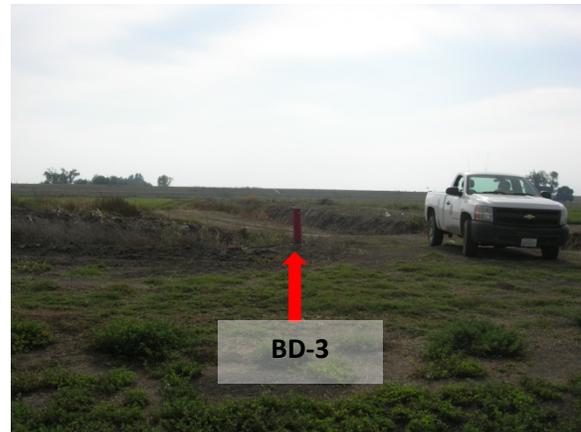
BD-3

Comments: Well is located at the intersection of two farm roads, and is on the north side of western end of the ditch.
